Preliminary Bat Roost Assessment Report

**Summerfield,
Horton-in-Craven,
BD23 3JT**

04.04.2024

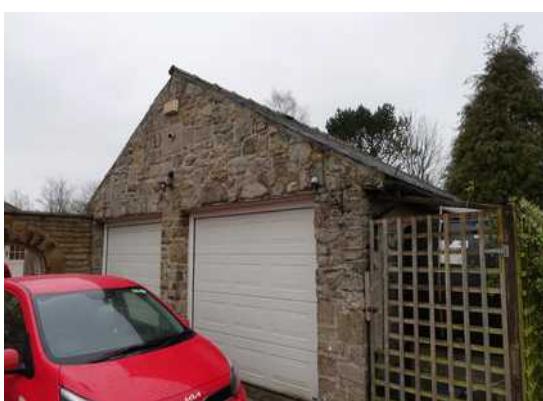
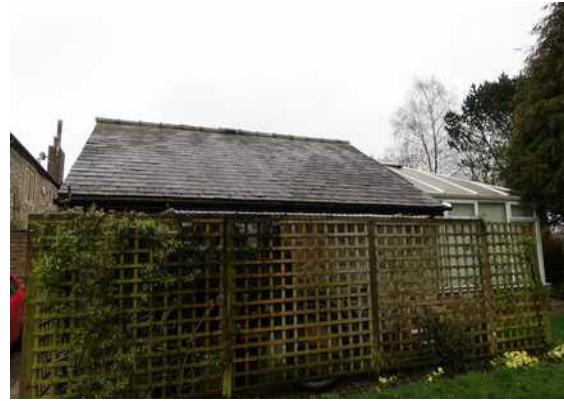
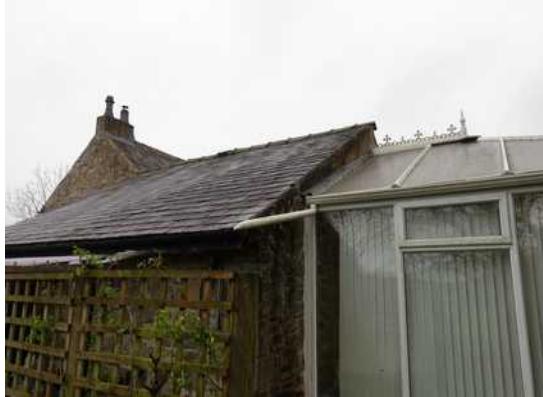
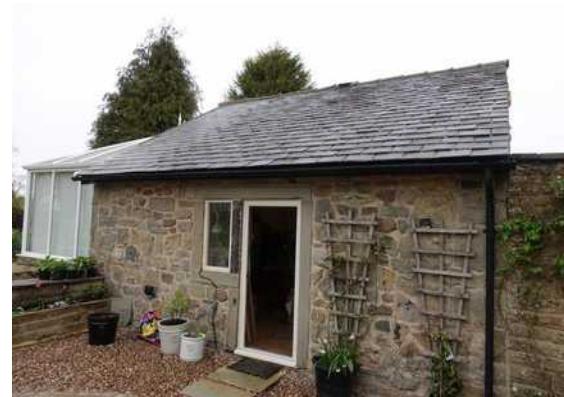
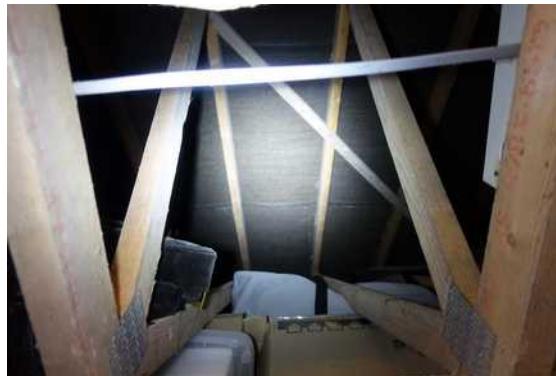
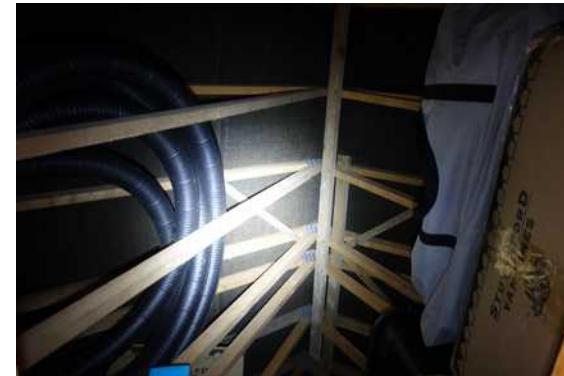
The property consists of a detached single storey stone built double garage with a double pitched slate roof. A single storey Upvc conservatory is present on the northern gable.

External walls are well pointed with no cracks, gaps or cavities present. Soffits and fascia boarding where present is generally close fitting and well sealed.

The roof is generally in good condition with close fitting slates, and no lifted, slipped or missing slates were observed. The ridge is pointed and sealed. Slates are lined with a bituminous roofing felt which is exposed to the interior.

Overall the property can be considered to offer negligible roosting potential.

The building was observed to generally have no obvious potential roost features present and was assessed as offering negligible bat roosting potential.

No evidence (in the form of scattered droppings, urine splashing, feeding remains or grease marking) to suggest use by bats was recorded despite suitable undisturbed horizontal surfaces being present within loft spaces.
