Preliminary Bat Roost Assessment Report

**4 Springs Road,
Longridge,
PR3 3TE**

29.05.2024

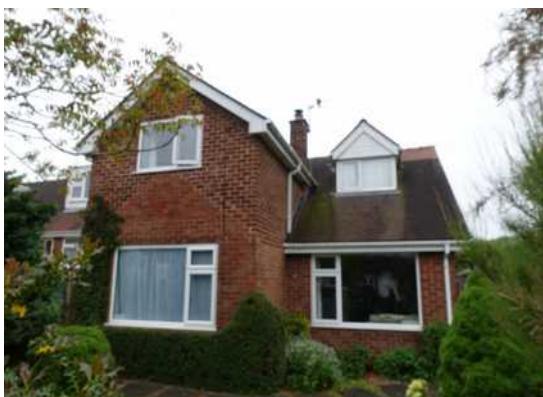
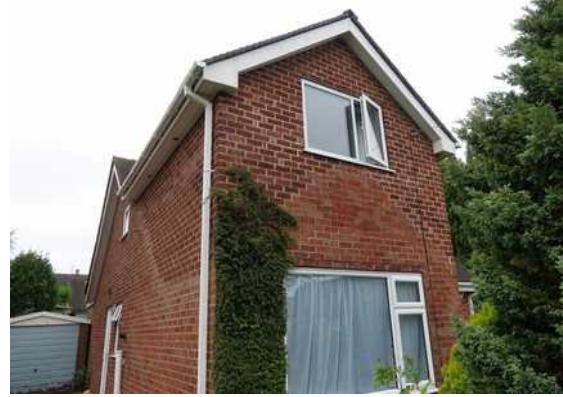
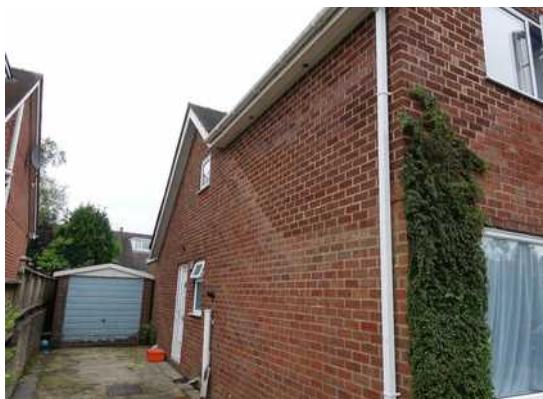
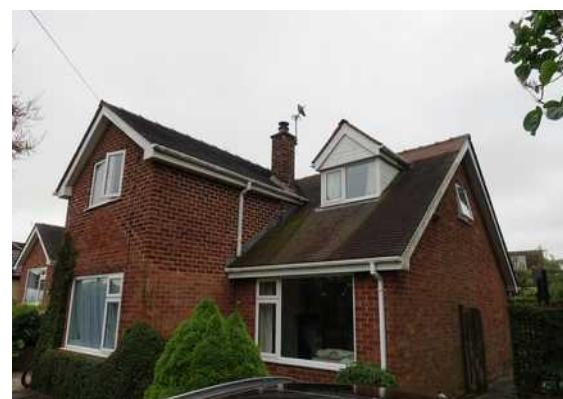
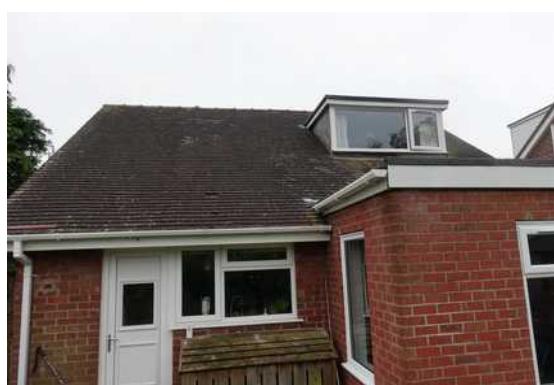
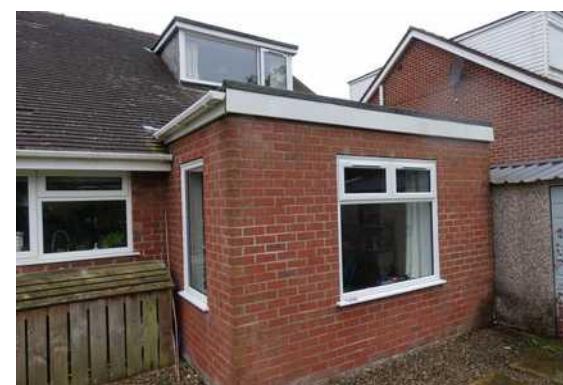
The property consists of a detached brick built two storey house with a double pitched tile roofs. Dormers are present on the frontage and to the rear.

External walls are well pointed with no cracks, crevices or cavities present. Gable ends are pointed and well sealed. Soffits and fascia boarding is close fitting and well sealed.

The roof is in good general condition with close fitting roof tiles, no slipped, missing or lifted tiles are present. The ridge tiles are pointed and sealed.

Overall the property can be considered to offer negligible roosting potential.
