**Bat Survey Report (preliminary day-time survey):
6A Lyndale Close,
Wilpshire,
BB1 9LX**

OS grid reference:
SD 6927 3321

Survey Date: 31/5/24

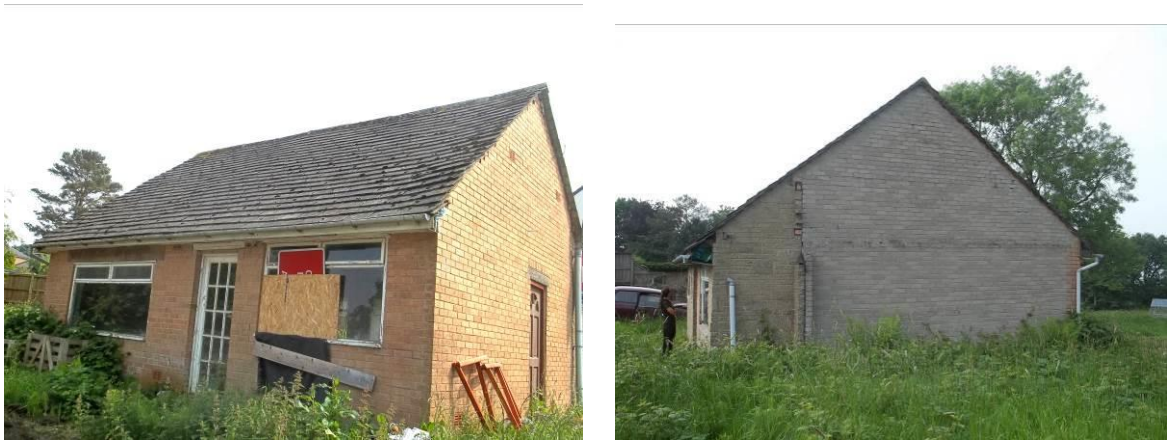
This is a small, modern, detached bungalow:

Front (north-facing) elevation and eastern gable end

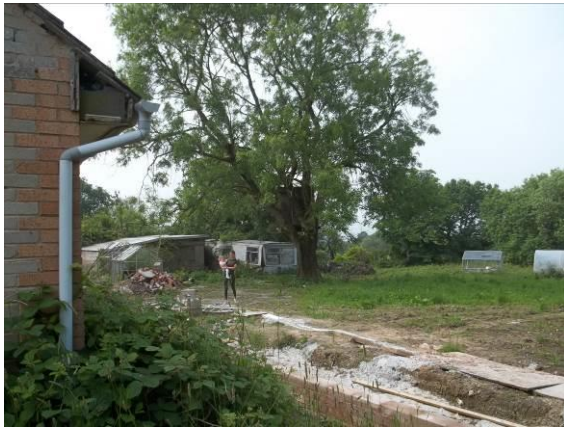
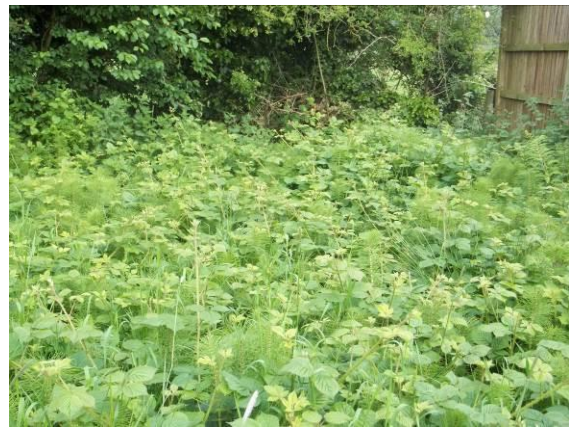
There is good bat feeding habitat immediately adjacent to the building and the garden of the property is becoming overgrown with brambles:

View from property looking north-west and east respectively

It will not be possible to undertake the bat activity survey work safely and effectively without some clearance of brambles. Fortunately, these currently are not very dense yet so probably are not being used by nesting birds. The clearance of a path to a vantage point to the south-east of the property should be possible. Clearance should be kept to a minimum however until the bat activity survey work is completed and in case any nesting by birds is taking place.

Safe access into the south-eastern part of the garden, which is currently becoming overgrown with brambles will be necessary. A surveyor will also need to be positioned on the neighbouring plot.

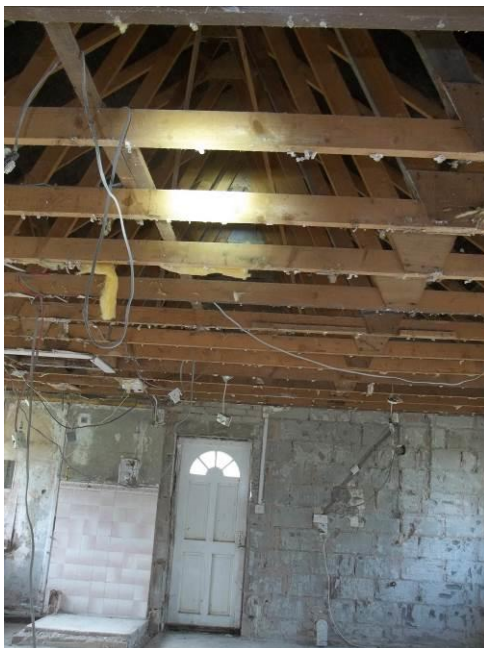
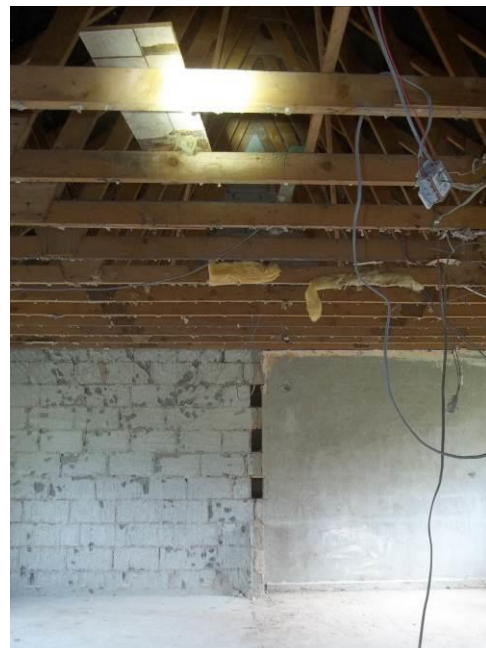
The interior has been completely stripped out, including the internal walls and ceilings, making the interior relatively unsuitable for use by roosting bats:

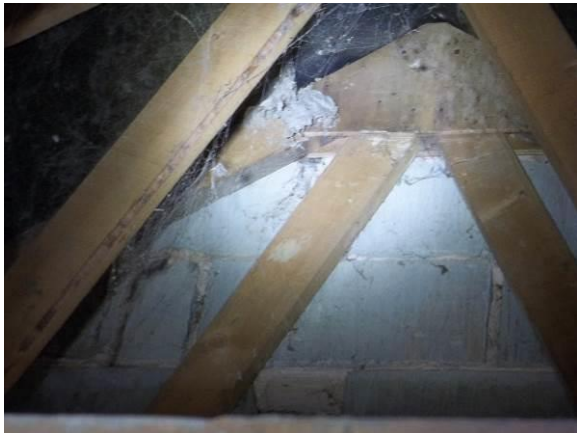
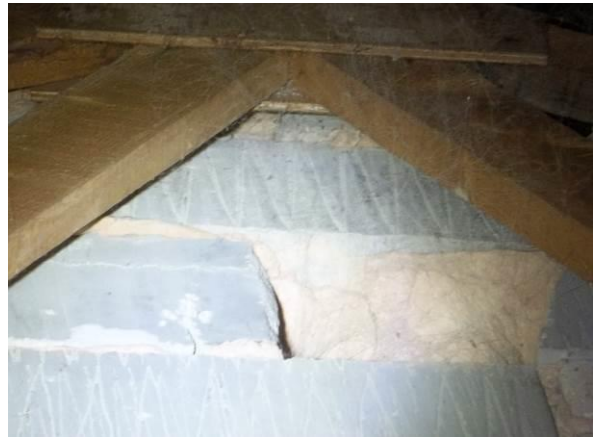
The internal surfaces of the upper gable walls were inspected as well as possible, for evidence of past roosting in the form of droppings attached to the walls:

There are places where bats could enter the walls from the interior and vice versa, but no evidence of past roosting was seen.

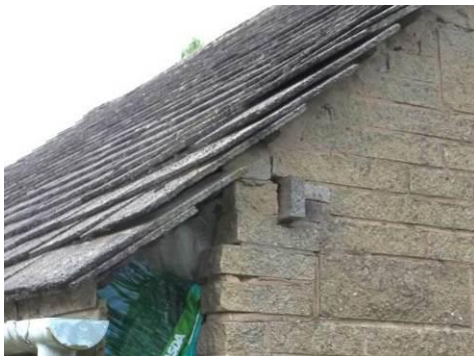
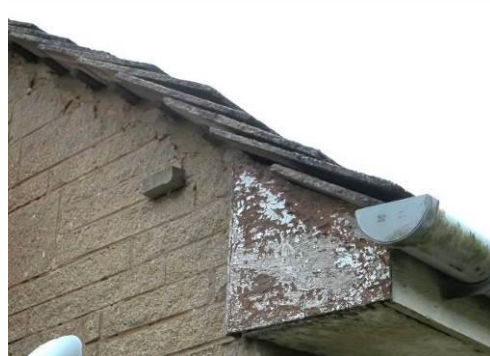
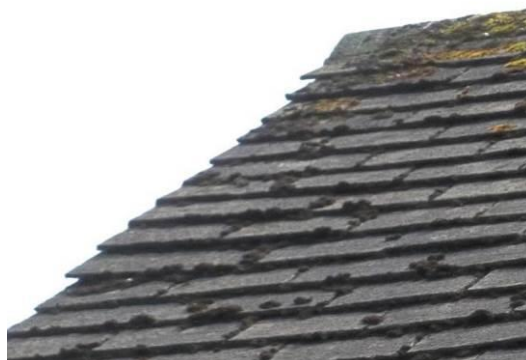
The roof-tiles are thin so generally close-fitting and are lined with bitumastic felt. There are a few places, mainly at gable ends, where bats could get beneath the tiles however:

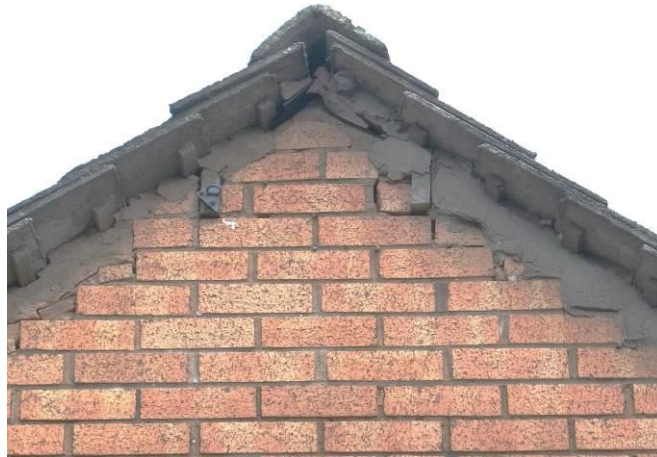
There's a gap at the west-facing gable apex allowing bats potential access under the ridge:

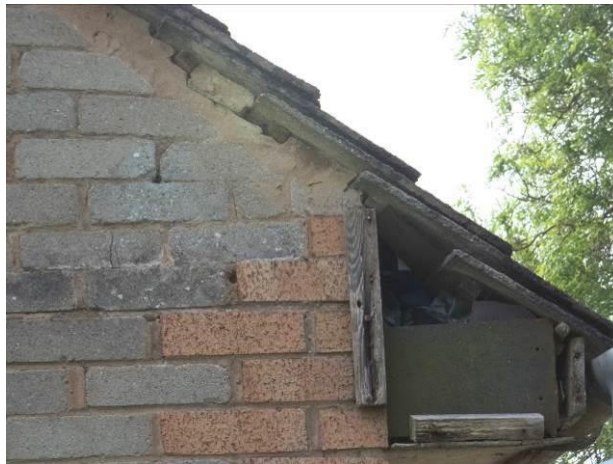
Verge mortar-work and eaves-boxing is missing in places:

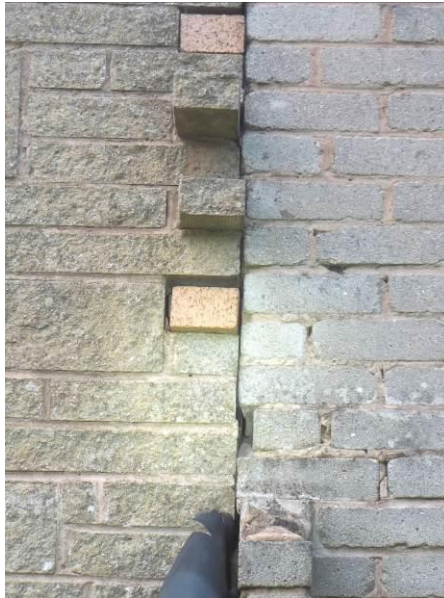
There is some potential access available into walls:

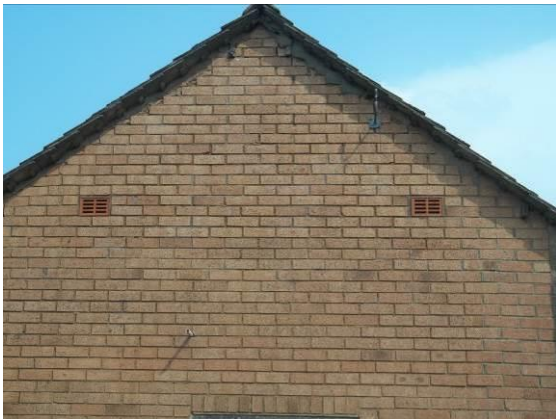
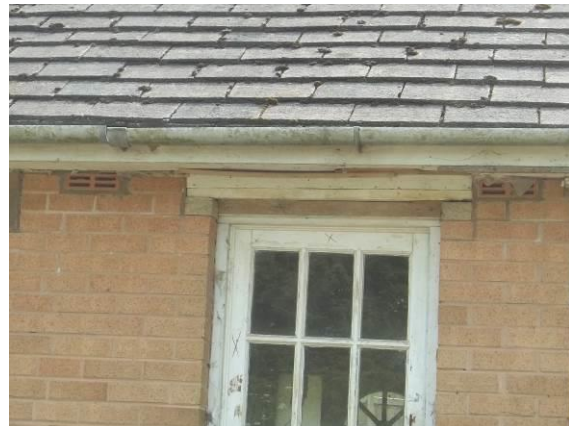
Air-vents also appear suitable for providing potential bat access into walls:

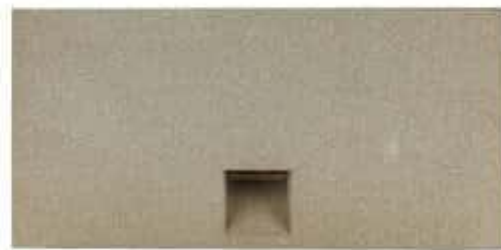
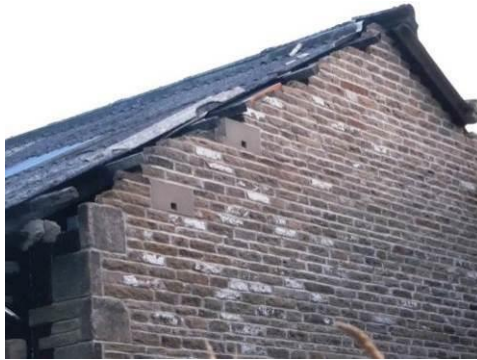
Cast Stone.

Dimensions: 440 x 100 x 215mm, with a 60 x 55mm aperture.

Above: typical unit of this design in situ. Photo © Angela Graham
