BAT SURVEY AT -  
6 RAILWAY VIEW ROAD  
CLITHEROE

DATE AND TIME OF VISIT  
24<sup>TH</sup> April 2024

REFERENCE NO. 6670

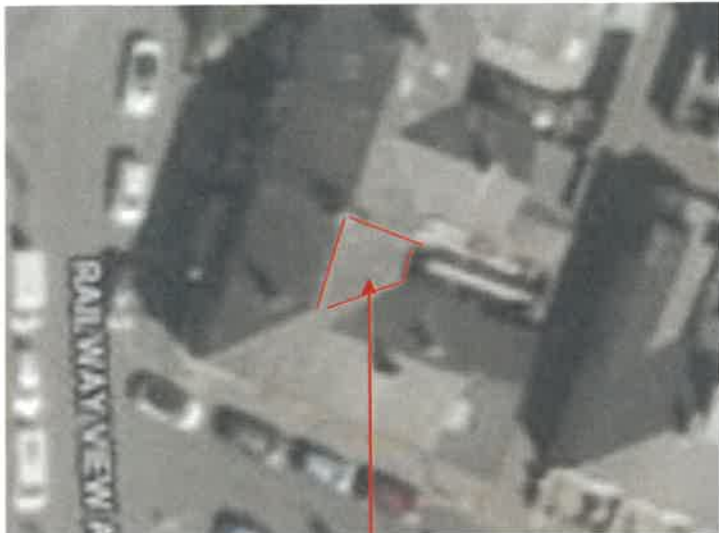
Location of proposed Dormer

Insertion of a dormer roof in the main roof rear pitch and conversion of roof space.

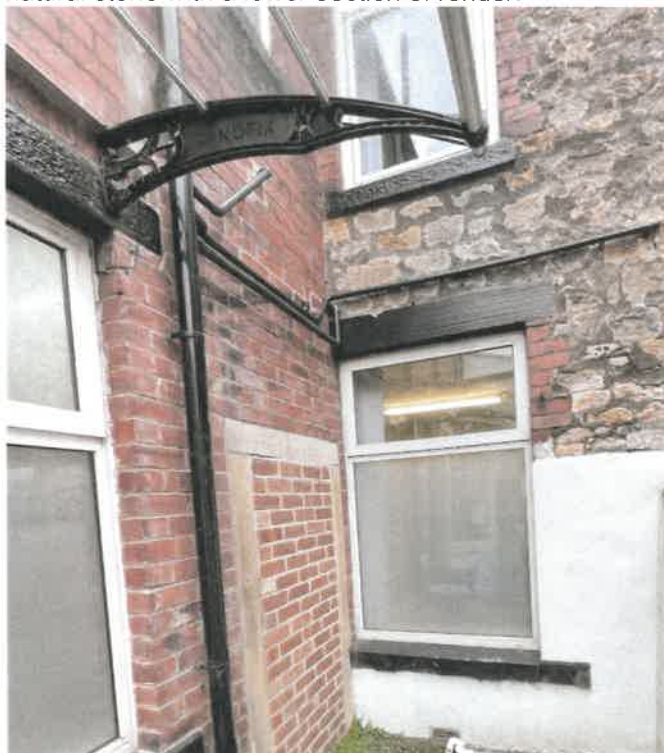
The walls are brick to the rear outrigger, the front elevation and rear wall of the main building is natural stone with a lower section of render.

The walls are well pointed and are in good condition. No cracks or crevices suitable for bat ingress were found to be present.

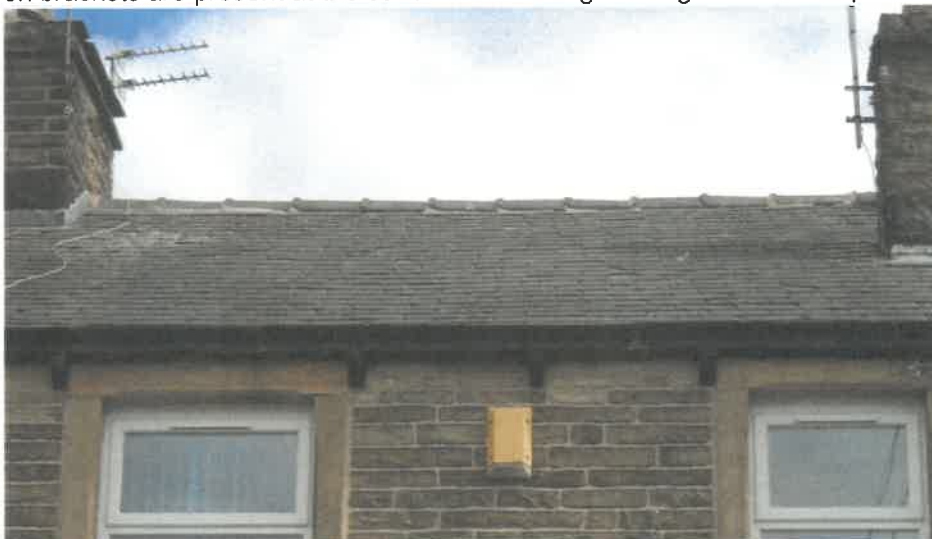
Main roof front pitch

The main roof and outrigger is blue slate with pointed ridge tiles and lead flashed chimney's. Gutters on brackets are present at the eaves. There is a glazed light in the rear pitch.

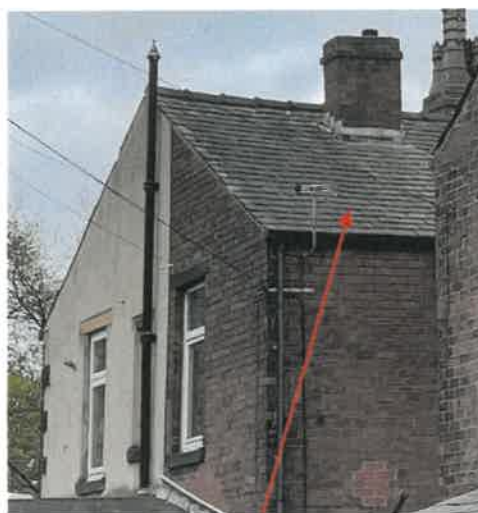
Outrigger mono pitch

The outrigger roof will not be affected by the insertion of the dormer roof.

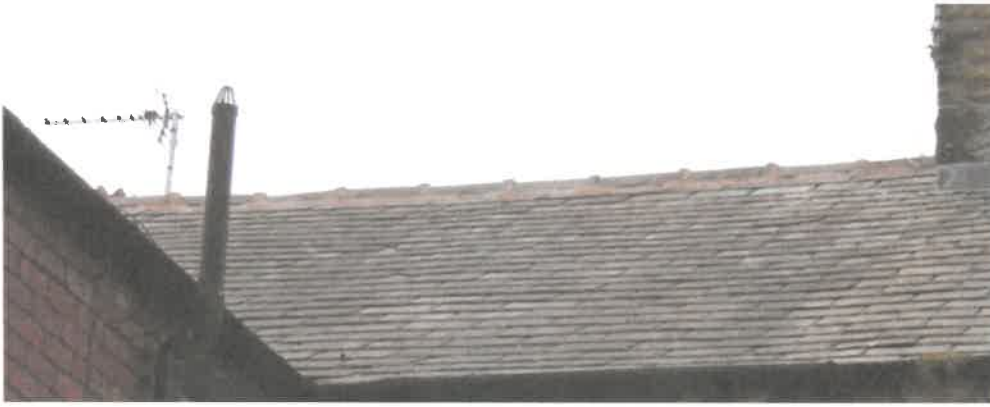
The roof is in excellent condition. The slates are very tight fitting and no slipped slates present. The pointing to the ridge tiles is in good condition with no missing sections or cracks. The gutters are in good condition and fit flush to the walls. No potential access points were evident.

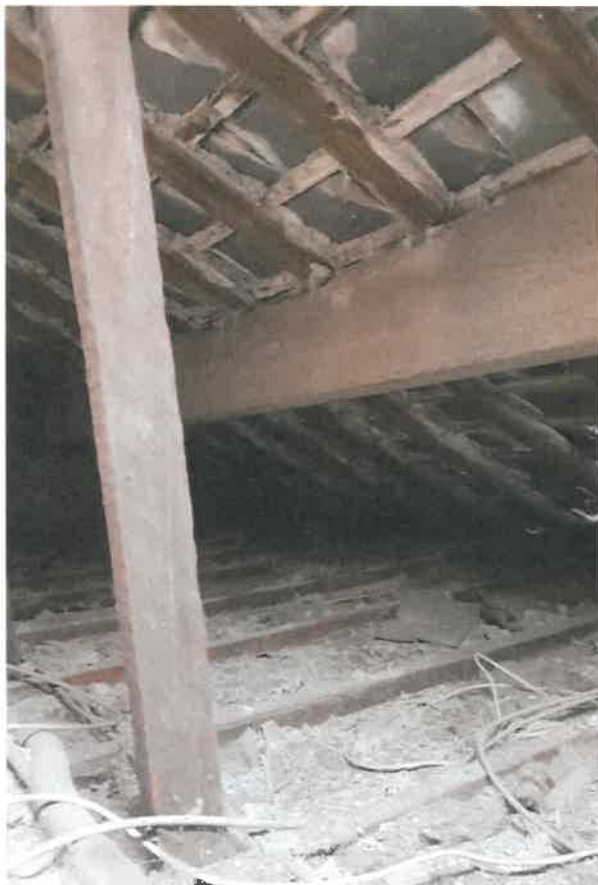
The roof space was accessible from the first floor landing. The timbers were in reasonable condition with no signs of rot or have any cracks present. The slates are fixed directly to the timbers no underlay is present. The space is very dusty due to the presence of back pointing to the rafters and battens.

The space is light due to the presence of the roof light.

The floor surface was examined for droppings or any insect remain feeding evidence, the result was negative.

The space does not provide any potential bat roost habitat.
