Project: 620

Newton in Bowland School Bell

Proposed Bell Restoration

Grade 2 List Entry 1072251

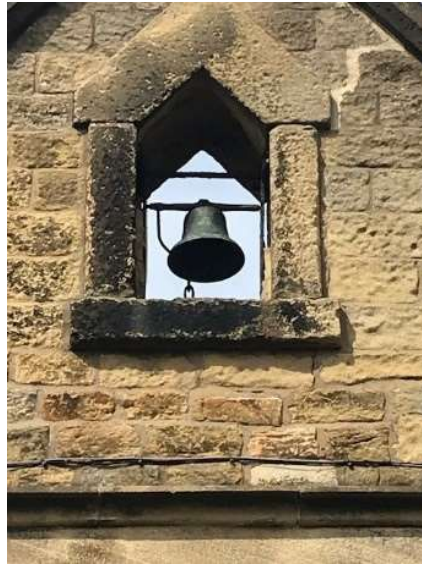
Appendix A

(see Appendix A) A photo of a (believed) local property provided by our client.

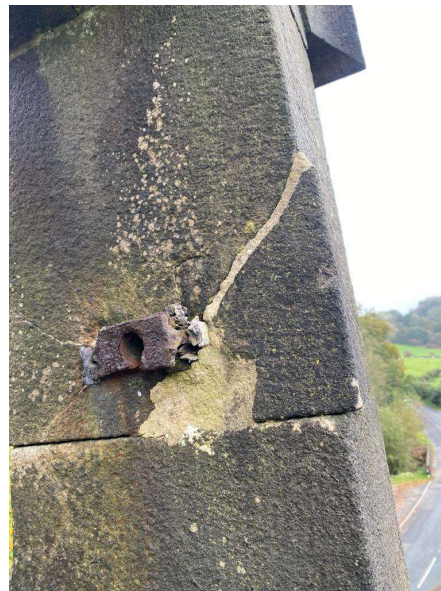
Appendix B

Based on the information gained and historic photographs provided and viewed on the web, Calibre have produced a working drawing (screenshot below for reference) for approval both aesthetically and structurally (attached with this document) scaled 1:10 @ A3.

We believe that the proposed arrangement is structurally capable of carrying the load of the heavy bronze bell (weighing around 20 kg) and will allow the bell to be rung from ground level.
