BAT SURVEY AT -
2 Church Close
Clitheroe

DATE AND TIME OF VISIT
3rd April 2.30 pm 2024

REFERENCE. Mr & Mrs S, Morton

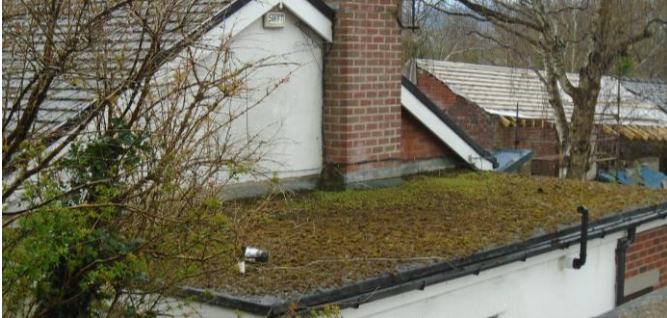
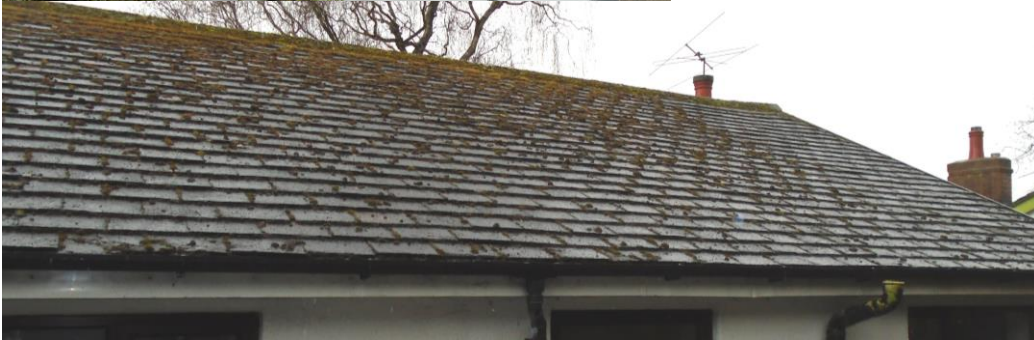
The main roof is pitched with a tile finish the eaves soffits, fascias and barge boards are white upvc. The flat roof is felt and lead flashed to the house gable wall . The white upvc fascias to the edge are flush fitting to the wall.

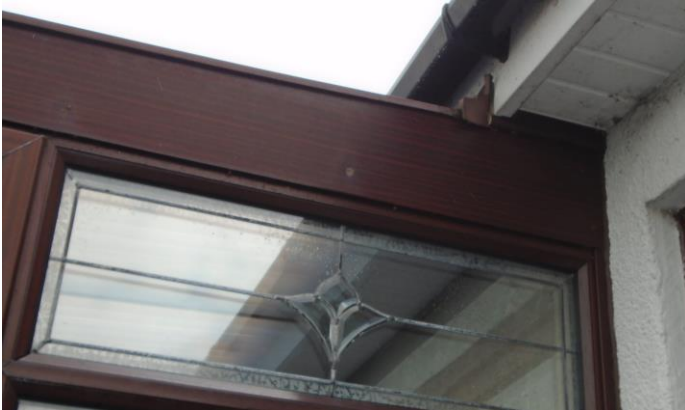
The conservatory/porch roof is clear polycarbonate with a slight fall from the eaves

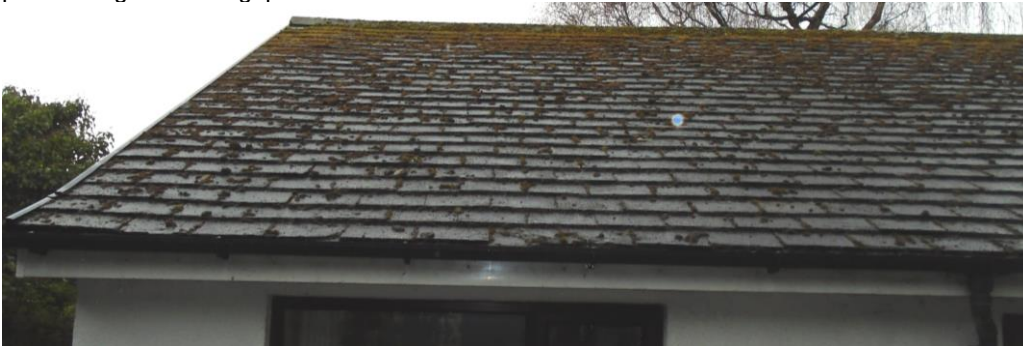
The tiles are very tight fitting, non are slipped or lifted. There is significant moss coverage to both pitches. The pointed ridges had no gaps and were well covered with moss.

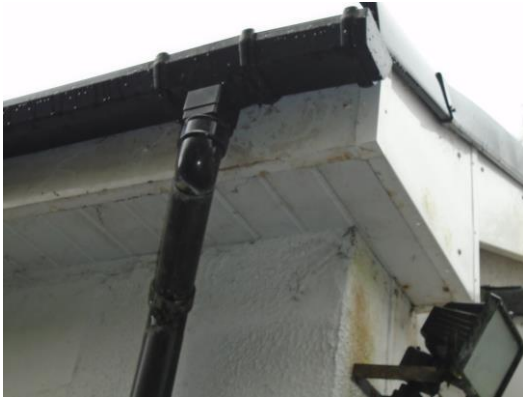
The upvc fascias and soffits are in good condition and very tight fitting at the wall abutments . No gaps could be found in the eaves. The fascias to the garage are flush with no gaps behind .

House soffit

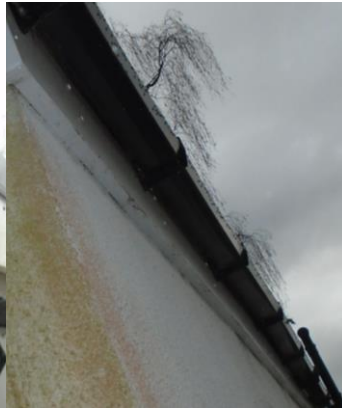
Garage fascia,

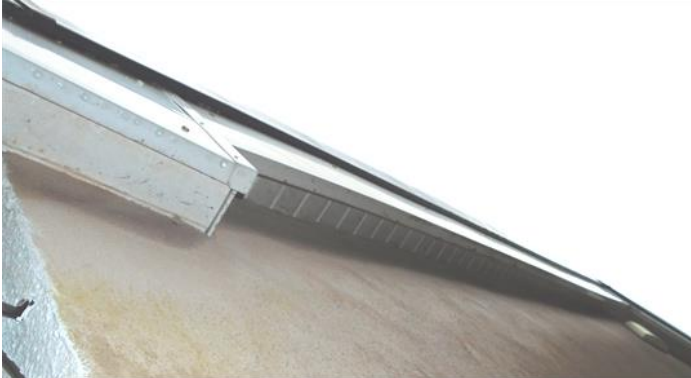
The flat roof has a significant moss coverage , the felt does not allow any potential for bat access . The flashing at the abutment with the wall is all in tact and tight fitting. The flat roof structure does not provide any potential bat habitat.

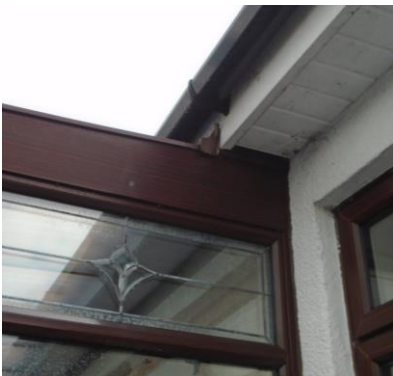
The porch roof and its flashing at the abutment with the house is tight fitting , access points, cracks or crevices are not present in the structure.

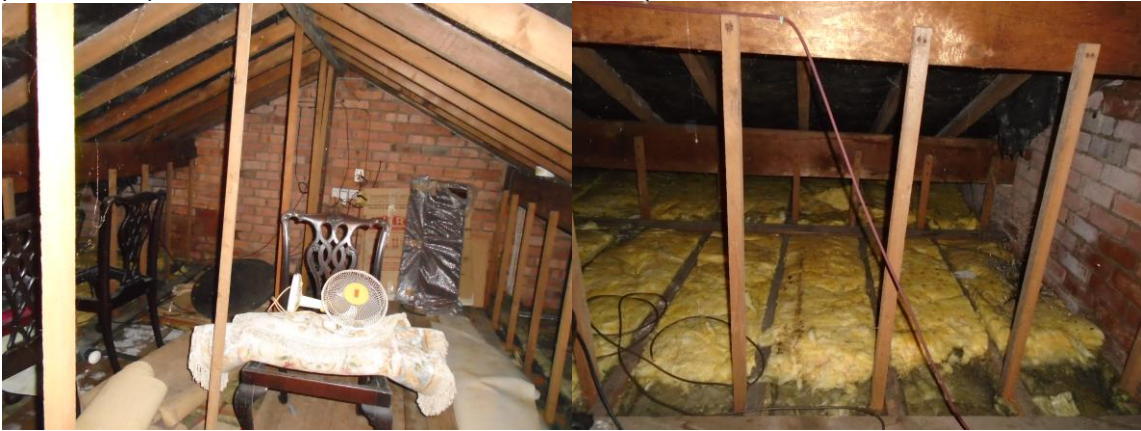
The main roof space is accessible via a ceiling hatch the timber rafters and purlins are in good condition with no cracks or crevices suitable for bat ingress. The felt is in good condition with no rips or sagging. The partially boarded floor and the visible insulation quilt is clean with no dropping or insect remains present, the space had no evidence of historic or current bat presence.

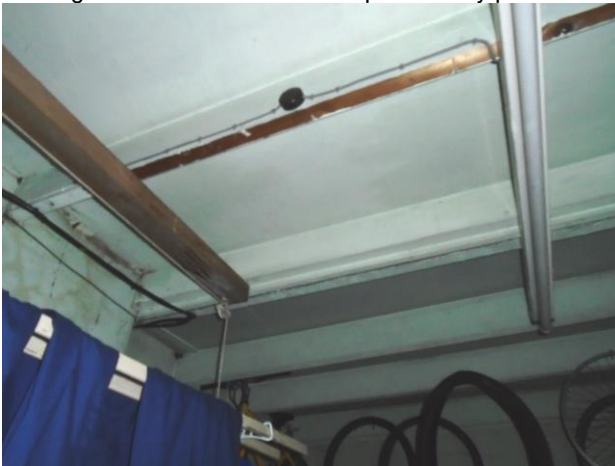
There is not an enclosed roof void in the garage, the joists and the boarded deck over are visible. It is in good condition and did not provide any potential bat habitat.

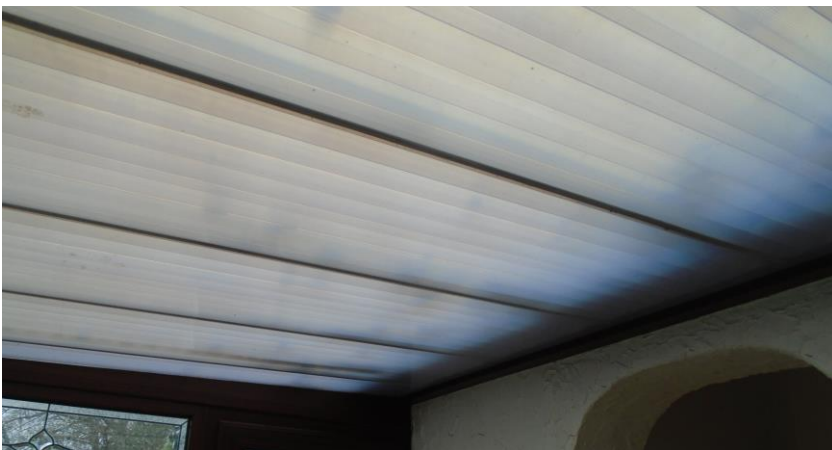
The polycarbonate roof sheet roof on the porch does not provide any roost potential.
