## LAND OFF CHAPEL HILL, LONGRIDGE

### Site Investigation & Ground Assessment

Report Ref: BEK-21960-2

April 2024

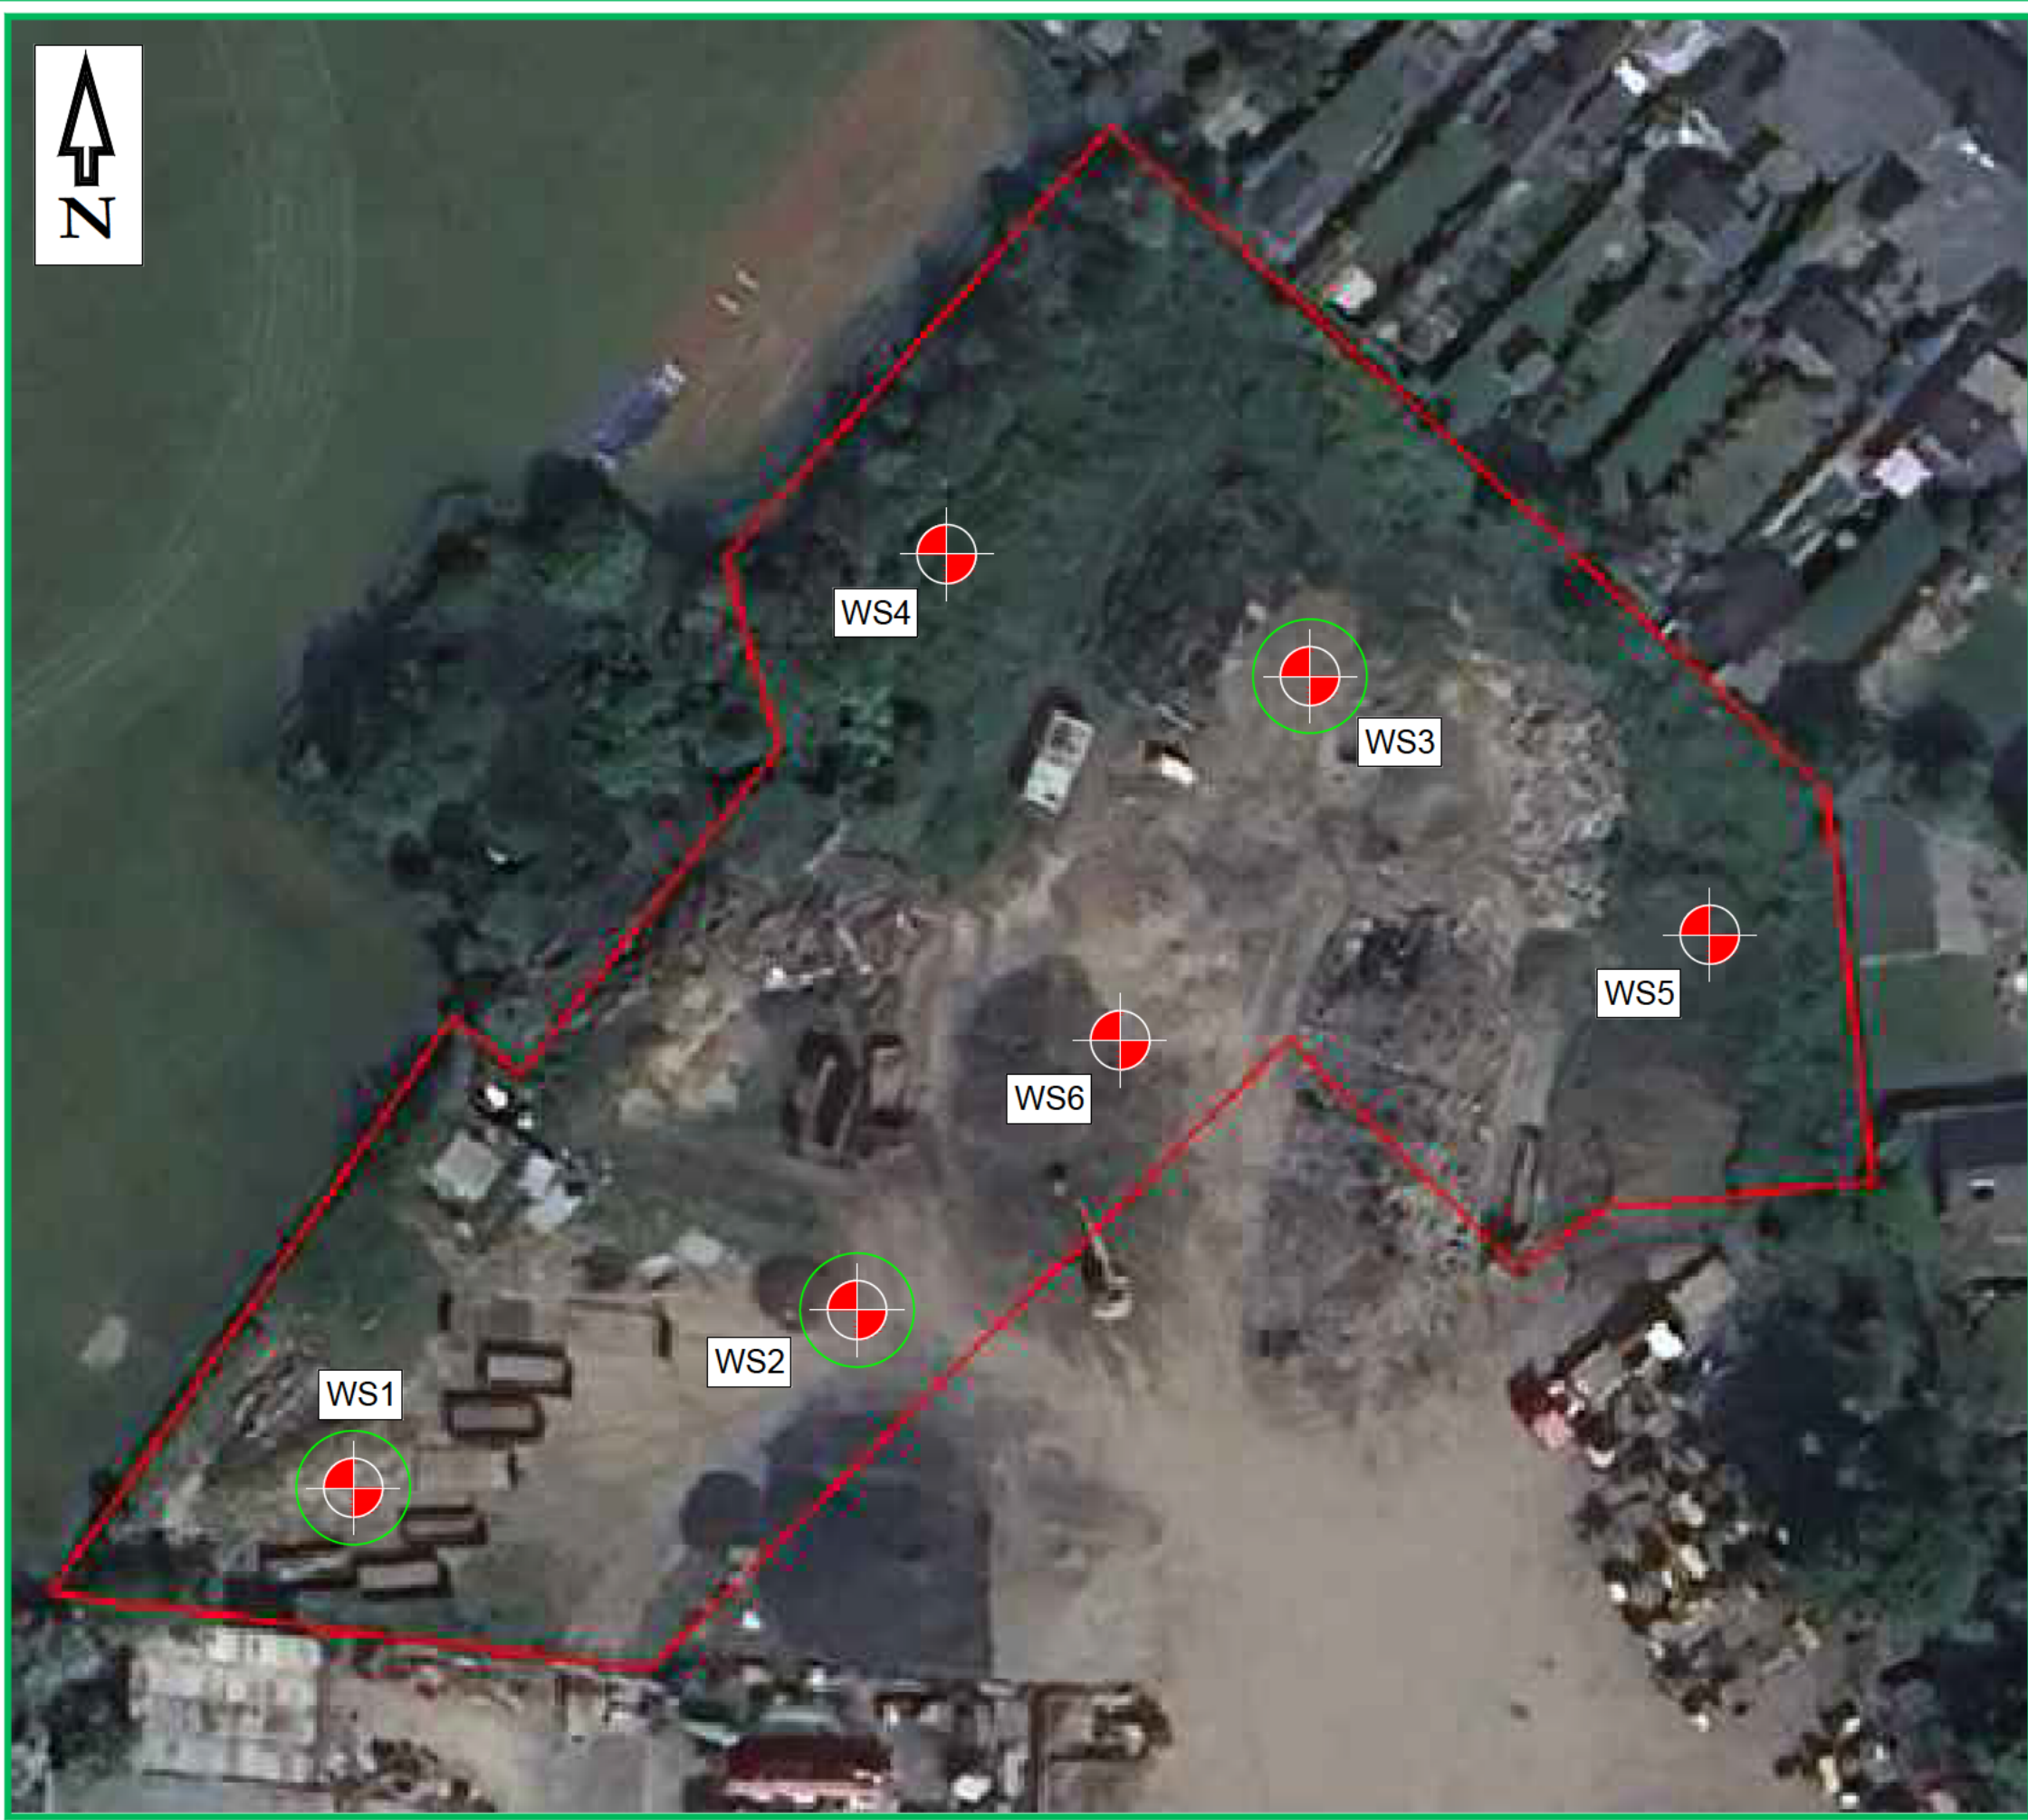
| DRAWING No.<br>21960-3 | | | REV.<br>- |

- 3.2.1 Six window samples were drilled using a window sample borehole rig to a maximum depth of 4.45 m. Borehole locations were set out by the site engineer in order to establish representative conditions at the site. In-situ testing (SPTs) were carried out in each of the boreholes.
- 3.2.2 The ground conditions were recorded by an engineer from BEK and samples were recovered for chemical testing. Gas and groundwater monitoring probes were installed in three of the boreholes (Borehole No WS1, WS2 & WS3), the details of which are presented in the borehole records.
- 3.2.3 Copies of the borehole records are presented in Appendix A. The window sample borehole locations are illustrated on BEK Drawing No 21960-3 presented in Appendix D.

- 3.1.1 This section provides a summary of the site investigation works undertaken by BEK during March 2024.
- 3.1.2 The site investigation has been designed to provide indicative information for the ground conditions across the site and to provide a quantitative assessment of potential risks associated with contamination and ground gas. The site investigation was also designed to provide recommendations with respect to foundation design.
- 3.1.3 Six exploratory locations were set out by the site engineer to establish representative conditions at the site. The exploratory locations are illustrated on BEK Drawing No 21960-3, a copy of which is presented in Appendix D.
