Proposed residential development
Land east of Chipping Lane
Longridge, Preston

Ground Investigation Report
(Phase 2)

**Proposed residential development
Phase 2
Land East of Chipping Lane
Longridge
Preston
PR3 2NA**

GROUND INVESTIGATION REPORT

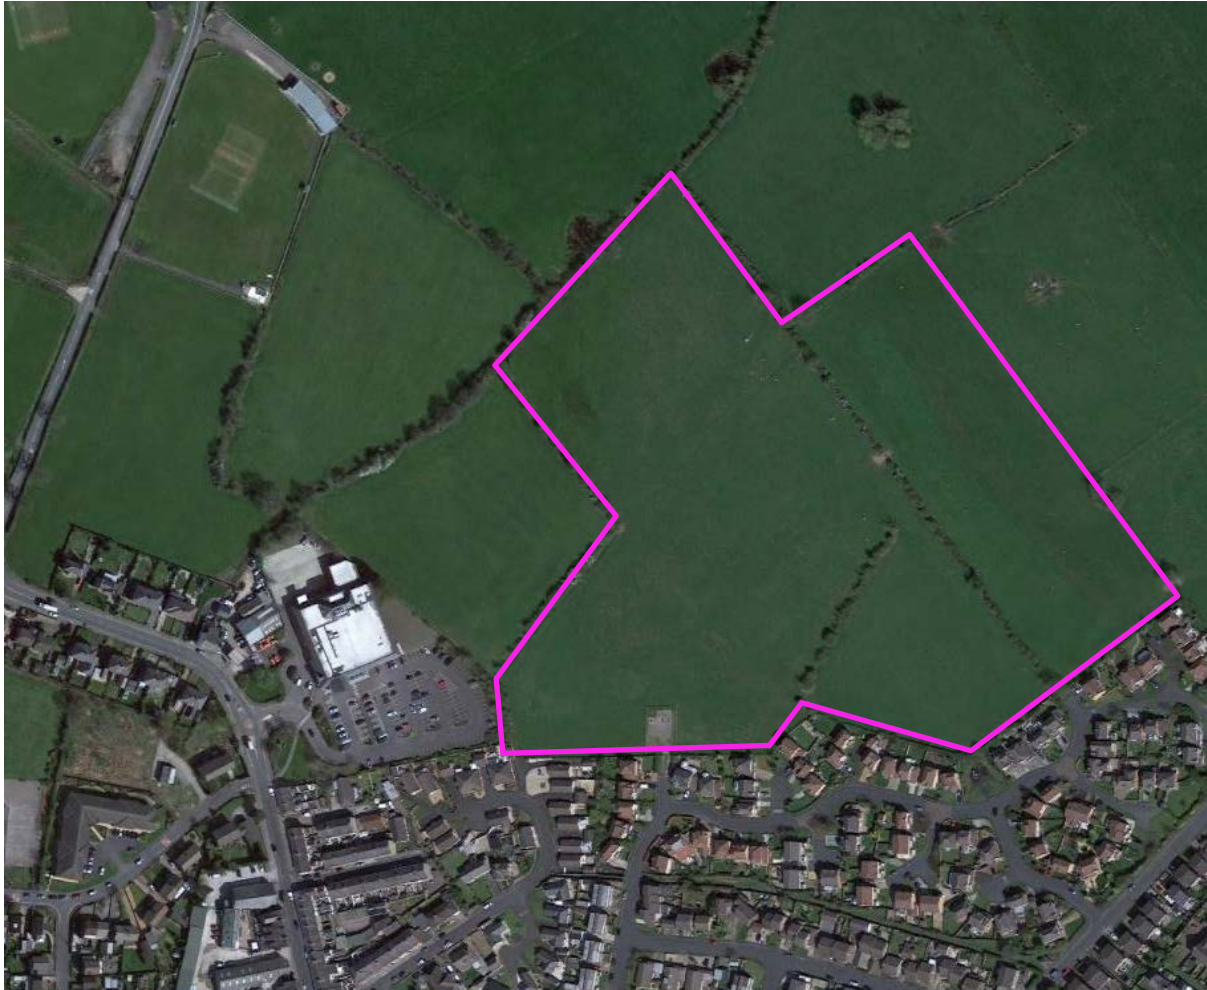
Aerial photograph of site

Approximate Phase 2 site boundaries edged in pink

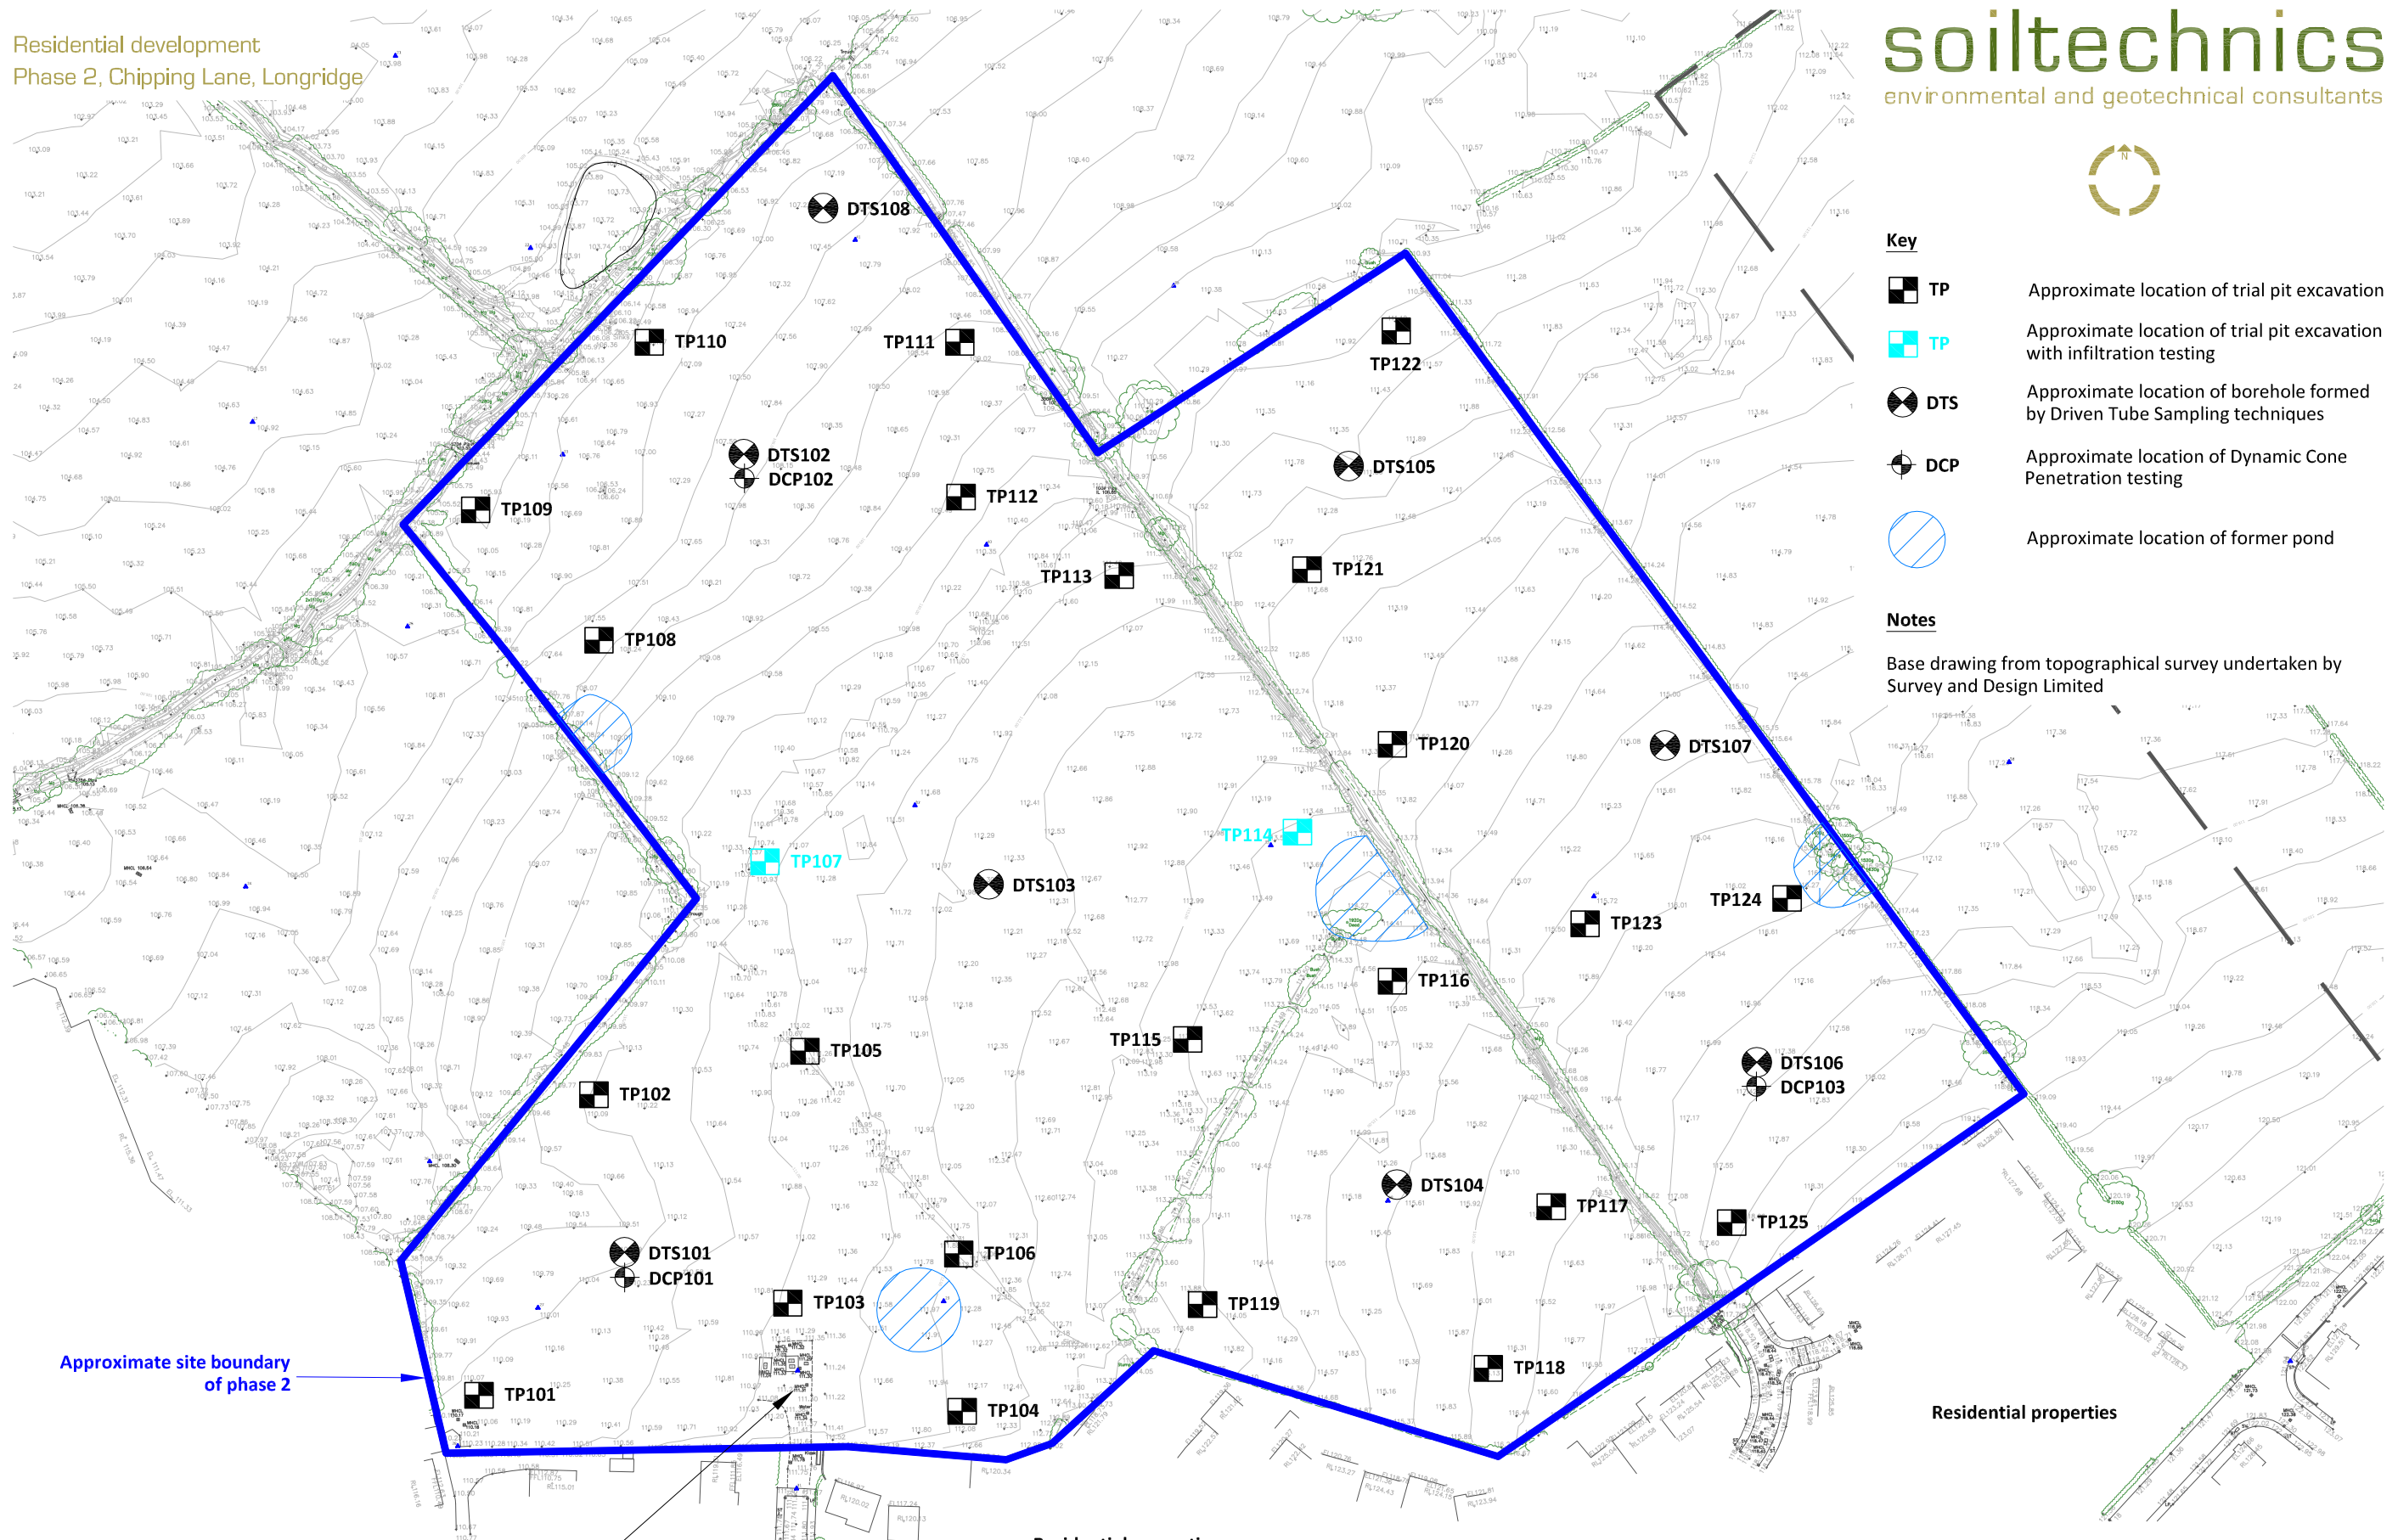
Base drawing from topographical survey undertaken by Survey and Design Limited

Approximate site boundary of phase 2

Underground services access area

4.1.2 A plan of the site showing observed/existing site features and position of exploratory points is presented on Drawing 02b. The position of exploratory points relative to site development proposals is presented on Drawing 03. The position of exploratory points shown on these plans is approximate only and confirmation of these positions is subject to dimensional surveys, which is considered outside our brief.

8.5.4.1 A full description of the site and observed adjacent land uses is provided in Section 3 of this report. A plan summarising observations made on site during our site reconnaissance visit is presented on Drawing 02b.
