Proposed residential development
Land east of Chipping Lane
Longridge, Preston

Ground Investigation Report
(Phase 2)

**Proposed residential development
Phase 2
Land East of Chipping Lane
Longridge
Preston
PR3 2NA**

GROUND INVESTIGATION REPORT

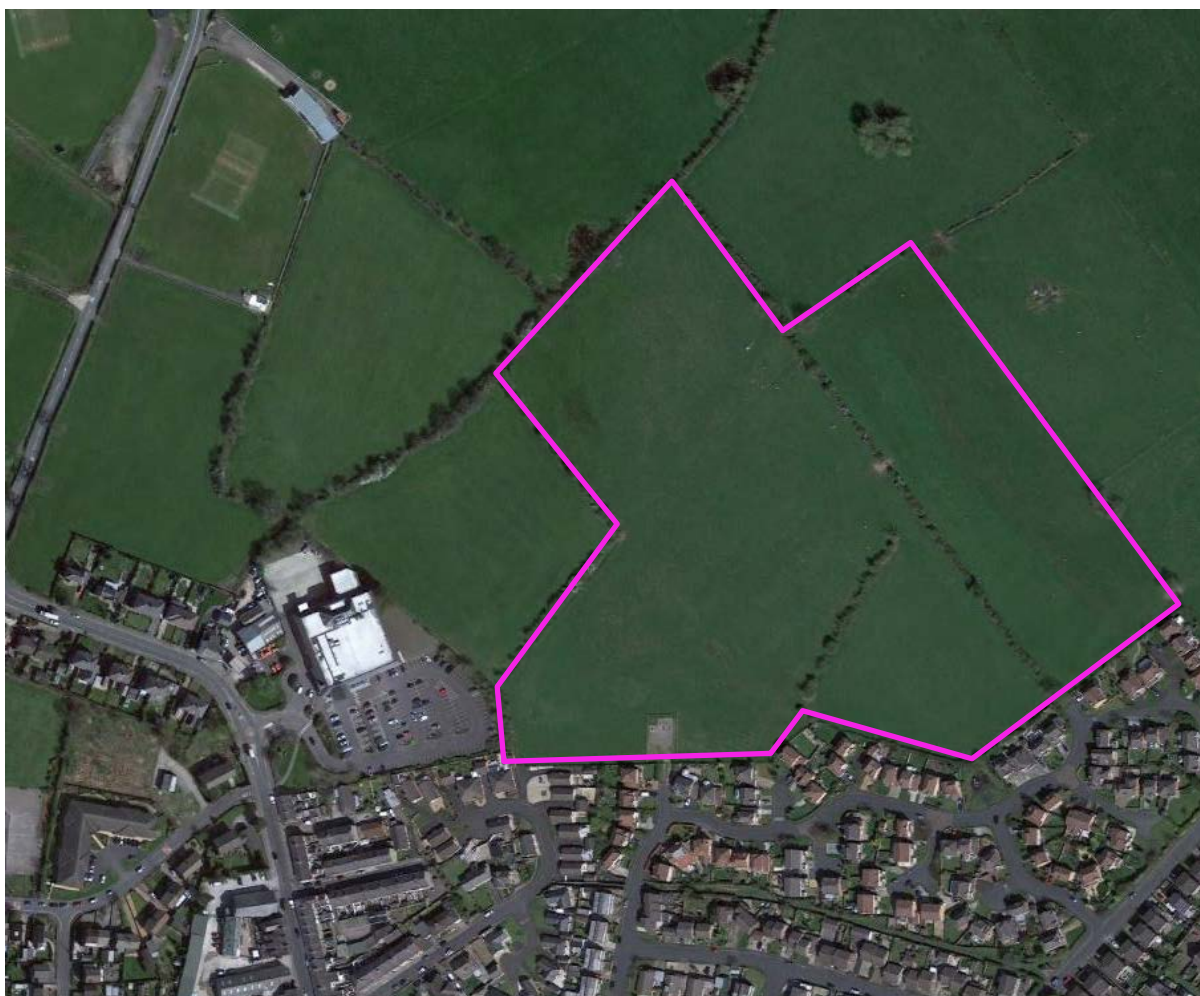
Aerial photograph of site

Approximate Phase 2 site boundaries edged in pink
