**Re: Preliminary Roost Assessment: 8 Belmont Court, Longridge, PR3 3TG**

PENNINE ecological have been commissioned to undertake Preliminary Roost Assessment (PRA) at the above site. The purpose of this study is to address any potential issues in relation to bats resulting from the proposal to extend the building.

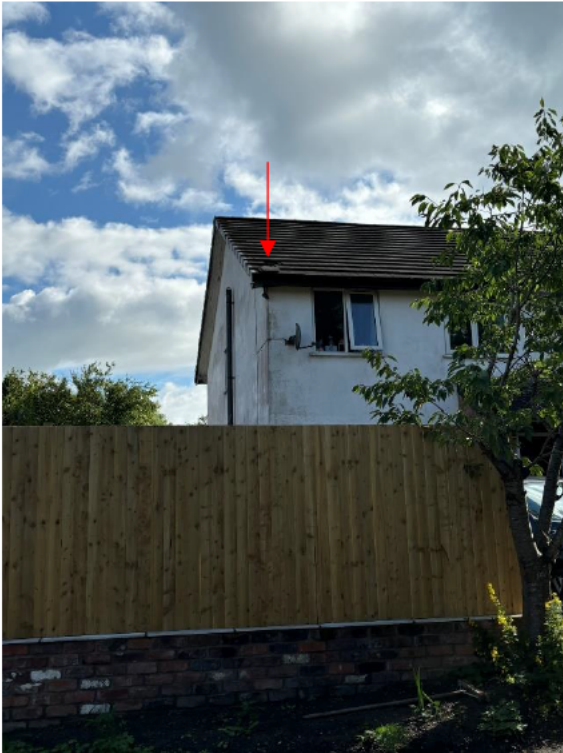
**Photograph 1: Overview of the front elevation (southwest). Building in fair condition with missing roof tiles.**

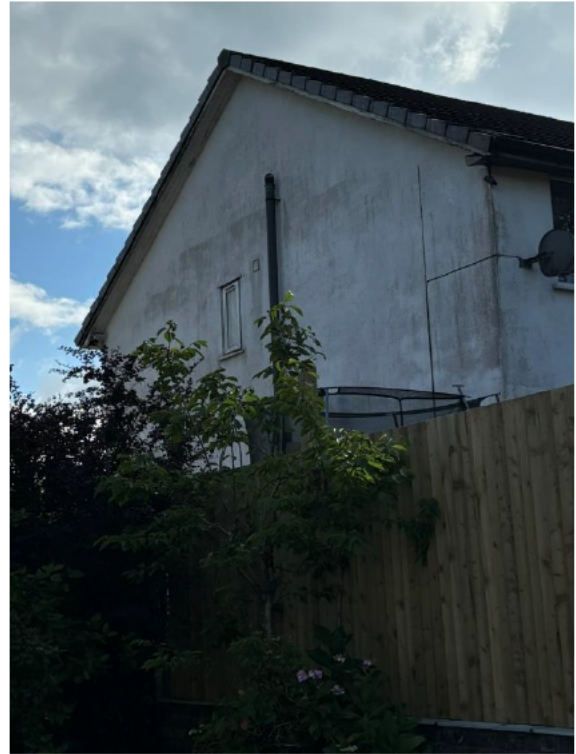
**Photograph 3: Overview of the northwest elevation.**

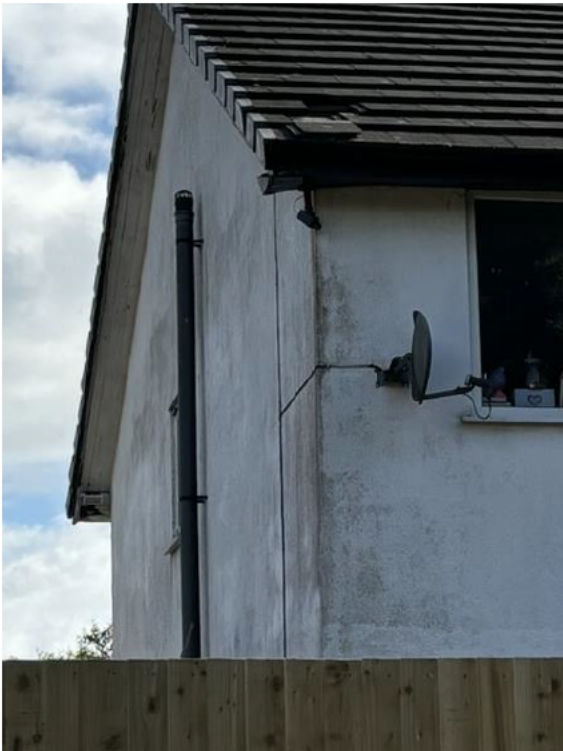
PRF ref	PRF description	PRF suitability
1	Missing concrete tile on southwest elevation of building towards bottom left corner of the roof. Whilst the cavity is large enough for bats to enter, the damage to the roof is susceptible to letting in rain making it unfavourable. Additionally, the homeowner informed the surveyor that this part of the roof had blown off during a recent storm and has since been repaired. The feature was assessed as being unsuitable for bats but is no longer present.	Negligible
2	Holes in the wooden soffits at the northern and western corners of the building. These appear water damaged and sub-optimal for use by bats.  Additionally, the northern corner of the building was occupied by nesting birds and further reduces the suitability of the feature for use by bats.	Negligible

**Photograph 2: Closer view of missing tile on southwest elevation. This has now been reinstated.**

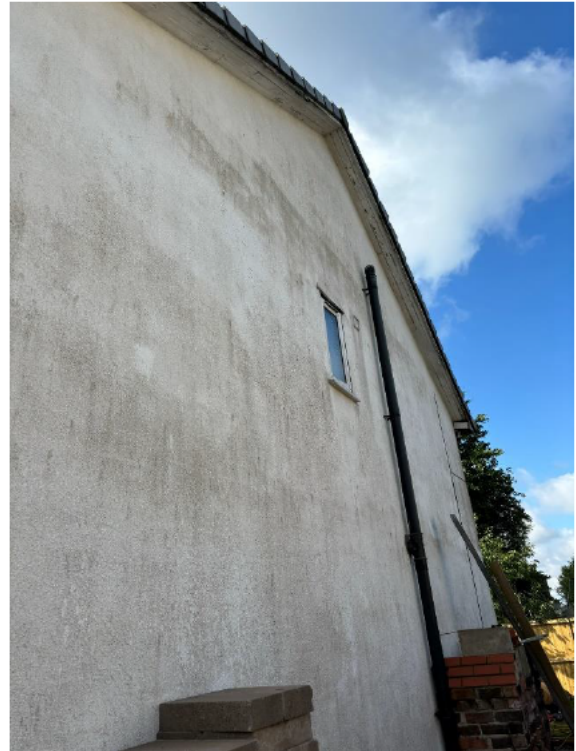
**Photograph 4: Under view of northwest elevations wooden soffit, in good condition.**

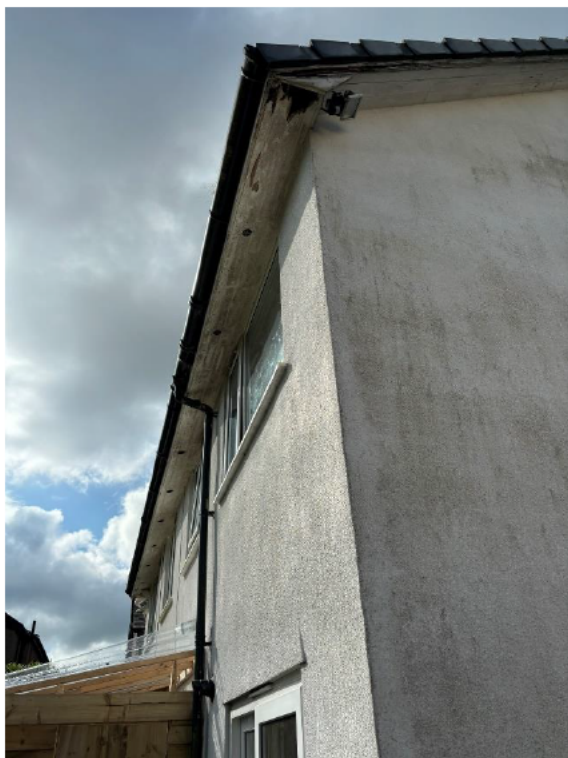
No evidence of nesting birds was recorded during the survey. However, the homeowner informed the surveyor that birds are currently nesting in the damaged soffit on the north east corner of the building (Photograph 5 below).

**Photograph 5: View of the northeast (rear) elevation. Large hole in the wooden soffit board and visible damage further along soffit leading to northwest apex. Bird nesting.**

As an active bird nest has been identified in the north east soffit, no works can proceed until it is proven that the nest is no longer in use.

The removal of soffits and other confirmed / suitable nesting provisions should be undertaken between September-February inclusive to prevent impact on nesting birds.

If works are required between April-August inclusive, then checks for nesting birds by a suitably experienced ecologist should be undertaken.

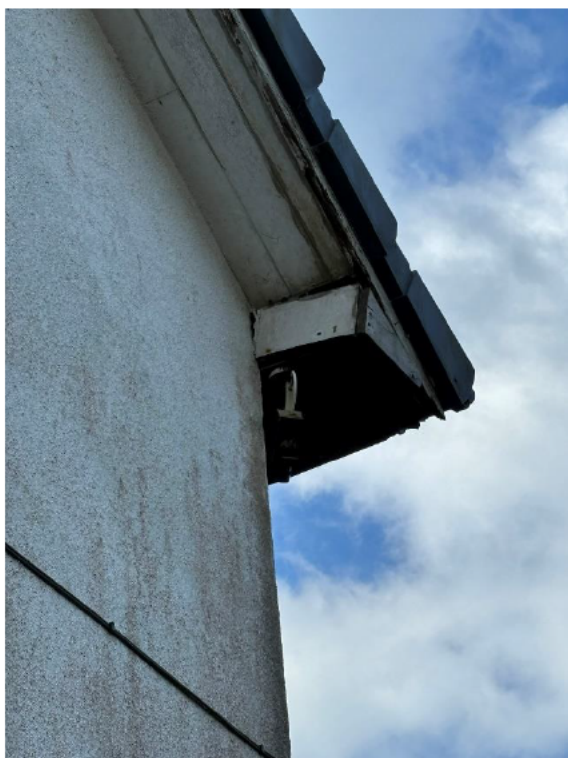
**Photograph 6: View of the damaged wooden soffit on the west corner of the building. Wood appears water damaged.**

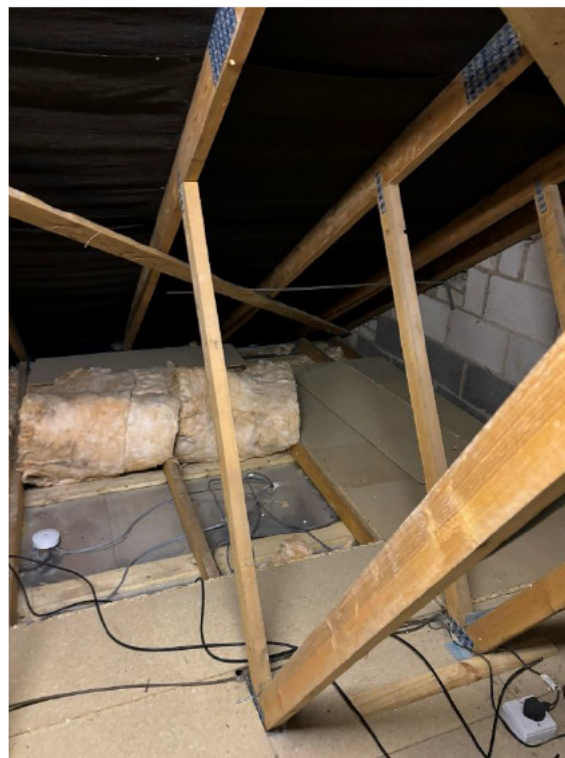
The loft space consisted of timber frames and rafters with roofing felt underneath the concrete tiles. There was light entering the loft space through missing soffit vents on the southwest elevation. No evidence of bats (e.g. droppings) within the lofts.

**Photograph 8: Timber frames, rafters and roof felt. No evidence of bats identified.**

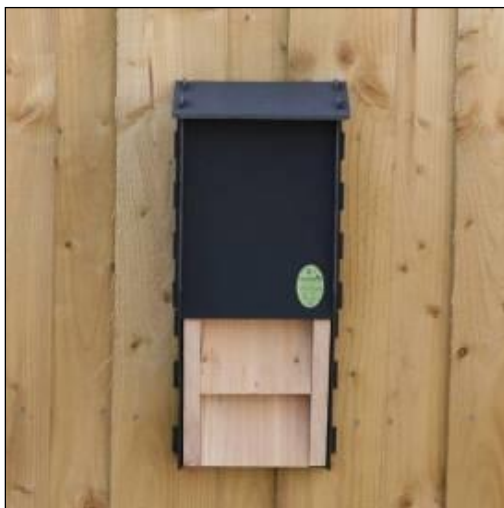
#### Externally fitted boxes

A large number of externally fitted box model for bats exist for buildings and trees. Suitable models for both buildings and trees may include the Eco Kent Bat Box.

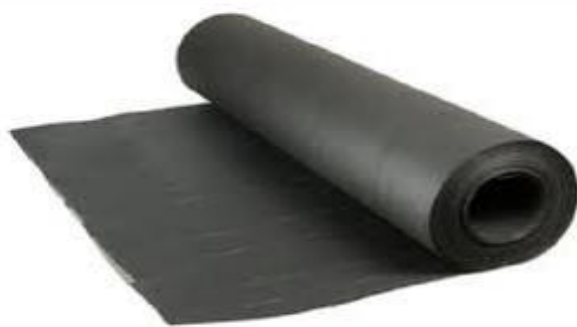
### Ridge access

Where appropriate, ridge tile access should be made with the incorporation of traditional Bitumen 1F underfelt immediately beneath ridge tiles. Breathable BRM membrane can cause significant problems where bats are in contact with it, whereby their fine claws become entangled within the fibres of the membrane, entrapping and killing bats.
