# Proposals Replacement of Structural Timbers

Barn on Talbot Street,  
Chipping,  
Lancashire,  
PR3 2QE

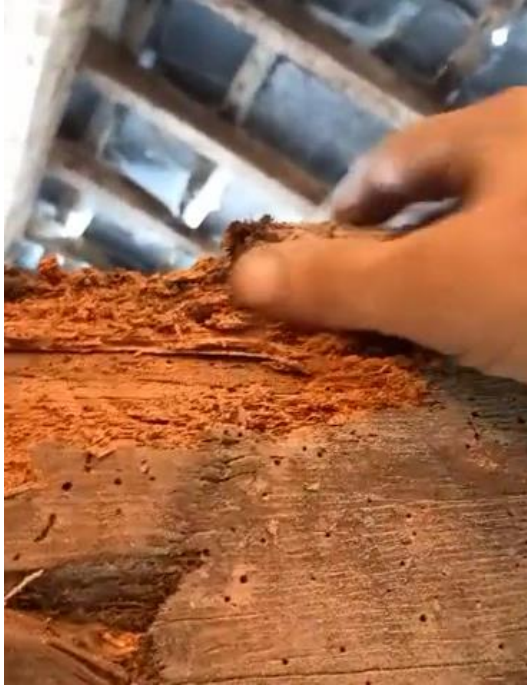
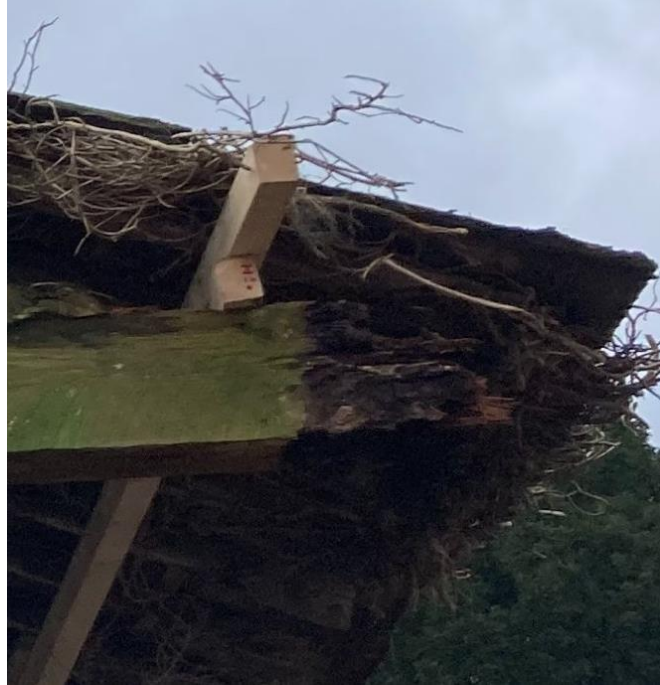
Please see above photographs of the existing beams at close range, as shown there has been large ingress of water over the years it has been derelict, resulting in excessive water damage to the beam ends. This is then worsened by the insect infestation which has resulted in the original timber being able to be pulled apart by hand.

Our plan was to keep and repair the trusses however they have gone too far into disrepair and are in the opinion of this Author a health and safety concern.

It has been noted that the king truss sections of the beams are mostly ok and could be re-used in the new beam build up.

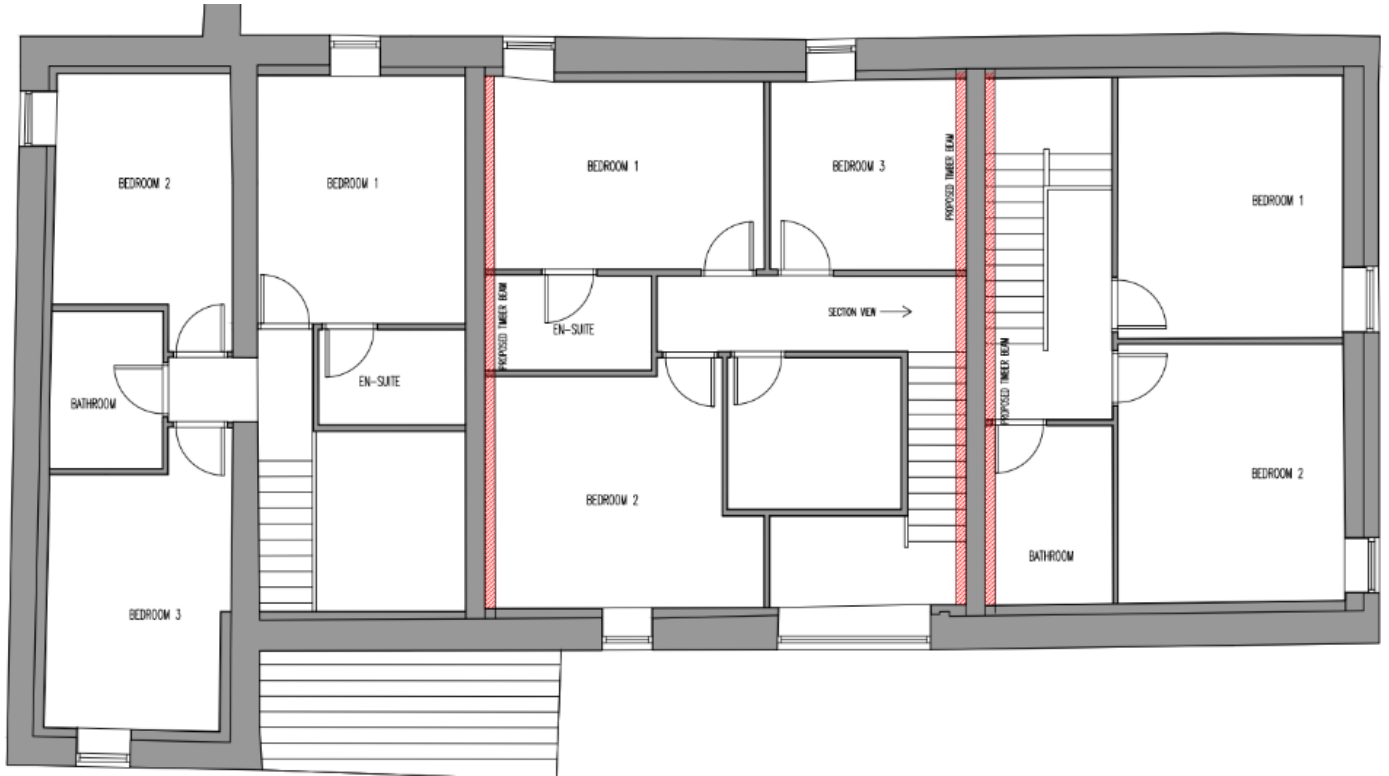
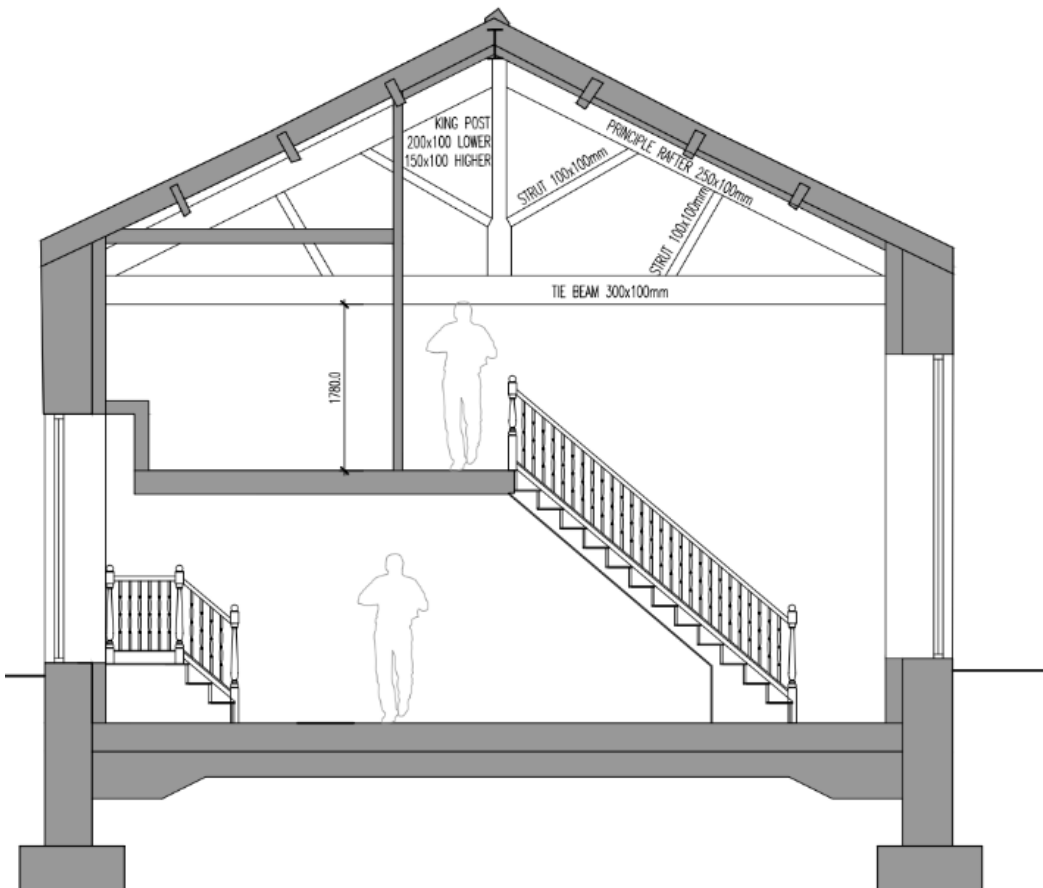
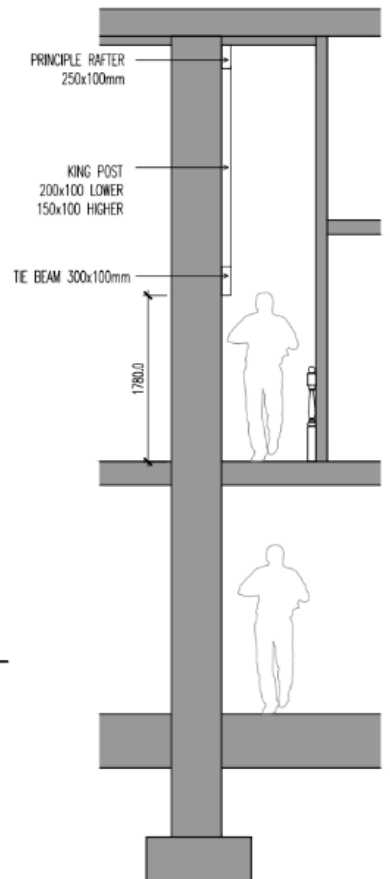
8. We will then aim to replicate the truss structure against the spine walls. These will be above roof plate level and secured against the spine walls using anchor bolts. Once the structure is in place the bolts will be cut back so they are inside of the beam and the bolt holes will be plugged so as not visible.

9. The trusses will be prepared and built on location using three meter jointed lengths of Douglas Fir in keeping with the current material.
10. Once the trusses are in situ against the spine walls, plasterboard will be cut and placed between the frame and remaining section of wall and this will then be plastered, thus giving the impression that the truss is half in the wall, but on full view to appreciate and add the desired character to the building.

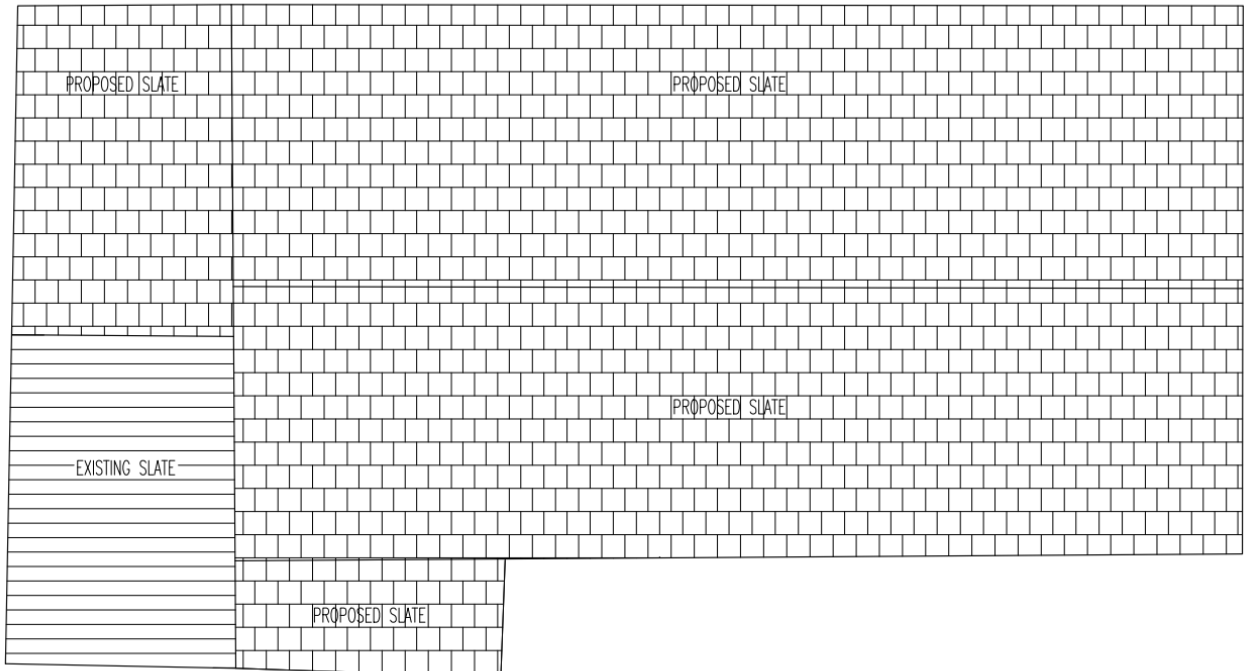
PROPOSED ROOF

Following the removal of the majority of the slates it was identified that most of the slate is either unstable due to existing damage or cut with a curved back (as they have been slid in and not fixed properly). As such there will be enough 'good' slate to re-installed on the roadside prominent roof to the southwest of the site (Highlighted in drawing below).

There are numerous areas across the barn roof which appear to have been patch repaired over the years with different materials as such the proposed scheme will look to remove these elements and consolidate the existing tiles into 1 of the 4 roof pitches. The pitch chosen to have been based on what is most prominent. The roof chosen is the front extension of the barn along which is raised to the north as this is highly visible when coming down the hill from Windy Street – Please refer to drawing on the next page.

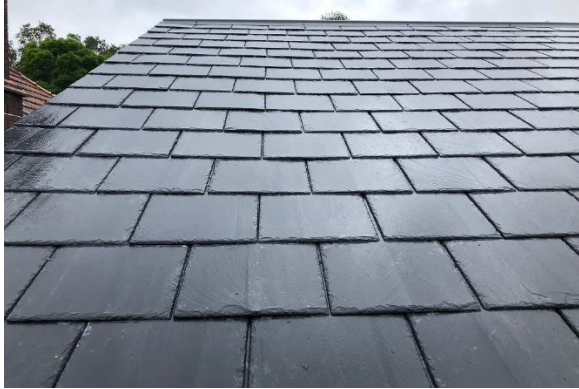
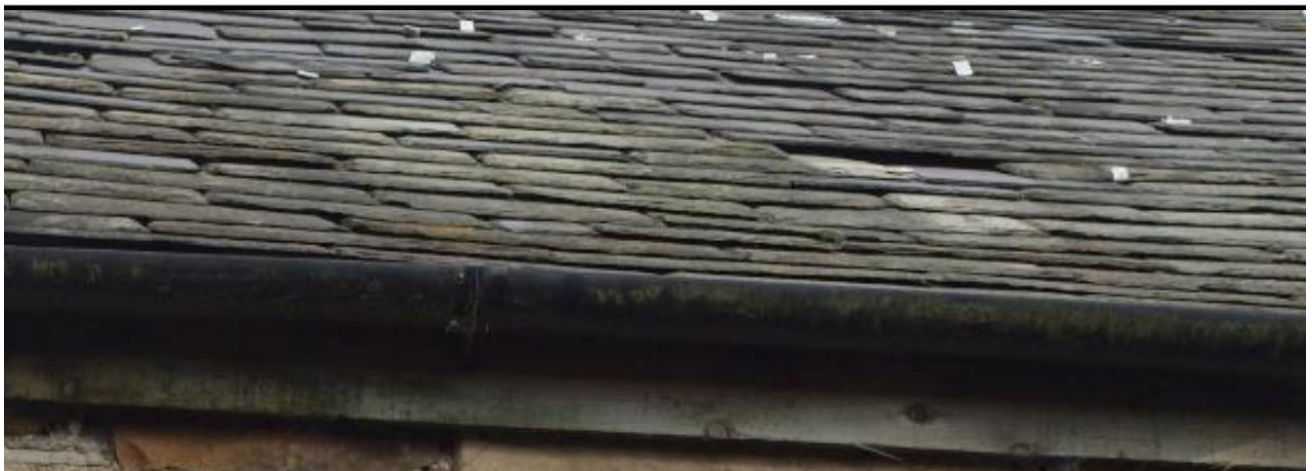
The layout for the tiles will be as per the middle picture. This shows the new tiles being installed evenly with 60% overlap. There is very few photo showing the existing roof layouts however this is the best one taken from the archaeology report. Its difficult to see but the image does show an even install lines with the majority of the tile covered.

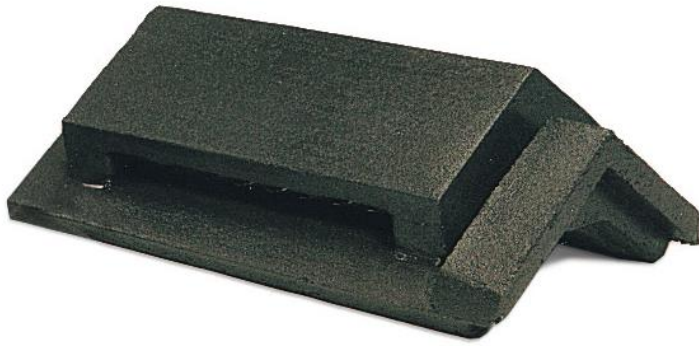
The existing roof had a few of vents along the ridge, instead of more modern methods of having the vents in the mortar joints the existing vents projected up from the ridge. We have found ridge tile which mimics this existing look below. They will be placed at 2m intervals (2x vents on house 1, 3x vents on house 2 and 2 on house 3).

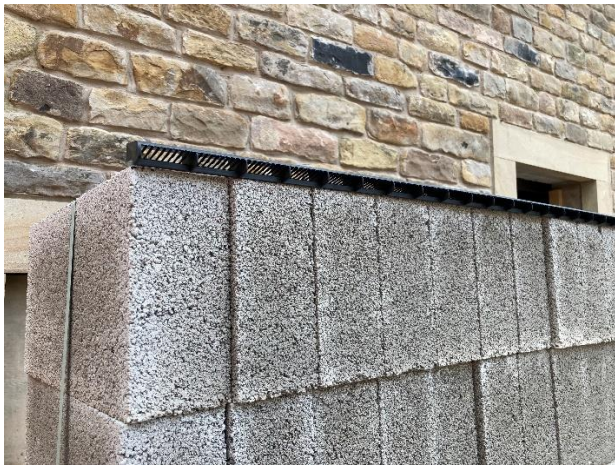
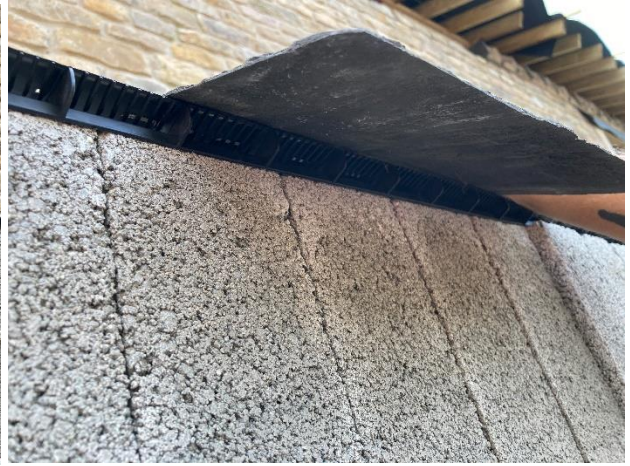
To achieve cross ventilation, we would usually have vents in a facias/soffit however the barn does not have soffits as such we are proposing to use a tile vent which will be installed just above the gutter (under the last tile). This will mean the building will achieve cross ventilation required and the vent will not be seen from street level. Please see photos below of system.
