Proposed residential development
Land east of Chipping Lane
Longridge, Preston

Ground Investigation Report
(Phase 2)

**Proposed residential development
Phase 2
Land East of Chipping Lane
Longridge
Preston
PR3 2NA**

GROUND INVESTIGATION REPORT

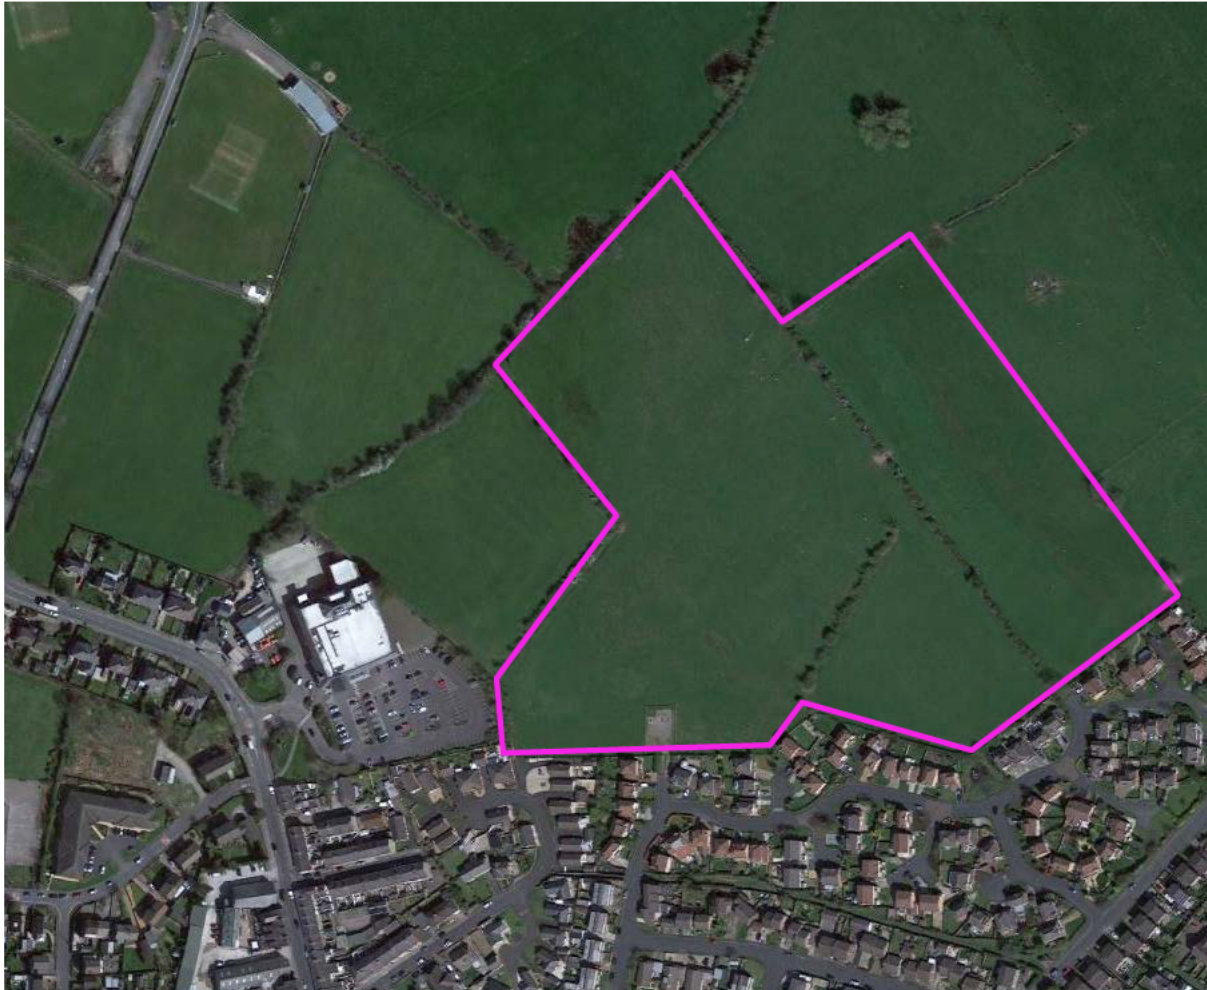
Aerial photograph of site

Approximate Phase 2 site boundaries edged in pink

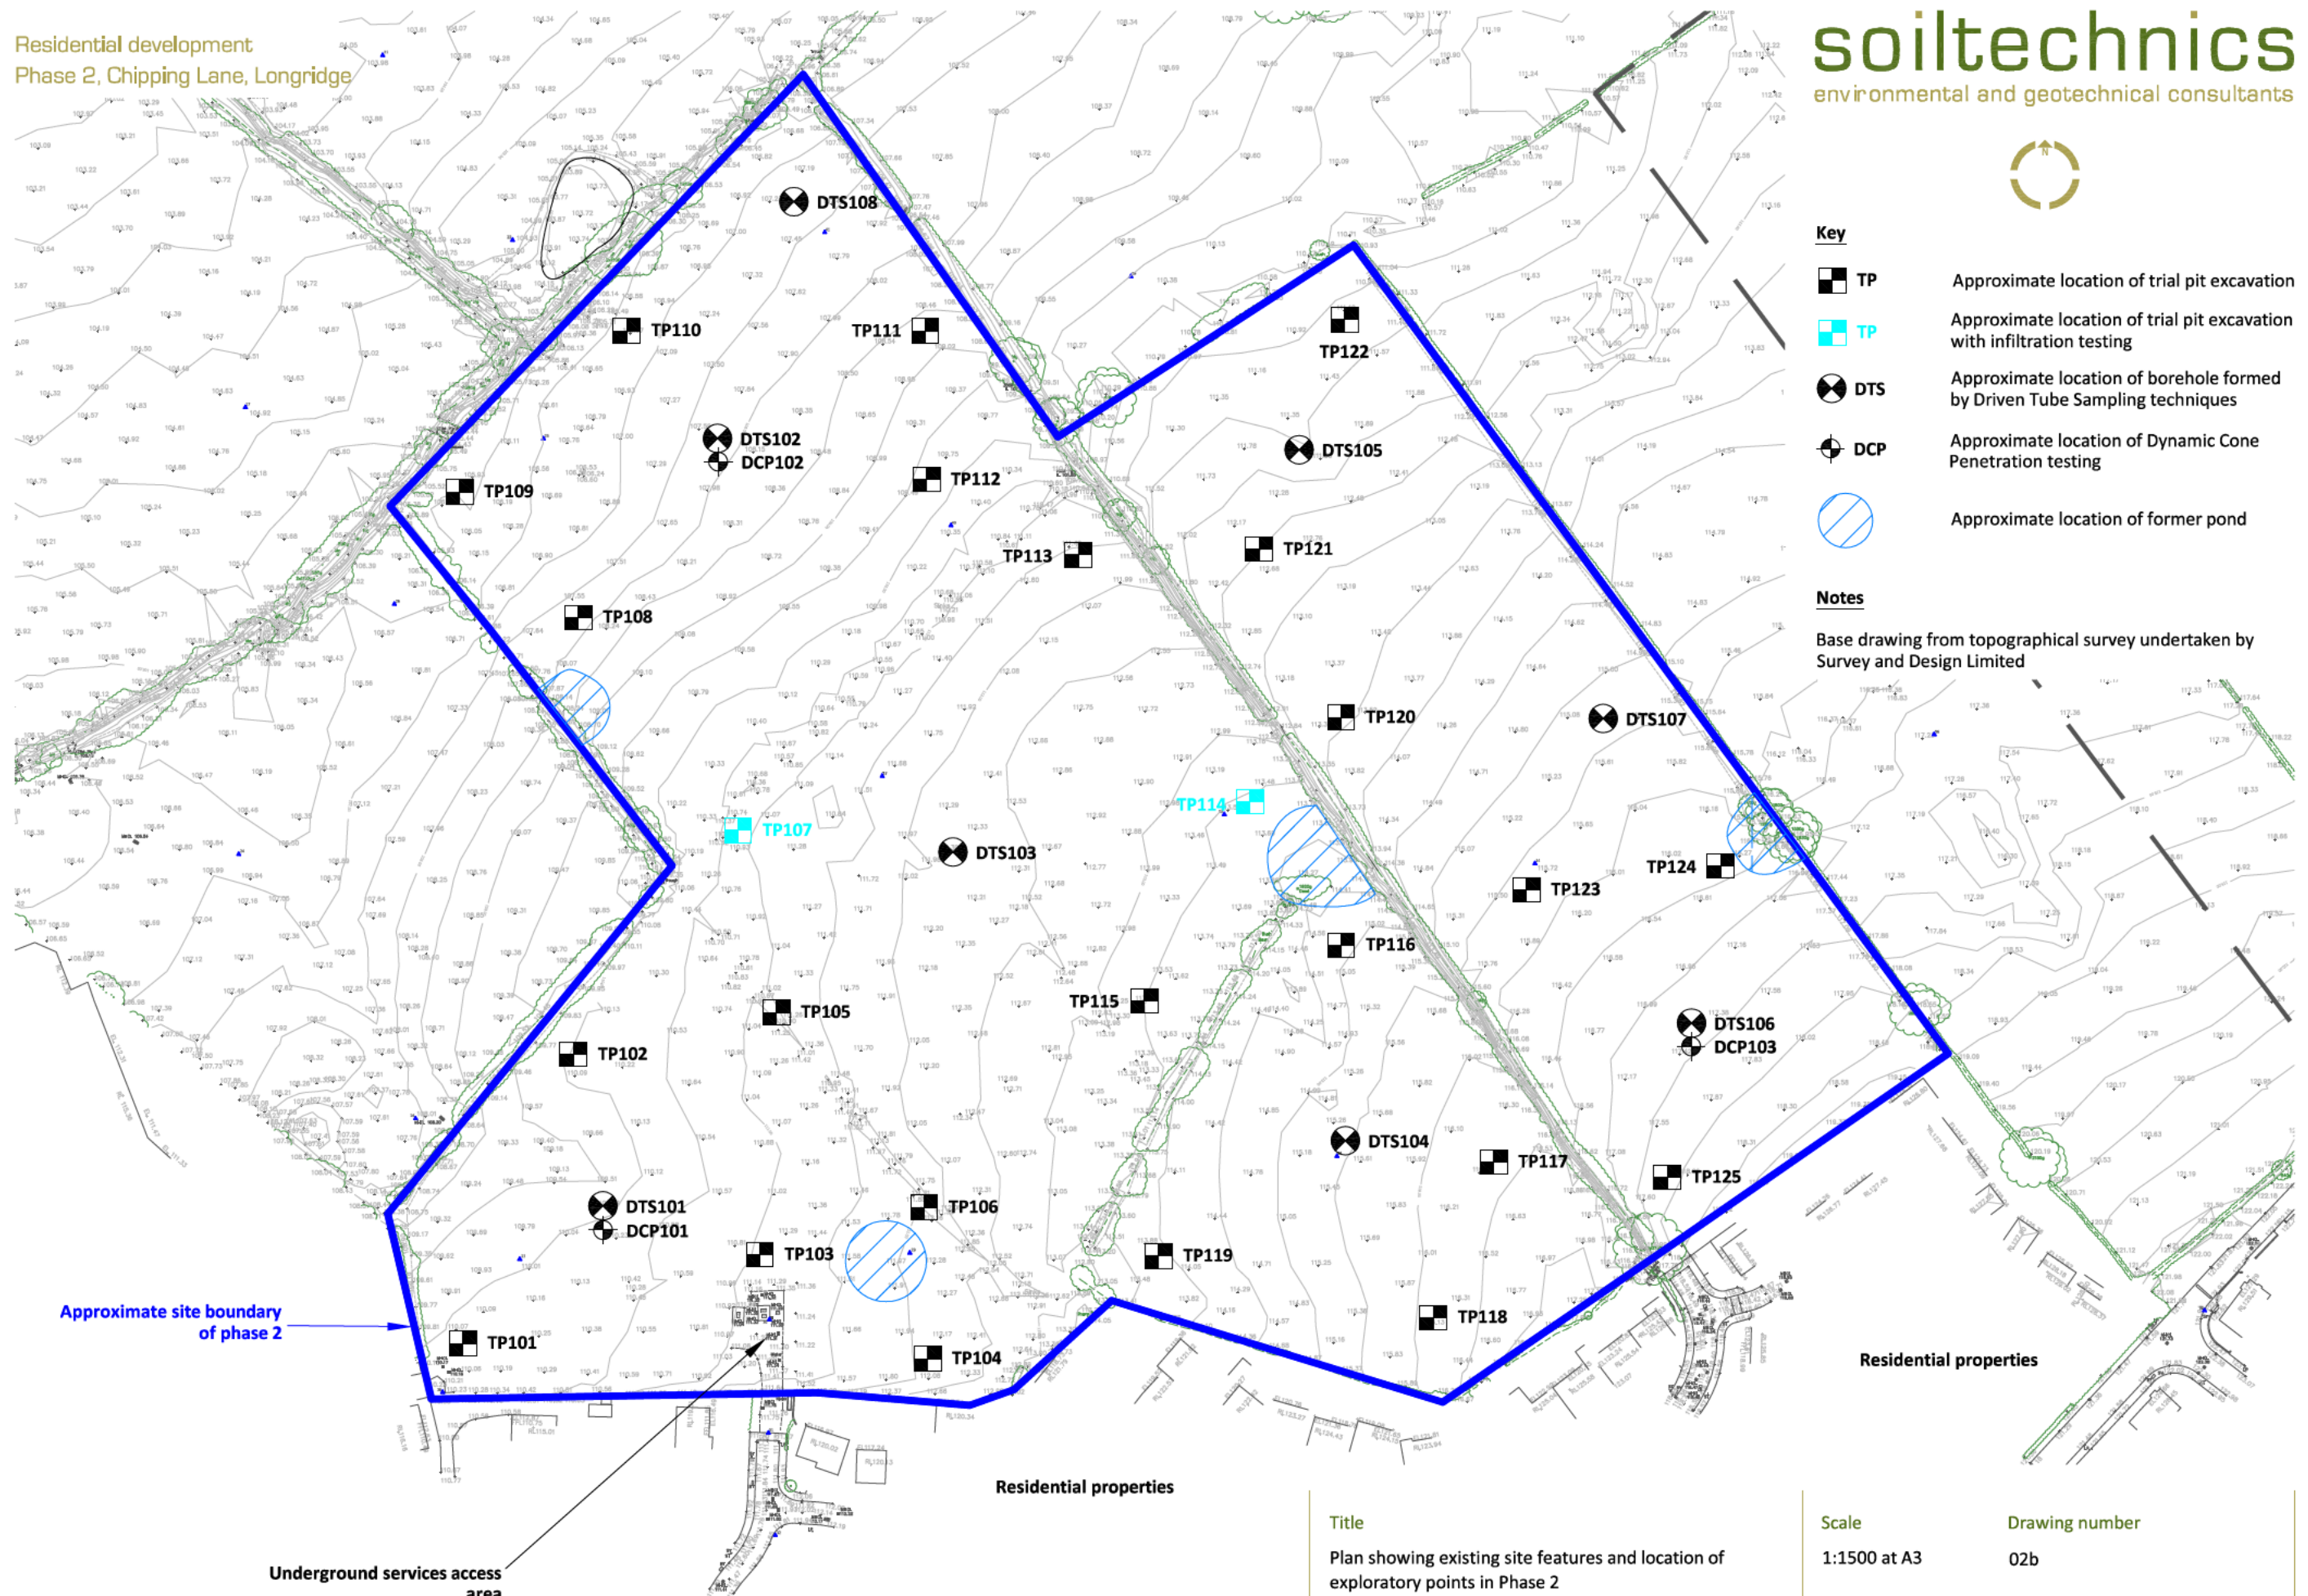
Plan showing existing site features and location of exploratory points in Phase 2

Base drawing from topographical survey undertaken by Survey and Design Limited

4.1.2 A plan of the site showing observed/existing site features and position of exploratory points is presented on Drawing 02b. The position of exploratory points relative to site development proposals is presented on Drawing 03. The position of exploratory points shown on these plans is approximate only and confirmation of these positions is subject to dimensional surveys, which is considered outside our brief.

8.5.4.1 A full description of the site and observed adjacent land uses is provided in Section 3 of this report. A plan summarising observations made on site during our site reconnaissance visit is presented on Drawing 02b.

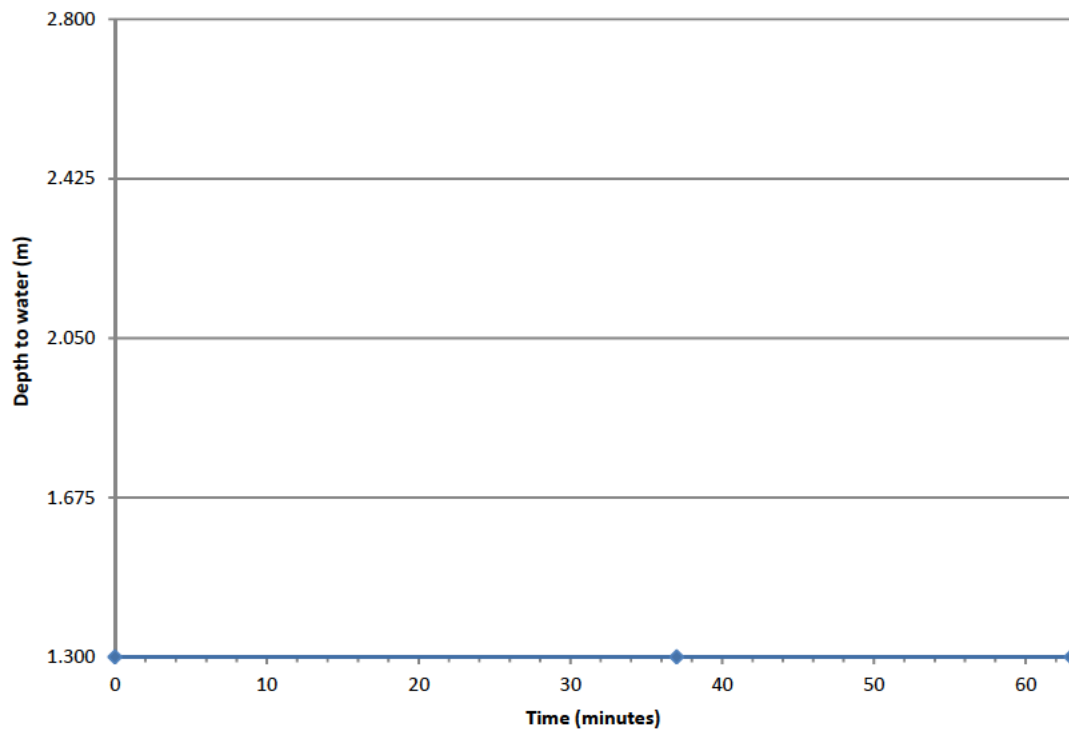
Plot showing time against depth to water:

TIME (mins)	DEPTH TO WATER (m)	TIME (mins)	DEPTH TO WATER (m)
0	1.3		
37	1.3		
63	1.3

- 4.3.9 Trial pit records are presented in Appendix C.
- 4.3.10 Soil infiltration tests were carried out in trial pits TP107 and TP114 at depths of between 1.3m and 2.8m. Infiltration tests were carried out following the procedures described in the Building Research Establishment (BRE) Digest 365 (2007) "*Soakaway Design*", with records of test results presented in Appendix E. Water placed in each trial pit did not dissipate and soils are considered to be effectively impermeable.

- 7.6.1 Based on infiltration testing undertaken in trial pits TP107 and TP114 at the site (refer to Appendix E), the Devensian Till deposits are considered to be effectively impermeable and would not be able to dispose of water using soakaway systems. Alternative means of storm water disposal will be required. Disposal into Higgin Brook could be an option and we understand that the surface water sewer, which cuts across the south-western part of the site, outfalls into the brook and serves a similar residential development adjacent to the south-east.

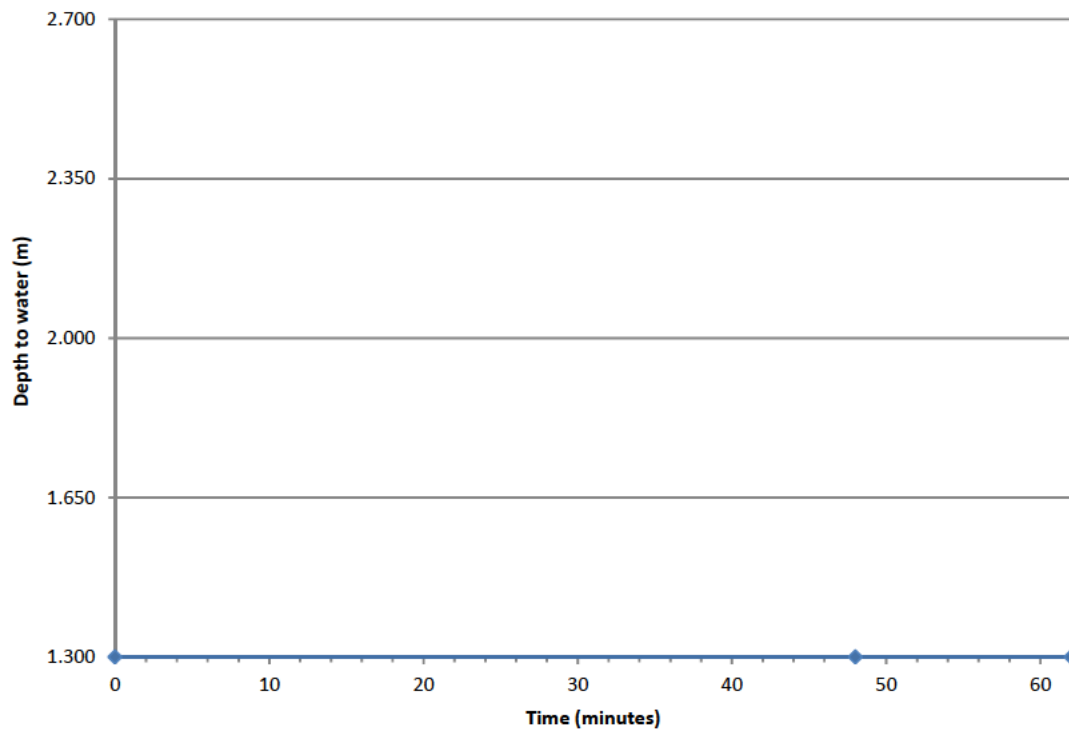
Plot showing time against depth to water:

TIME (mins)	DEPTH TO WATER (m)	TIME (mins)	DEPTH TO WATER (m)
0	1.3		
48	1.3		
62	1.3
