Preliminary Bat Roost Assessment Report

18 Queensway, Waddington, Clitheroe, BB7 3HL

17.06.2024

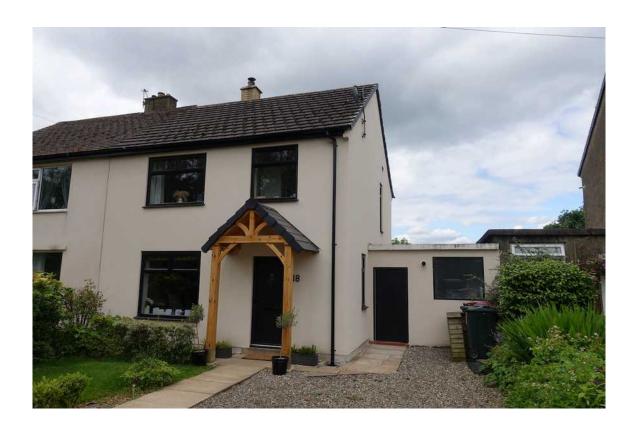
The property consists of a semi detached two storey house with a double pitched tiled roof. A single storey flat roofed extension is present on the gable end and the property has a Upvc conservatory to the rear.

External walls are well pointed and rendered with no cracks, crevices or cavities present. Upvc soffits are close fitting and sealed. The gable end is pointed and sealed.

The roof is in good general condition with close fitting tiles, no lifted, slipped or missing tiles are present. The ridge is pointed and well sealed.

Overall the property can be considered to offer negligible roosting potential.
