**Bat, Breeding Bird and Barn Owl Survey**  
**Cockshotts Barn, Sabden**

July 2024

Cockshotts Barn  
Wesley Street  
Sabden  
Clitheroe  
BB7 9EH

**2023 - 1605**

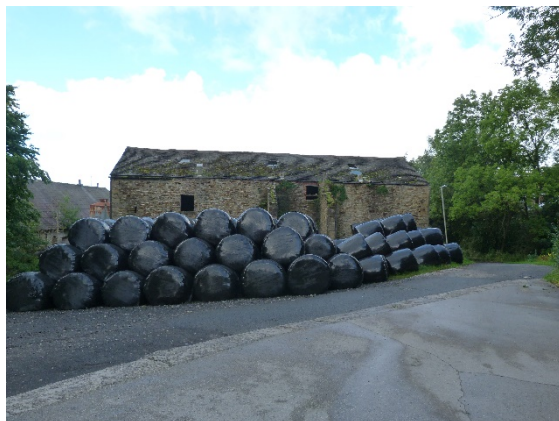
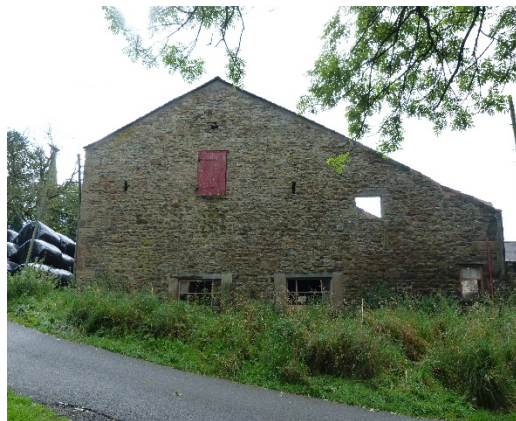
Traditional stone built agricultural building with some areas of intact tile roof and other areas with a caved in roof. The building is quite damp, and the second floor was not accessible as a result.

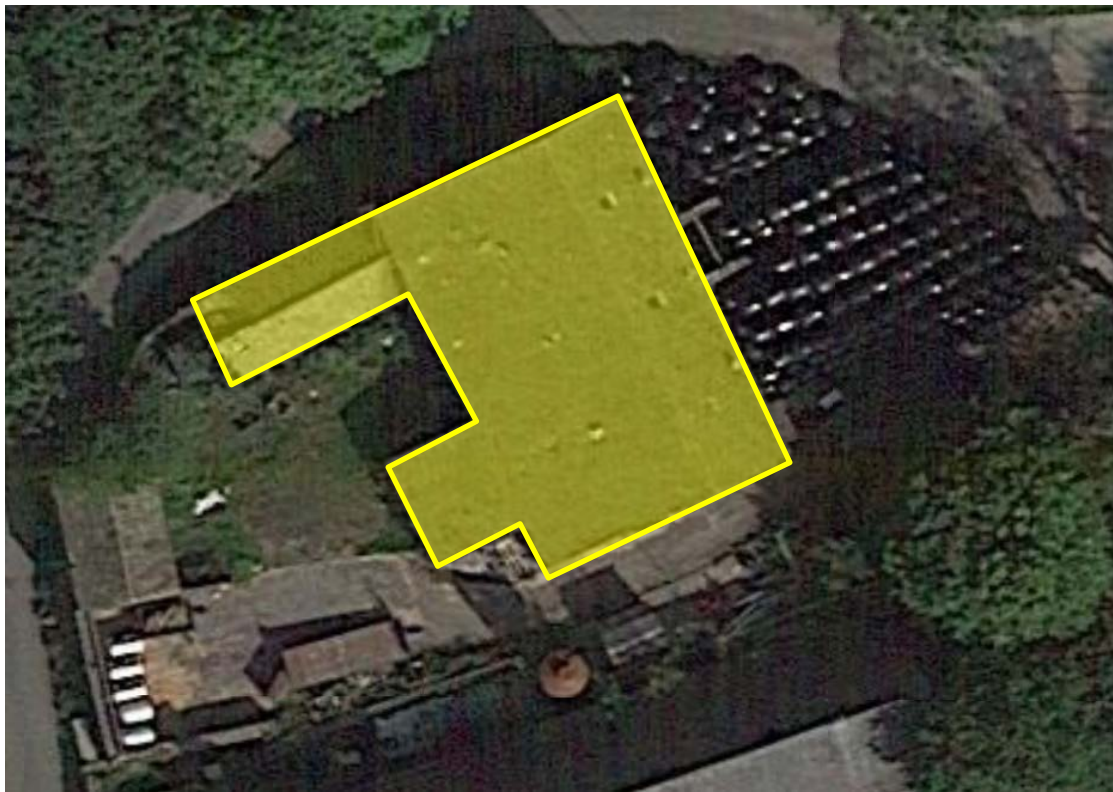
Figure 4. Surveyed building. Google Earth.

The site was assessed as having low risk of supporting roosting bats. This is due to the areas of potential bat roosting habitat including: wall top gaps, masonry crevices, gaps around the lintels and gaps between tiles. The full loft void could not be accessed due to the damp, unsafe conditions of the flooring. There was no evidence of bats found on site, which indicates an absence of maternity roosts. In addition, the poor condition of the building (cold and damp) makes maternity roosting unlikely. However, bat roosts could not be ruled out entirely as not all areas were accessible. In particular, the external masonry crevices are likely to support some day roosting bats, given the habitat suitability in the surrounding area. There is also a risk of hibernating bats due to the deep masonry crevices.

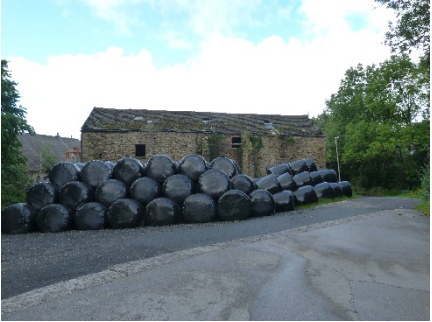
| Building ref | Description & photos | | | | PBRH features |
|---|---|---|---|---|---|
| | <p>Photo 1: Eastern aspect.</p> | <p>Photo 2: Eastern aspect.</p> | <p>Photo 3: Northern aspect.</p> | <p>Photo 4: Western aspect.</p> | |

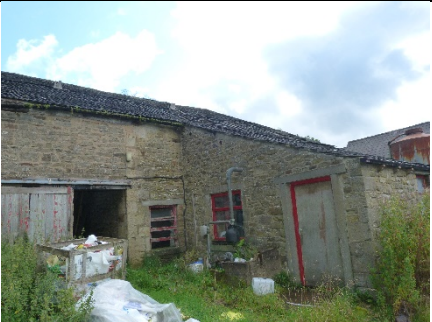
| Building ref | Description & photos | | | | PBRH features |
|---|---|---|---|---|---|
| | <p>Photo 5: Western aspect.</p> | <p>Photo 6: Eastern aspect – lifted tiles, external crevices, wall top gaps.</p> | <p>Photo 7: Internal view.</p> | <p>Photo 8: Internal view of roof.</p> | |

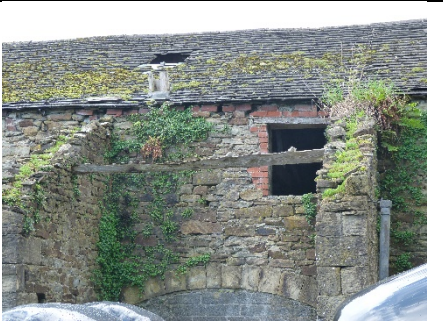
| Building ref | Description & photos | | | | PBRH features |
|---|---|---|---|---|---|
| Low risk of supporting roosting bats | Traditional agricultural building, stone built with an unlined slate roof. Interior is cluttered and damp with windows open to the exterior. Abundance of gaps between stone slate tiles, gaps along wall tops, internal and external masonry crevices, crevices surrounding door and window lintels. Loft void could not be accessed due to safety concerns. No evidence of roosting bats (droppings/feeding remains) identified. Evidence of nesting birds was identified in the form of swallow nests. | | | | Gaps in tiles<br>Wall top gaps<br><br>Internal and external masonry crevices<br><br>Gaps around door and window lintels |

Works to the building should follow the standard good practice measures set out in Appendix 2. Replacement crevice habitat should also be installed to mitigate the loss of potential roost habitat.

9.2.1 Replacement crevice roosting habitat will be provided on site through the incorporation of 1 integral bat brick into the new build and/or the installation of a

professional long-lasting crevice bat box on site, in a suitable location to be agreed by the ecologist.

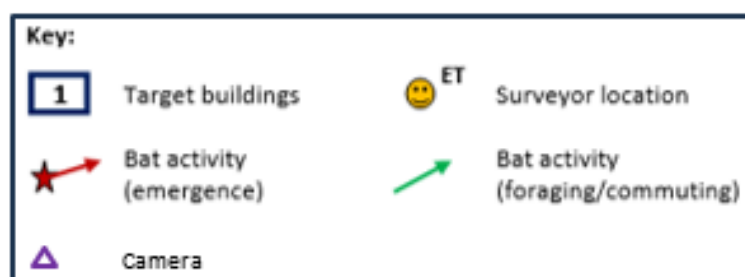
**Summary:** No roosts identified. Foraging and commuting activity was moderate throughout the survey, mostly of common pipistrelles and myotis species. A few bats entered the building during the survey to forage.

Figure 5 – Surveyor locations and bat activity recorded during survey.
