**Happy Cottage,  
Lovely Hall Lane,  
Copster Green,  
Salesbury,  
Blackburn,  
Lancashire  
BB1 9EQ**

**Preliminary Ecological Appraisal  
in respect of Protected/Notable Species Including  
Bats and Nesting Birds, (including Barn Owl).**

**Echo Calls Bat Surveys**

**10<sup>th</sup> September 2024**

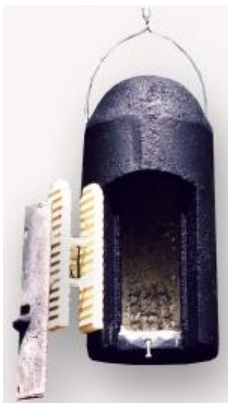
### Schwegler 1FD Bat Box

This Schwegler 1FD bat box has been developed specifically for smaller bats. The interior and the type and size of the entrance hole match the requirements of smaller species. It features a special layout inside the domed roof, an increased interior height, and two grooved internal wooden front panels with precise spacing between them.

These boxes are to be erected as recommended by the Bat Conservation Trust guidelines which state that

- Ideally, erect the boxes facing so they face in different directions, to provide a range of temperature conditions. For example, boxes facing from south-east to south-west allow the sun to fall on each box for part of the day. During very hot days a south-facing box may overheat, but the other boxes should have some shade during the day.
- Bat boxes should be located close to a linear vegetation feature such as a tree line or hedgerow or to lines of buildings. Some bat species use these features for navigation between their roosting site and feeding ground and to avoid flying in open and exposed areas.
- Ensure that tree branches or other items will not impede the bats’ approach to the box – clear away underneath the box so the bats can land easily before crawling into the box.
- Boxes should be erected at a height of approximately 4m above ground level.

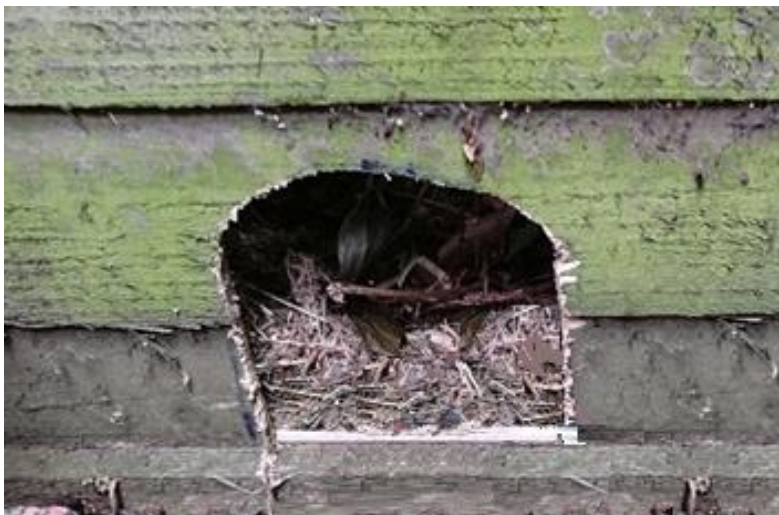
A 13cm by 13cm square hole is sufficient for any hedgehog to pass through, no matter what the wall or fence is made from. This will be too small for pets and dogs to pass through to pursue hedgehogs.

- Remove a brick from the bottom of the wall.
- Cut a small hole in your fence if there are no gaps.
- Dig a channel underneath your wall, fence or gate, to obtain enough depth.

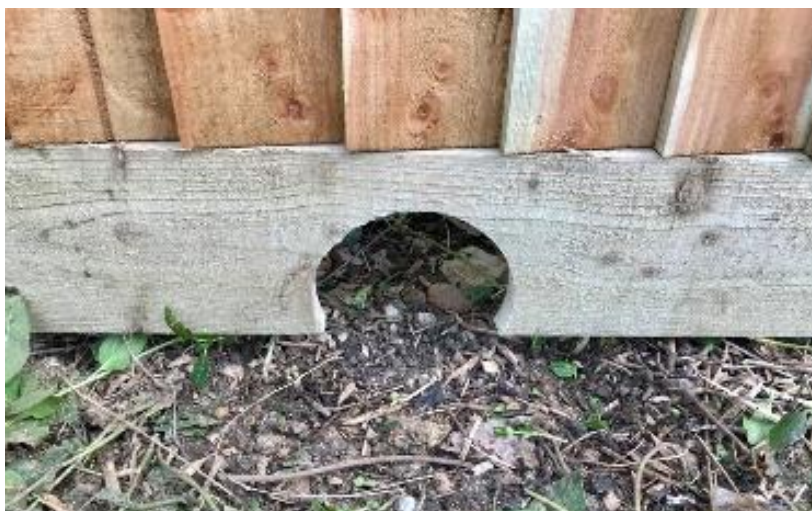
- A 13 cm diameter circular hole through brickwork creates a tunnel.

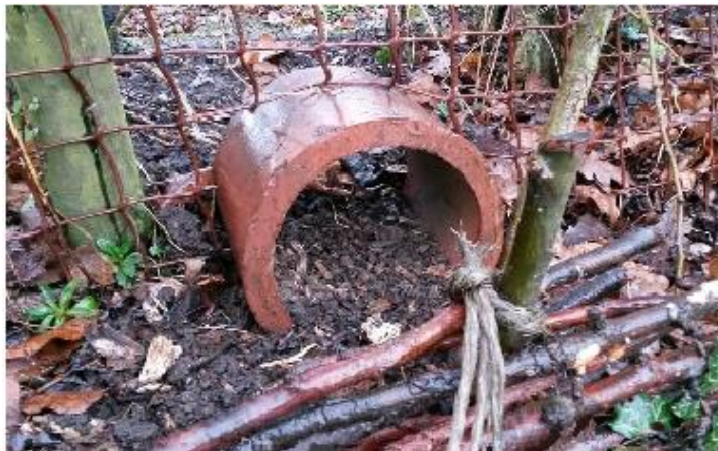
- Similarly, a 13cm diameter drain pipe would suffice through vertical fencing
