**BAT SURVEY AT -
91 Ribchester Road
Clayton Le Dale
Blackburn
BB1 9HT**

DATE AND TIME OF VISIT
12 th June 2024 9.15am

REFERENCE NO. 6984

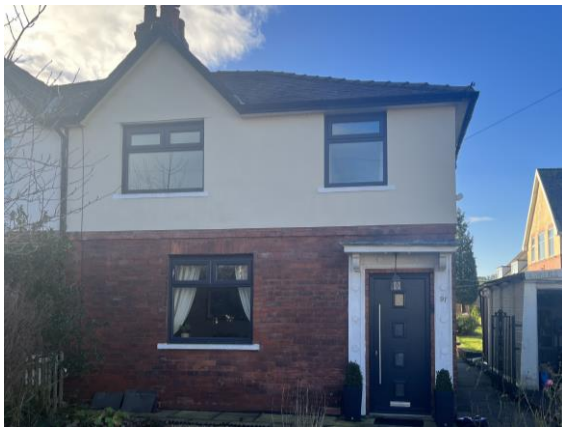
Front Elevation

The property is a semi detached dwelling with an adjacent detached garage. The house possibly dates from the 1940's /50's. The house has had a modern flat roof extension to the rear.

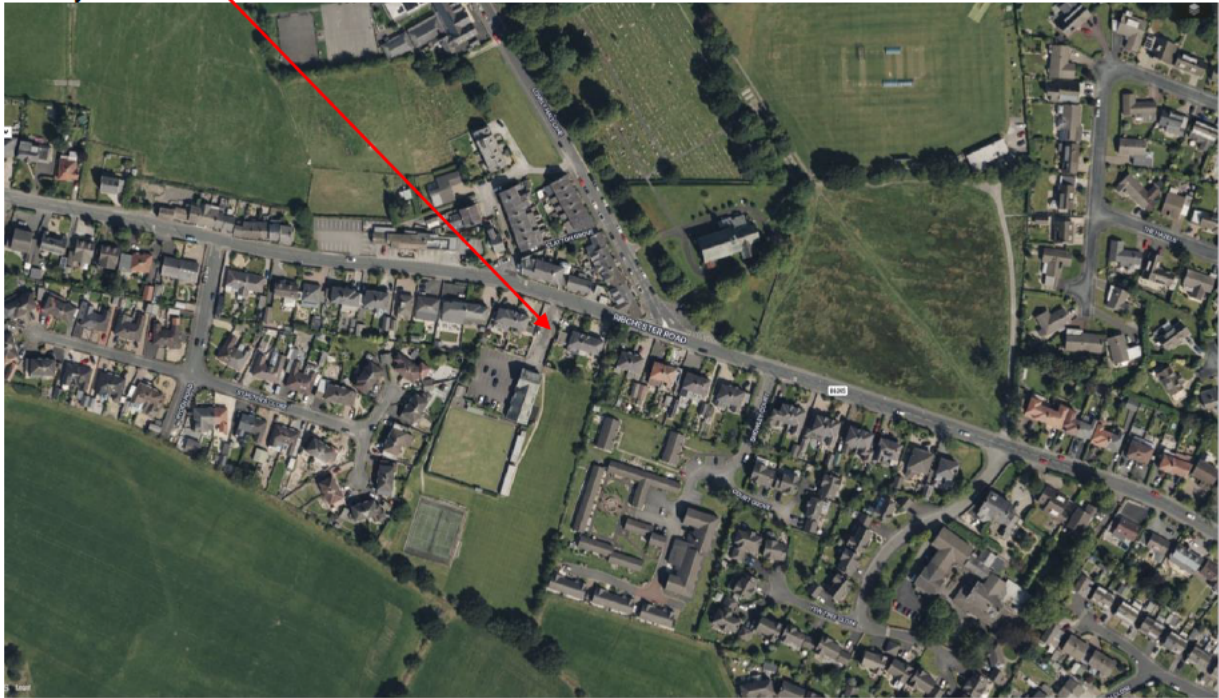
The house is located directly on the south side of Ribchester road within the built up settlement area of Clayton le Dale

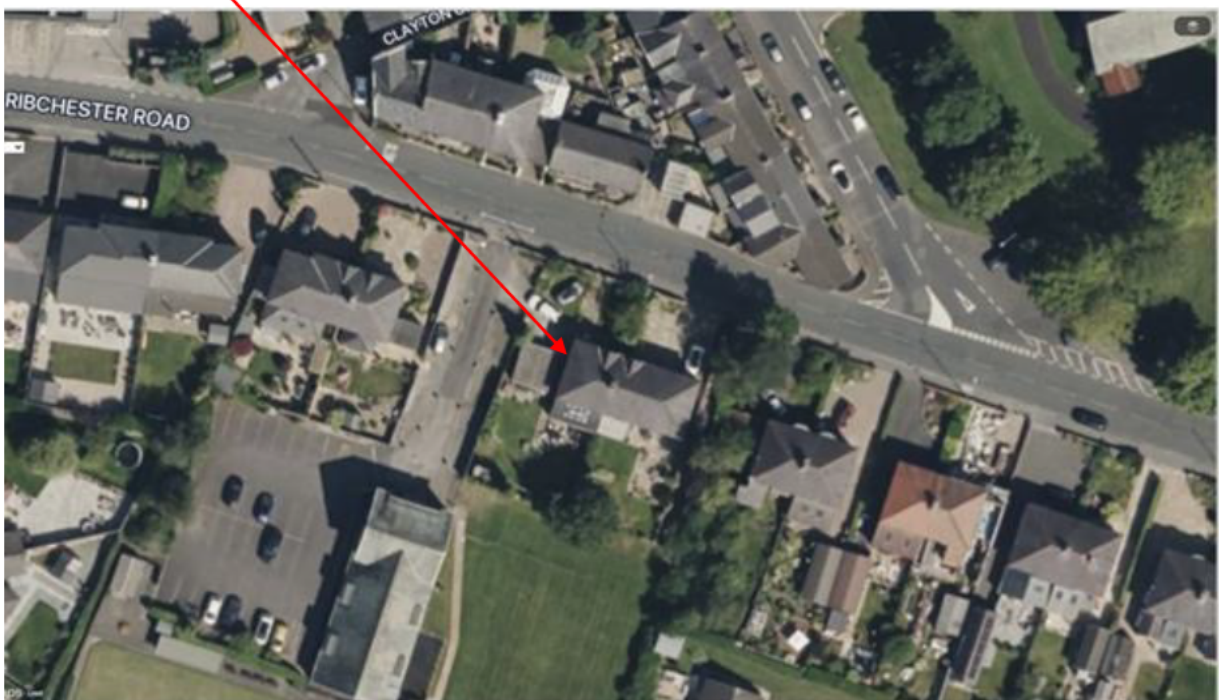
The house is located amongst other properties of a similar type and age all having gardens containing domestic planting. and lining the south side of Ribchester road.

Directly behind the house are playing fields which extend to the pastureland which surrounds the settlement area to the north and south. Lines of mature trees are present around the church 59m to the north east. A further line of mature trees extends along the east boundary of the playing fields .

The greater locality to the West and East has minimal forage potential, to the south of the house and north (adjacent to the church) has some mature tree lines with the potential to provide forage and commute routes.

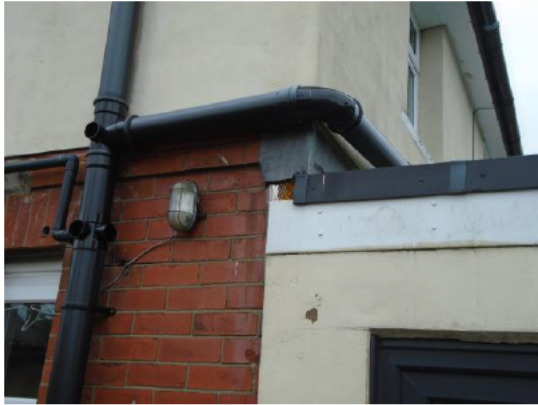
The walls to the original house are brick to first floor level with a render finish above. The rear extension is rendered.

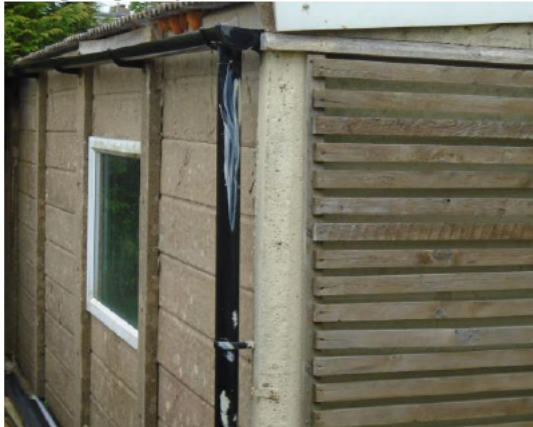
The garage is prefabricated concrete, the rear elevation has a timber slat panel attached.

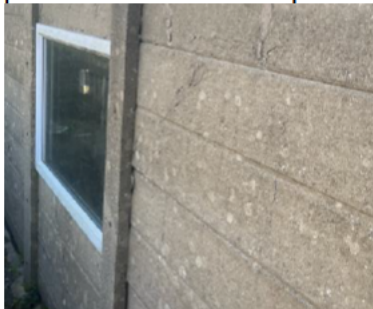
The Garage walls are solid concrete with no gaps at the panel abutments. No access points are present. The timber slat panel did not form any suitable bat roost habitat.

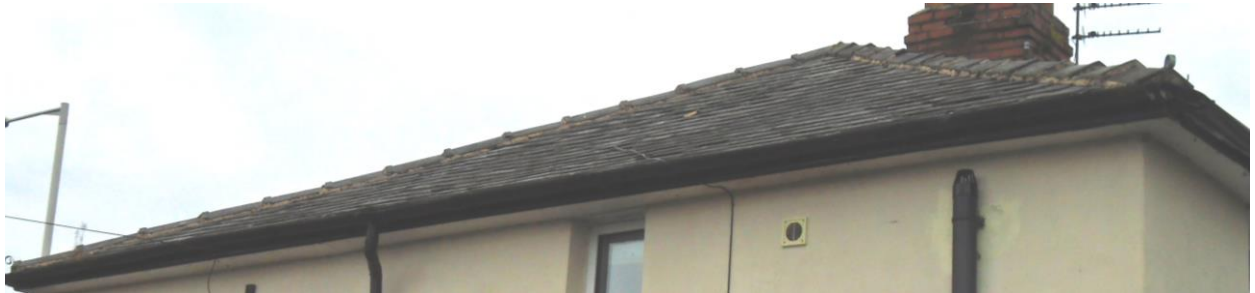
The roof is a hipped construction with a blue slate finish with ridge and hip tiles. The eaves overhang has a boarded soffit with timber fascia's

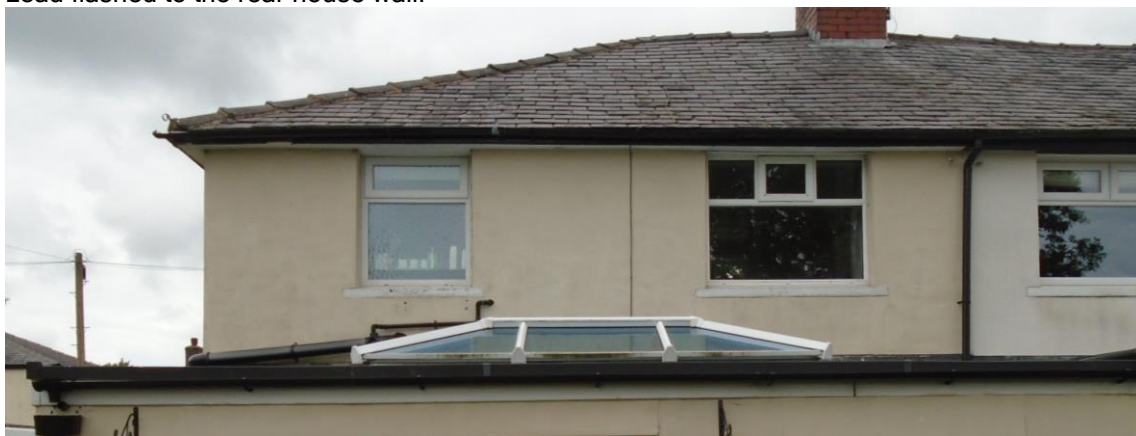
The flat roof extension has a felt finish with a lantern light . Upvc fascia's are fixed flush to the walls. Lead flashed to the rear house wall.

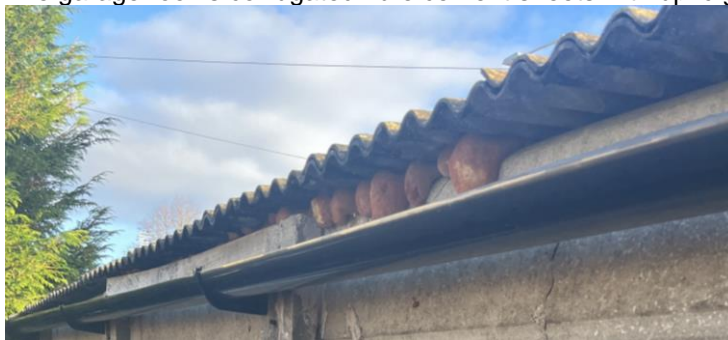
The garage roof is corrugated fibre cement sheets with upvc gable trims.

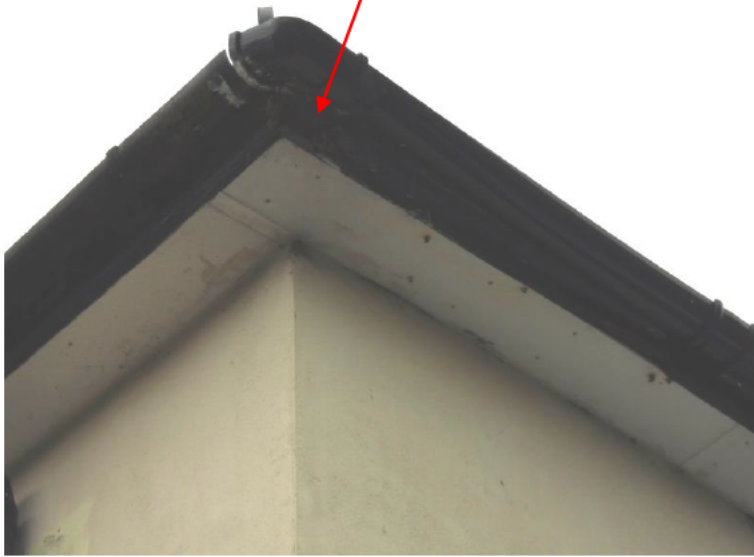
Location of current Sparrows nest

There is a rotten fascia on the south west corner of the House as indicated below which is currently being used by nesting sparrows.

No further survey effort is considered necessary and mitigation is not essential however No work should commence until the birds nest has been vacated after which the hole in the fascia should be blocked to prevent any future ingress prior to the next nesting season and work commencing on site.

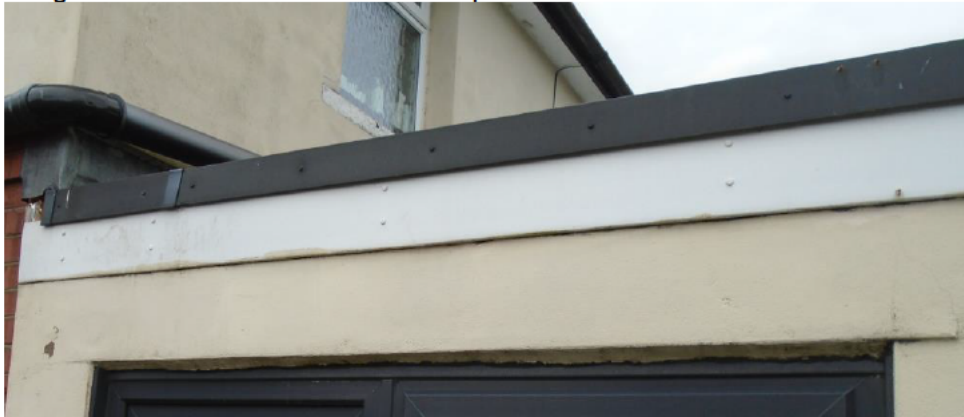
The flat roof covering is in good condition as are all the abutment flashings. The fascia trim is tight fitting to the walls. There are no access points in the roof.

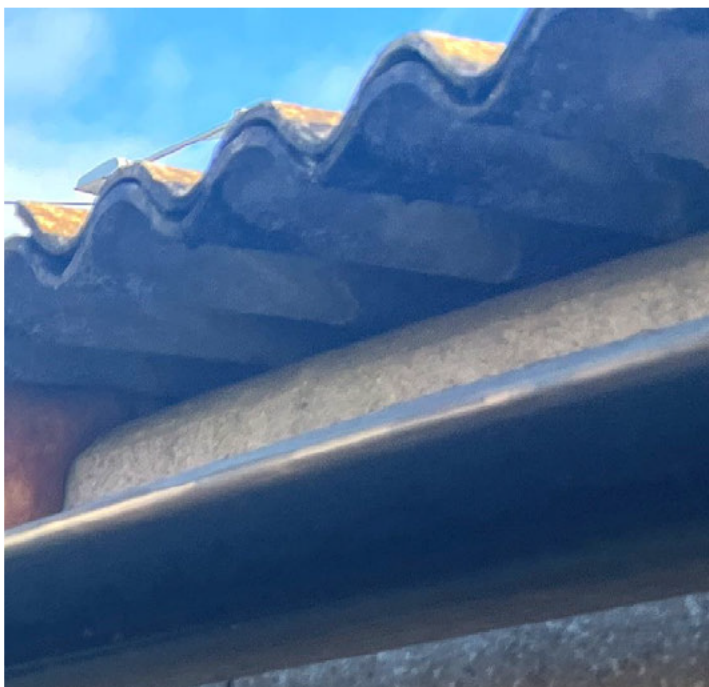
The Garage roof sheets are in reasonable condition with tight laps, however the corrugations to the eaves form openings directly to the interior.

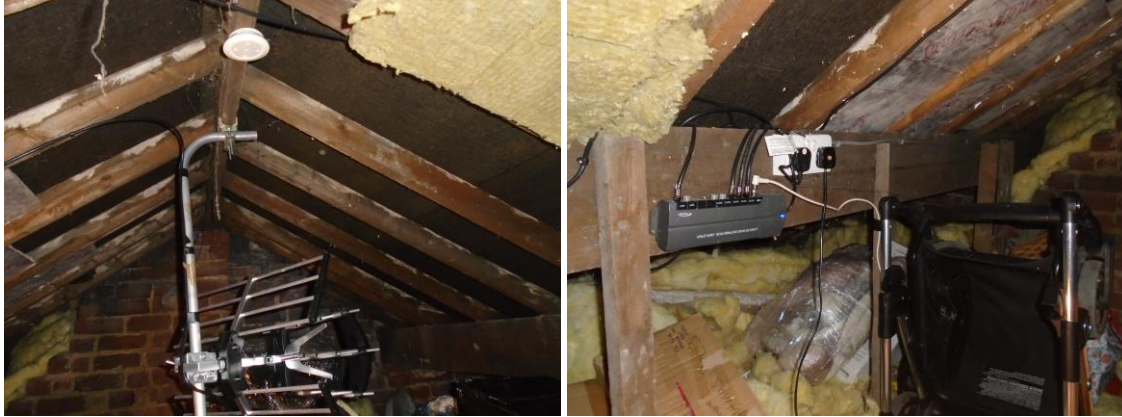
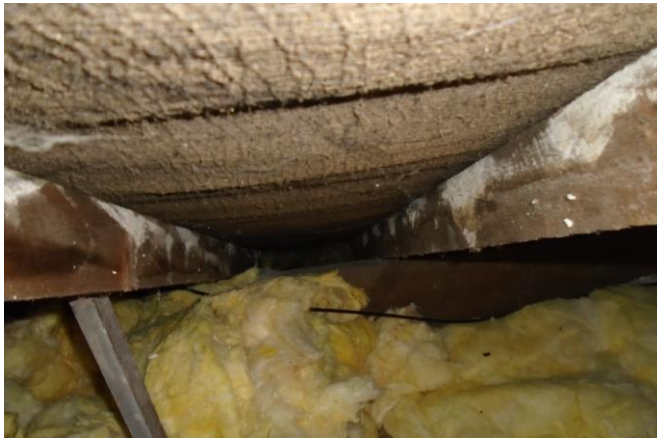
The roof space accessible via hatch is very compact, the timber rafters, hips and purlins were in reasonable condition, no cracks or crevices were present. Underlay was in average condition and in some sections ridged insulation had been fit between the rafters. Insulation quilt was present. Partial boarding to the floor. All surfaces were clean with no sign of droppings or insect remains. The space did not provide any high value roost potential. No signs of current or historic presence was found.

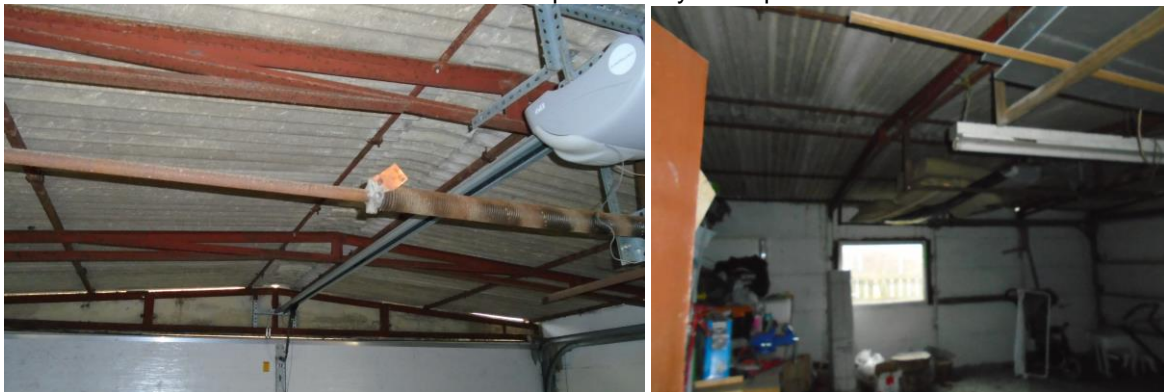
The garage did not have an enclosed roof void, it was a marginally pitched roof of corrugated fibre cement sheets over steel trusses. Gaps were present at the eaves in the corrugations where the sheets met the wall. The roof structure did not provide any roost potential.
