Preliminary Bat Roost Assessment Report

Chipping & District Memorial Hall,
Garstang Road,
Chipping,
PR3 2QH

12.08.2024

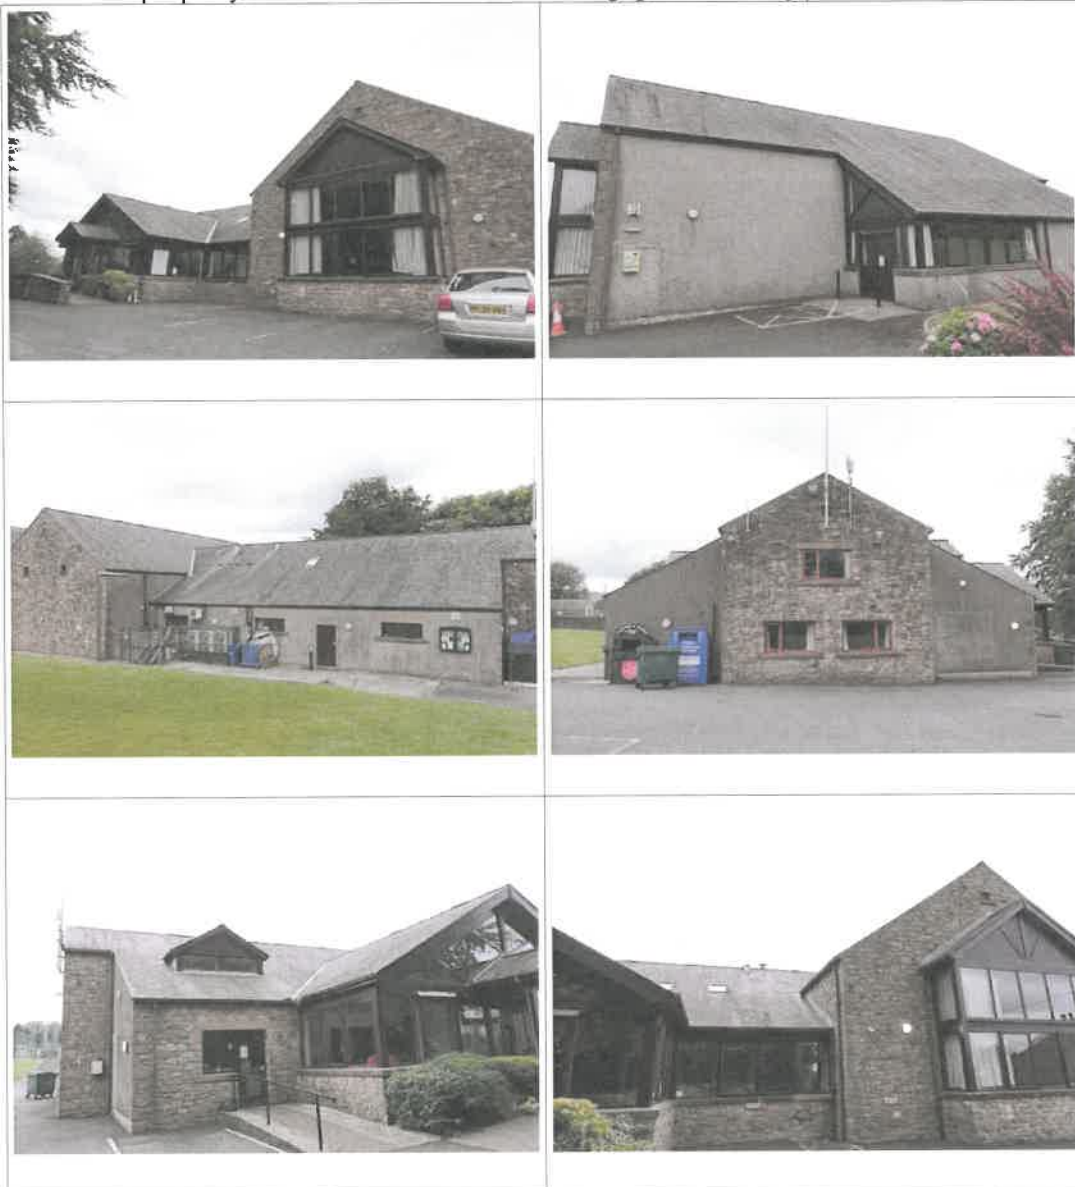
The property consists of a two storey stone built building with a double pitched slate roofs.

External walls are well pointed and rendered with no cracks, crevices or cavities present. Eaves are generally well sealed.

The roof is in good general condition with close fitting slates. No lifted, slipped or missing slates were observed and ridge tiles are well sealed.

Overall the property can be considered to offer negligible roosting potential.
