**BAT SURVEY AT -  
6 RAILWAY VIEW ROAD  
CLITHEROE**

DATE AND TIME OF VISIT  
24<sup>TH</sup> April 2024

REFERENCE NO. 6670

Insertion of a dormer roof in the main roof rear pitch and conversion of roof space.

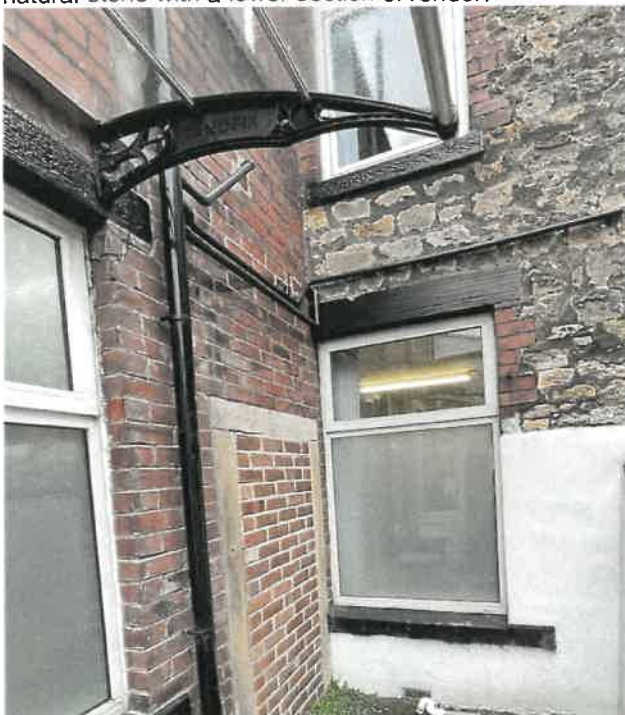
The walls are brick to the rear outrigger, the front elevation and rear wall of the main building is natural stone with a lower section of render.

The walls are well pointed and are in good condition. No cracks or crevices suitable for bat ingress were found to be present.

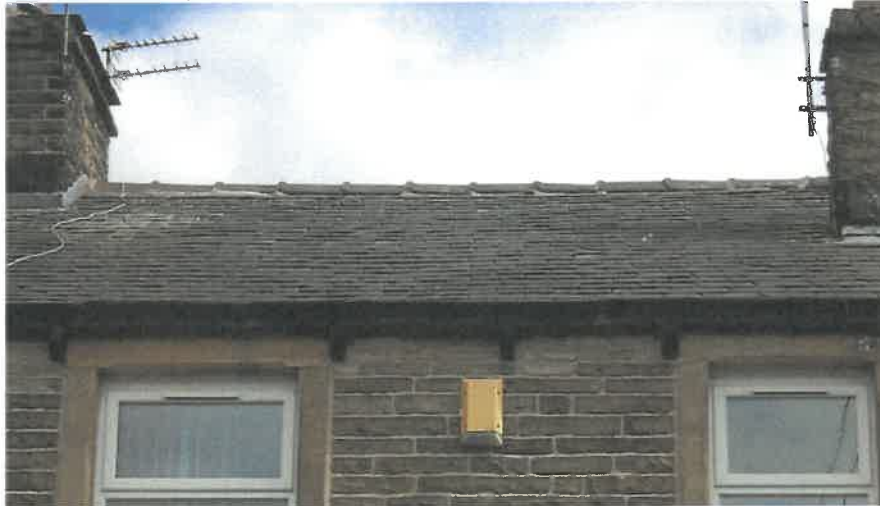
Main roof front pitch

The main roof and outrigger is blue slate with pointed ridge tiles and lead flashed chimney's. Gutters on brackets are present at the eaves. There is a glazed light in the rear pitch.

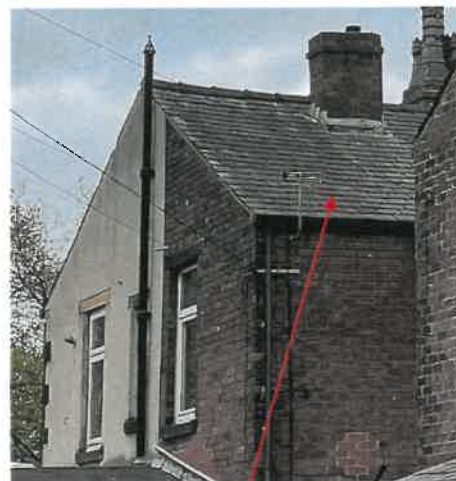
Outrigger mono pitch

The outrigger roof will not be affected by the insertion of the dormer roof.

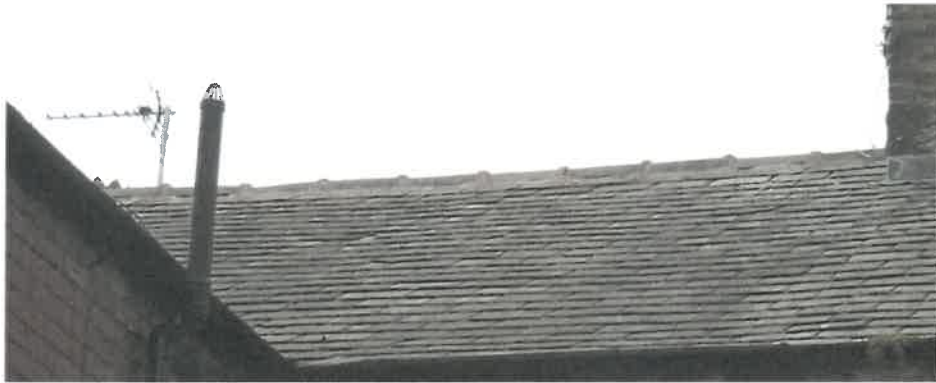
The roof is in excellent condition. The slates are very tight fitting and no slipped slates present. The pointing to the ridge tiles is in good condition with no missing sections or cracks. The gutters are in good condition and fit flush to the walls. No potential access points were evident.

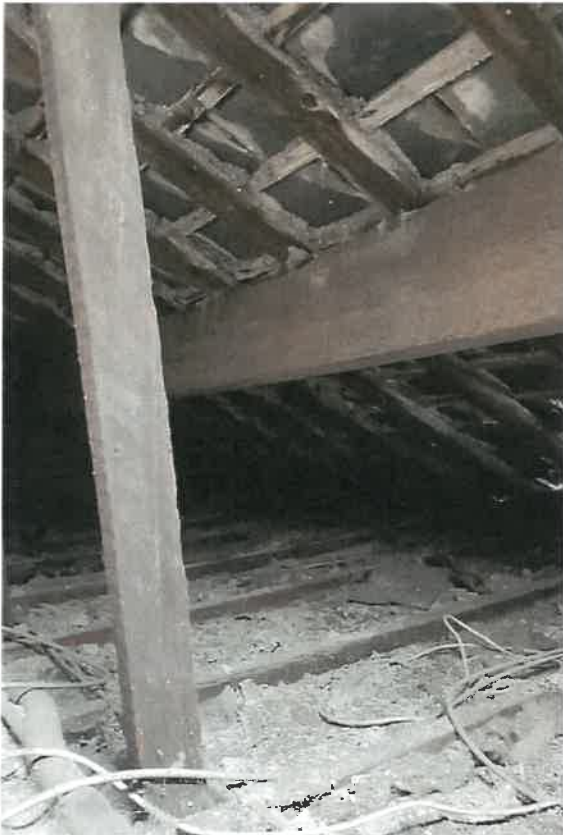
The roof space was accessible from the first floor landing. The timbers were in reasonable condition with no signs of rot or have any cracks present. The slates are fixed directly to the timbers no underlay is present. The space is very dusty due to the presence of back pointing to the rafters and battens.

The space is light due to the presence of the roof light.

The floor surface was examined for droppings or any insect remain feeding evidence, the result was negative.

The space does not provide any potential bat roost habitat.
