## Preliminary Bat Roost & Emergence Survey Report

<b>Client:</b>	<b>AW&amp;A Architects</b>
<b>Site:</b>	<b>Hall Foot Barn, Worston, Clitheroe</b>
<b>Report Issue Date:</b>	<b>03/07/2024</b>
<b>Report Author:</b>	<b>Carol Edmondson MSc MRSB</b>

This report presents the results of a daylight preliminary bat roost assessment (PRA) undertaken on 31<sup>st</sup> May 2024, at Hall Foot Barn, Worston and the follow up dusk emergence survey. The work has been commissioned to support a proposed planning application to convert the barn.

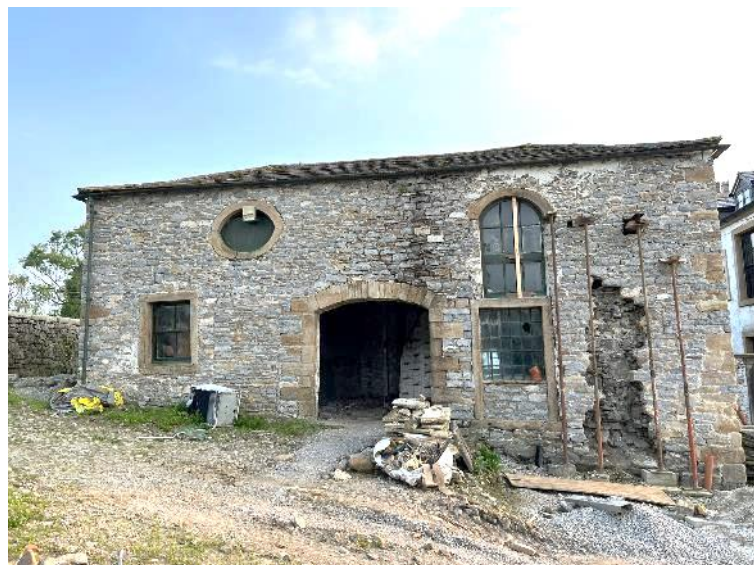
Figure 3: North elevation of the building.

On the front (North elevation; Fig.3), there was some structural movement, with some missing stone from the wall. The resultant gaps were inspected by high power torch & endoscope.

**There was no evidence of bats roosting in any of these gaps.**

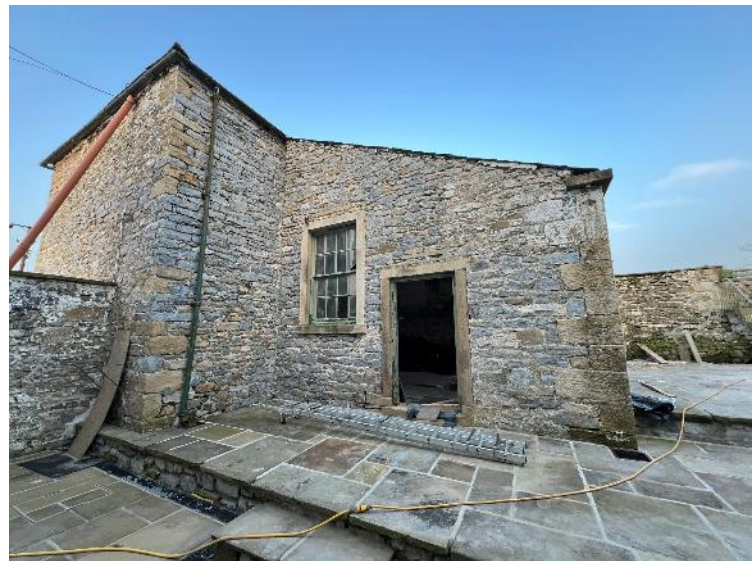
Figure 4: West elevation.

The removal of the rendering had exposed many gaps in the pointing between the stonework, however the majority of these were too wide for crevice dwelling bats. Those that appeared more suitable were inspected by endoscope.

There were no gaps behind any of the barge boards, or at the eaves.

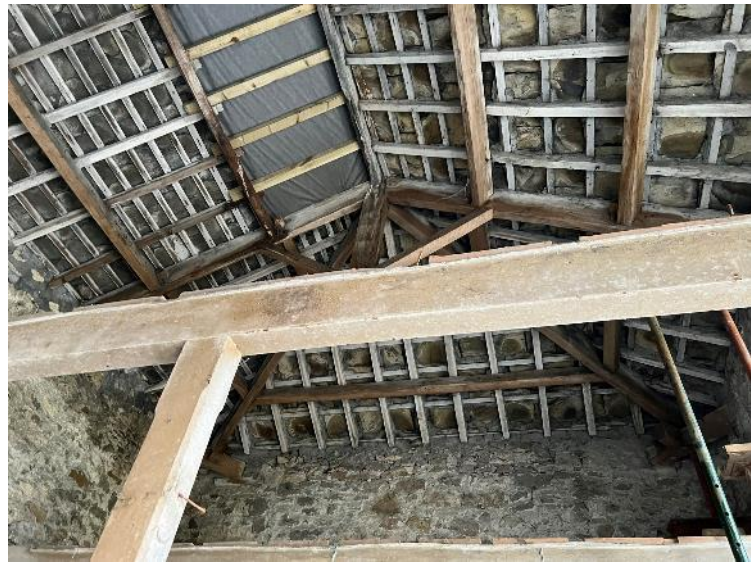
Figure 6: Example of exposed timbers and roof tiles.

Most ceilings have been removed, with the laths & purlins exposed. In some roof spaces the tiles have no lining, whereas the repaired areas have breathable roof membrane installed as the lining.

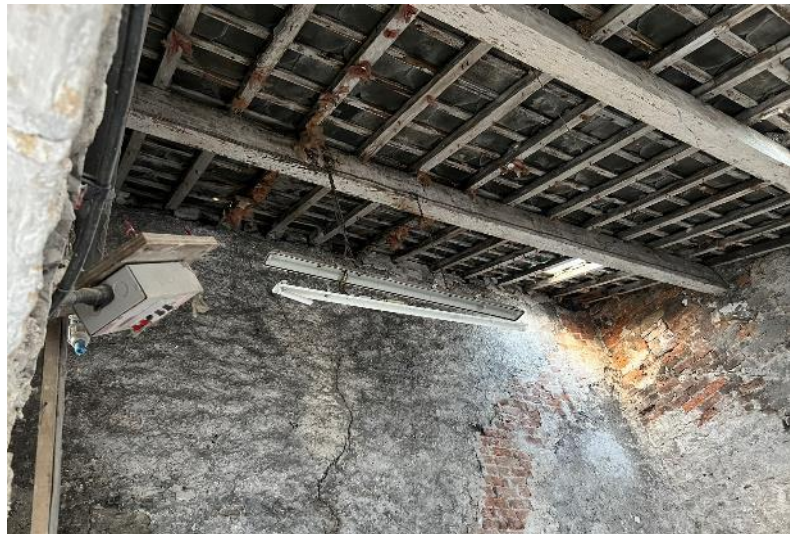
Figure 7: Roof open to the underside of the roof tiles.

The floor had a reasonable layer of dust and debris (i.e. not recently swept). There were mice and swallow droppings evident but no bat droppings.

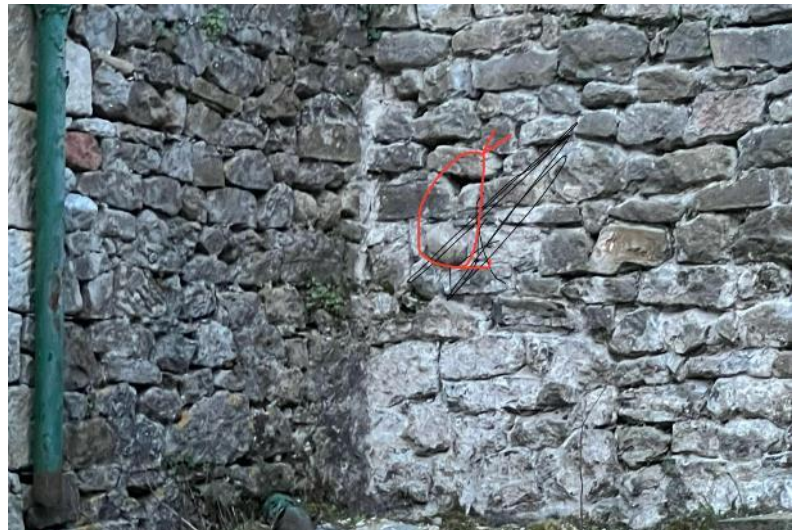
Figure 8: Location of wren nest in the inside of the east garden wall.

There was some evidence of nesting/roosting birds inside the building (feathers and some nesting material). There were swallows flying in and out of both sections of the building, with some nesting material present in the rafters. A wren was seen entering a hole in the garden wall on the inside of the east elevation (Fig.8) and another into the main barn entrance, carrying feeding material.

- Due to the transient nature of bats their presence can never be entirely ruled out, and a precautionary method of working should be adopted.
- **If bats are found during any stage of development, work should stop immediately and a suitably qualified ecologist should be contacted to seek further advice.**
- **No further work should be undertaken until the young have fledged from active nests. A breeding birds check will be required before work can be continued on this building, or can be resumed after the 31<sup>st</sup> August.**

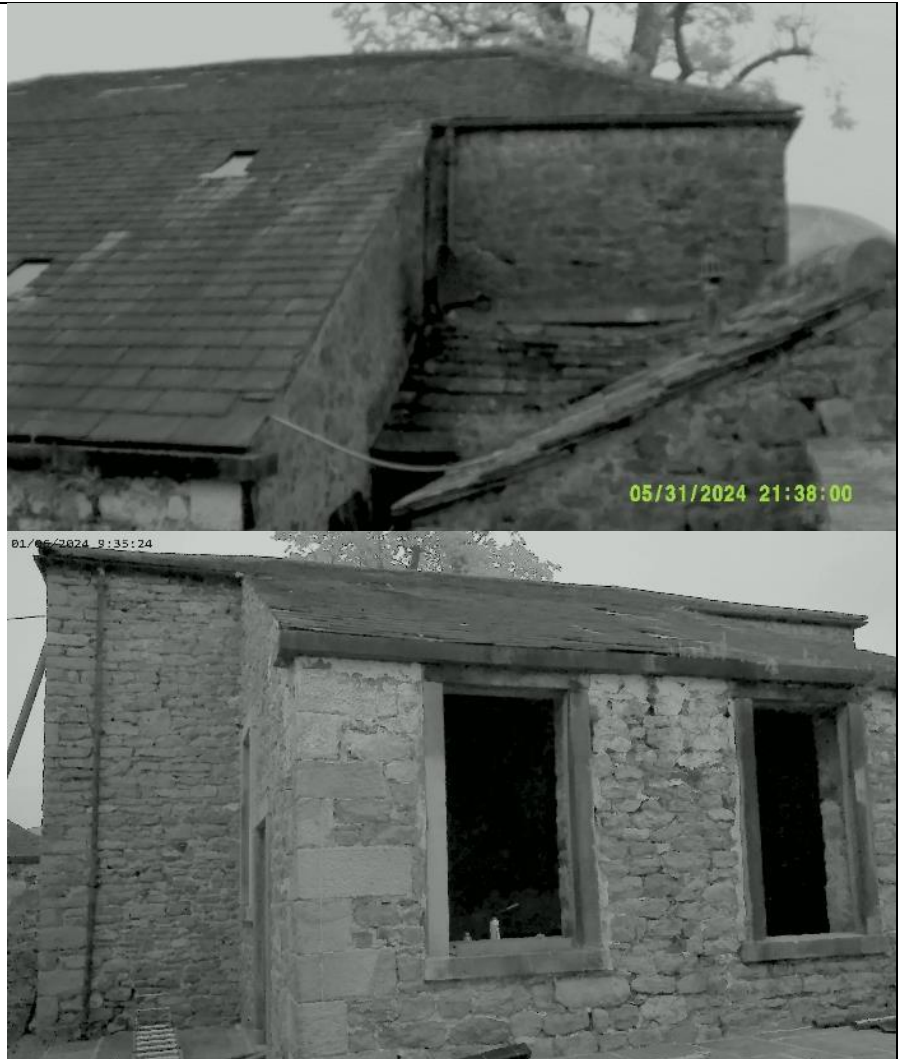
(2 x NVA's one covering roof area, one covering walls & gable end)

Occasional foraging (arriving from behind surveyor from southwest, looping round the courtyard and exiting to the northeast of the building) single common pipistrelle from 22:06 to 22:48

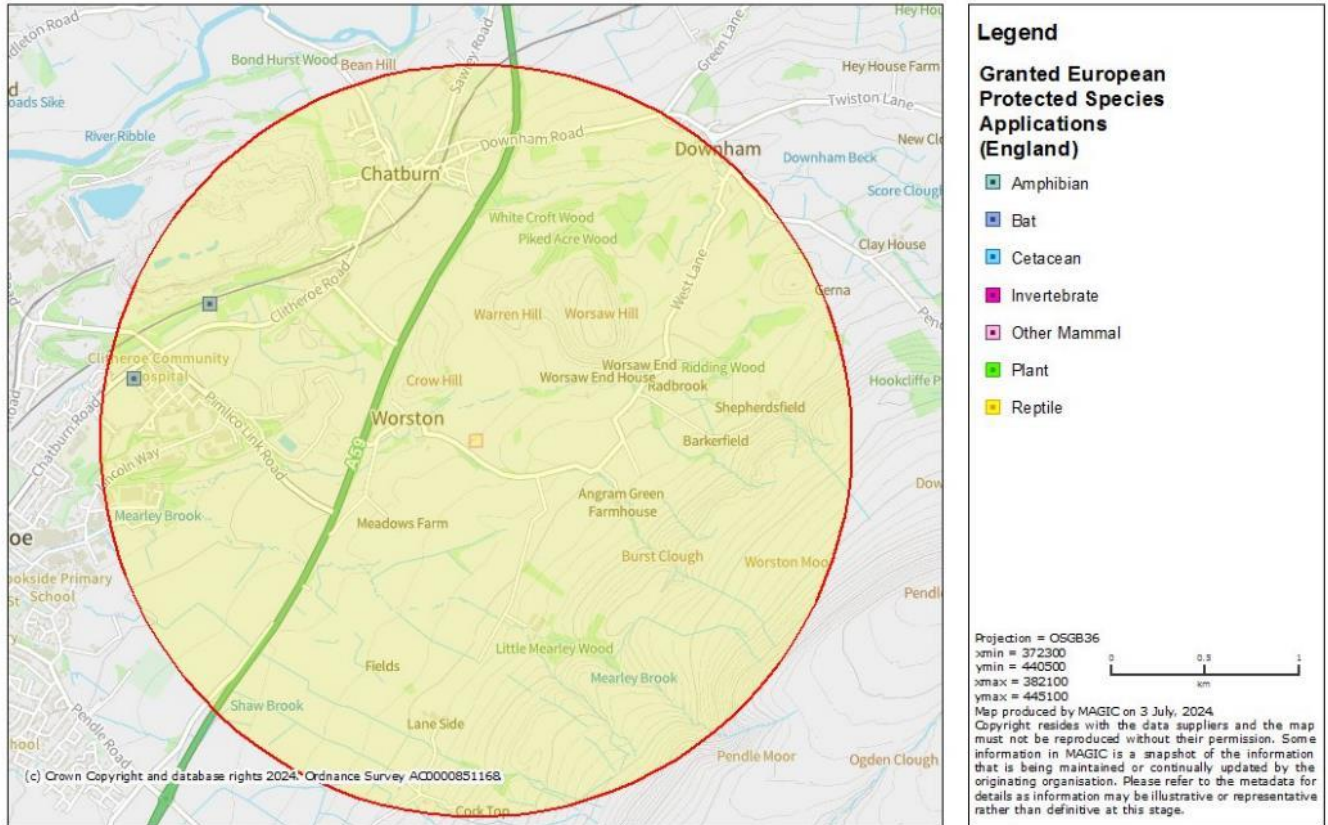
EPSML's within 2km

A search of the magic database for granted European Protected Species Mitigation Licences (EPSMLs) within a 2km radius found two licenced sites which include damage to a resting site for common pipistrelle *Pipistrellus pipistrellus*, soprano pipistrelle *P.pygmeus* and whiskered bat *Myotis mystacinus*. This is evidence of the presence of these species within the proximity of the site but does not exclude the presence of other bat species. These species of bat are known to roost in residential areas and buildings, foraging along hedgerows and under trees around urban areas and parks.
