Heritage statement to support planning application
for conversion of former stables
at Hall Foot, Worston, Lancashire

1 Introduction

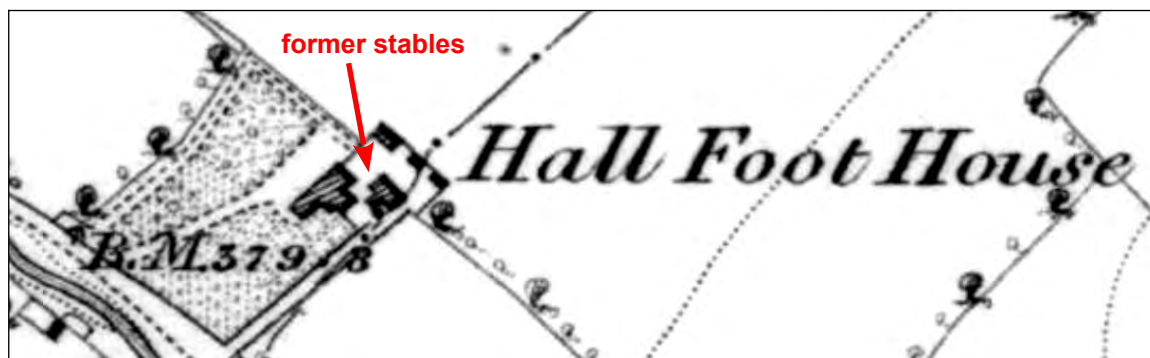
Figure 1: OS 1:10,560 map, 1847

- 3.2 The former stables are of an architectural form which suggests they date from around the late 18th or early 19th century. They are shown on the Ordnance Survey's 1:10,560 map of 1847¹ (figure 1), while the 1:2500 map of 1912² (figure 2) implies they were later extended at the rear (south-west).

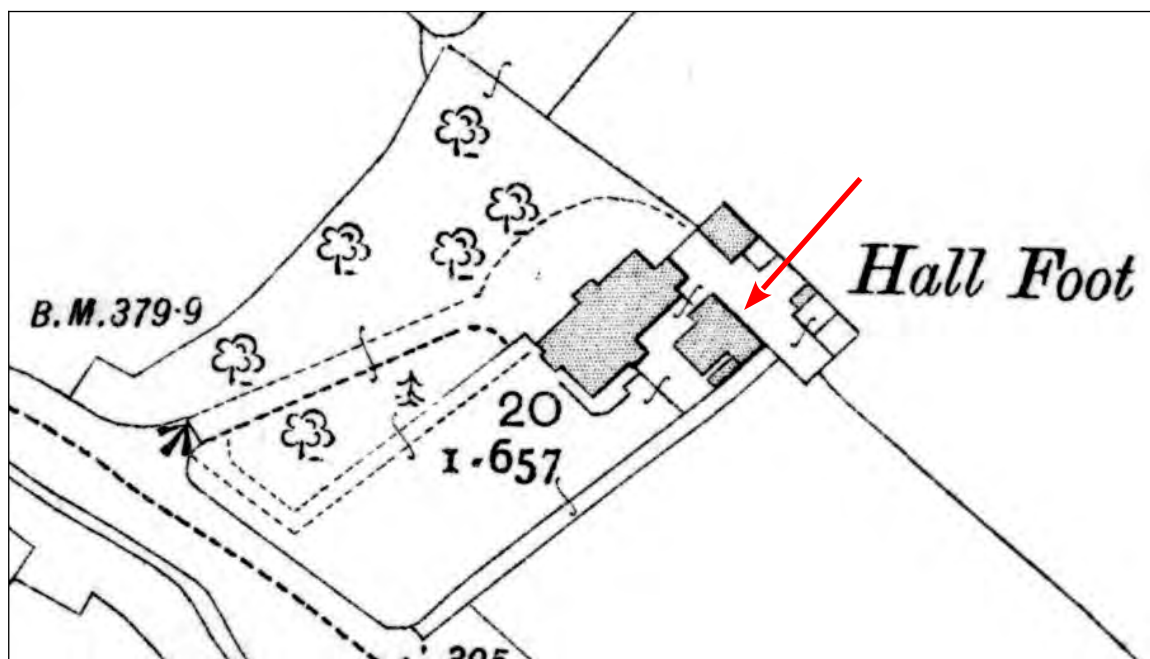
Figure 2: OS 1:2500 map, 1912

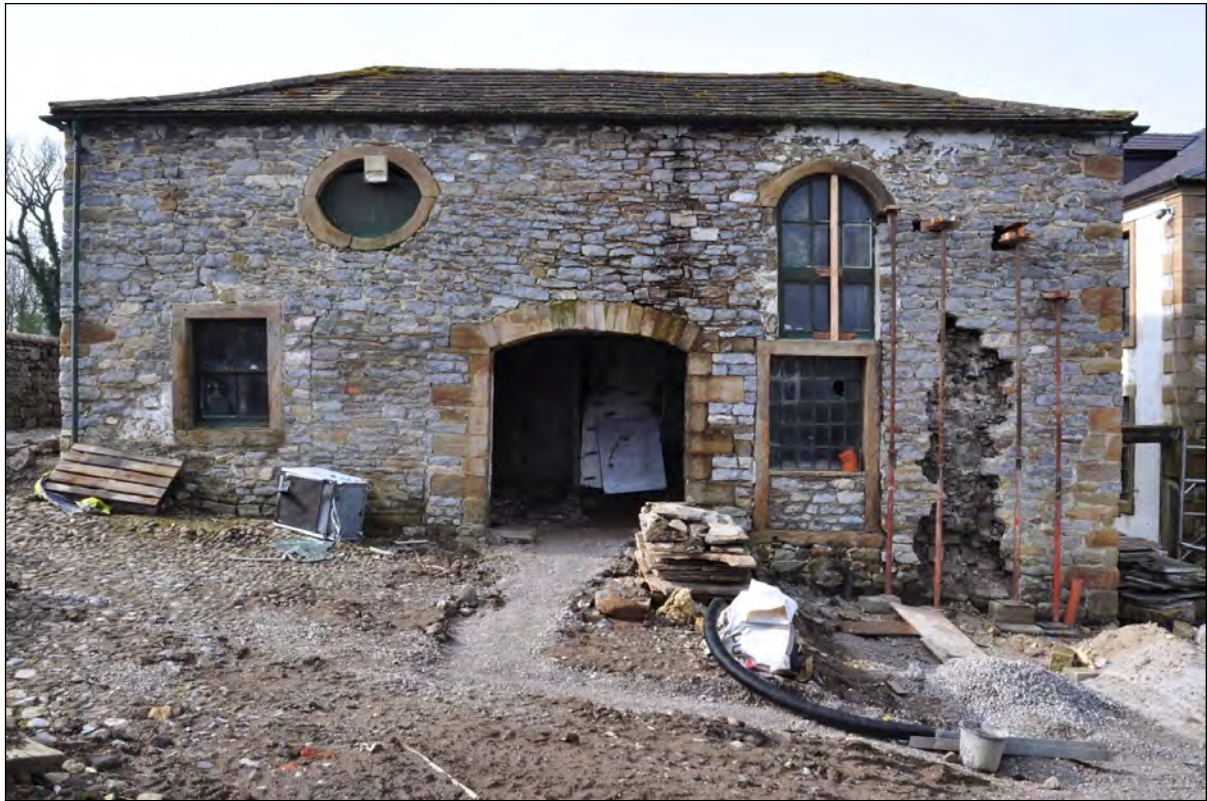
- 4.2 The main block (photos 1 & 2 below) has a hipped roof and appears originally to have had a symmetrical façade in a neoclassical manner, arranged around the focal central doorway with segmental arch. To either side of this were personnel or equestrian doorways with monolithic jambs: that to the right retains its surround, but has been reduced to a window fitted with cast iron multi-pane frame, while the left-hand one has been walled up and its dressings removed, perhaps for re-use within the nearby window, which has probably been inserted. The former doorway is still evident inside the building, where part of it forms a narrow recess next to a non-original internal cross-wall, probably introduced during the late 19th century.

- 4.3 There also appears formerly to have been a matching pair of elliptical forking eyes to the front at first floor level, in line with the original doorways, though again only one remains intact, and the right-hand one has been rather crudely cut down to form a full-height window.

Photo 1: Front elevation

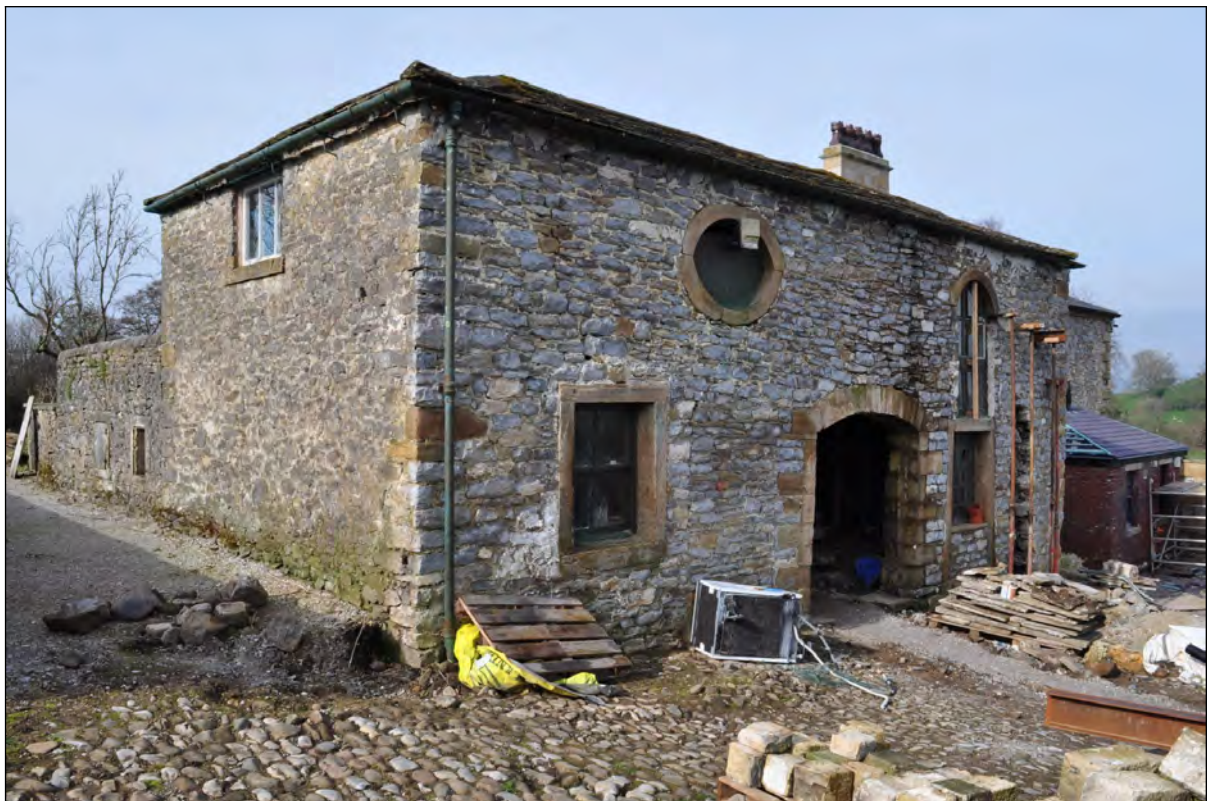
Photo 2: View from east

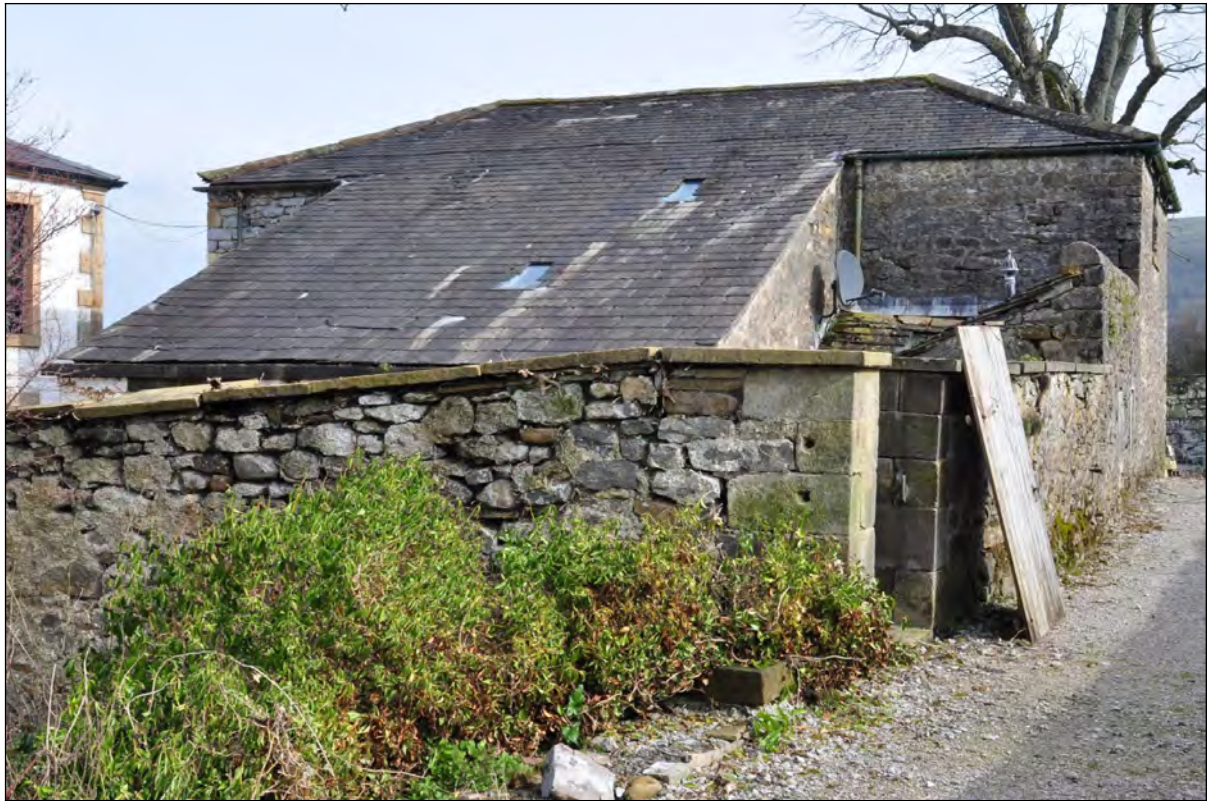
- 4.4 The north-west side elevation is blind, but the south-east side has a first floor window, perhaps a 19th century insertion. To the rear, the large added outshut conceals much of the original building (photo 3), but within its former rear wall is a blocked window or similar.

Photo 3: Rear of building

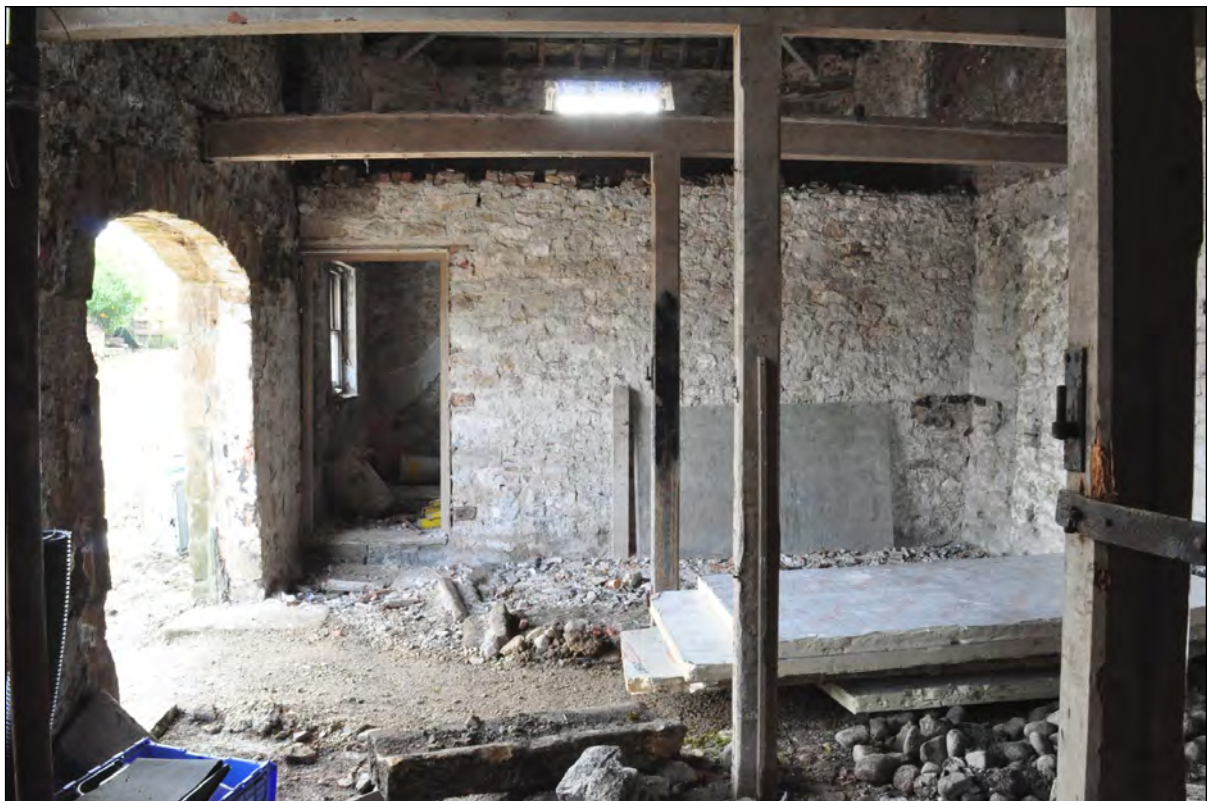
- 4.5 The most recent arrangements within the ground floor of the two-storey block comprised a row of four stable stalls or narrow loose boxes, with the cross-wall enclosing a separate tack room in the south-east end (photo 4), but this is not believed to have been the original arrangement, rather a 19th century reconfiguration. Very few historic fixtures remain, but they include a fireplace (photo 5) and four-pane sash in the tack room. There was also a loft throughout the block with stairs in the east corner, but these would have been at least partly non-original. The roof structure is of imported softwood, with king-posts and tusk-tenon purlins, indicative of a date around 1800.

Photo 4: Ground floor of main block, looking south-east

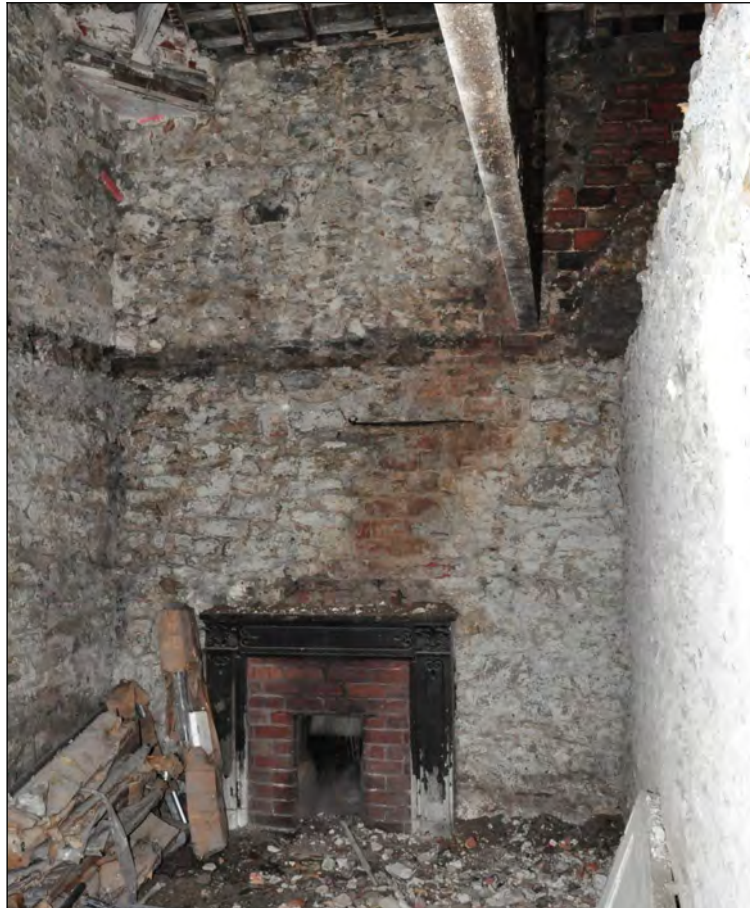
Photo 5: Tack room, looking south-west

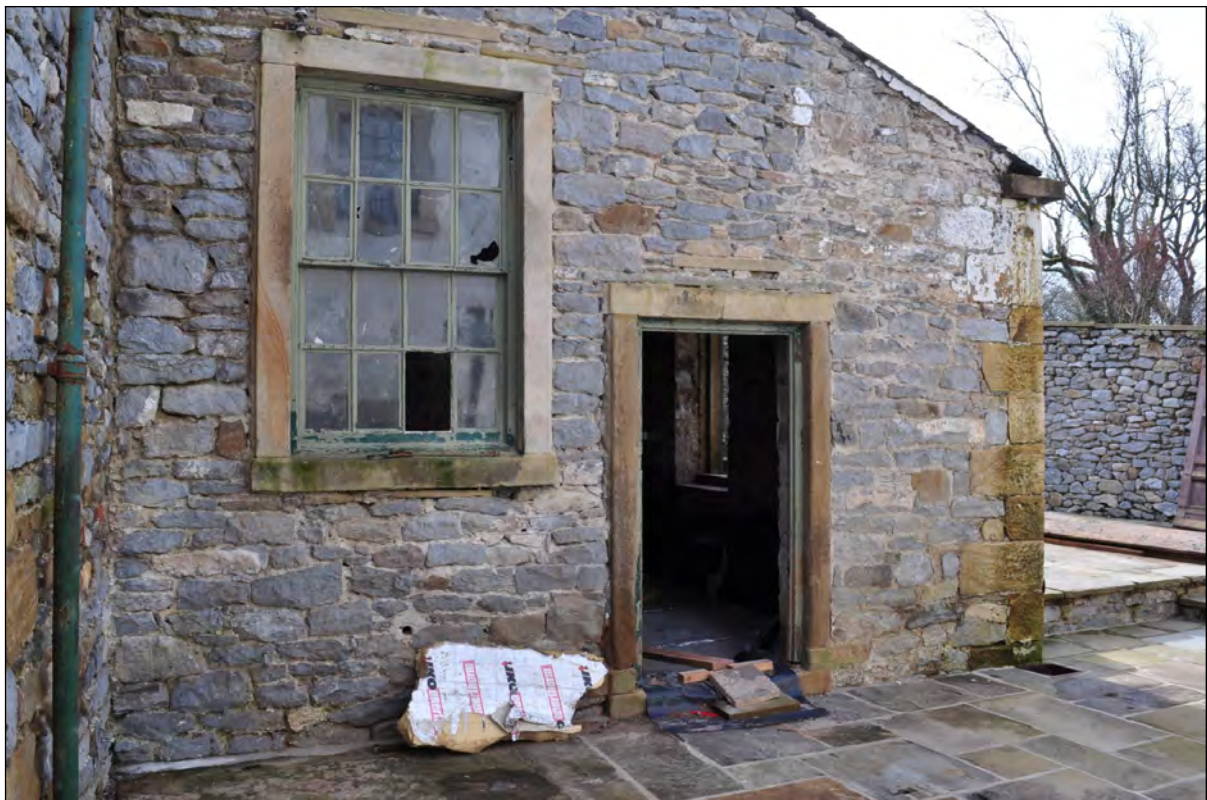
- 4.6 The large outshut is built from similar materials, albeit with more regularly cut dressings and a stone rainwater trough at the eaves, and was also formerly covered with lime. Its entrance is in the north-west side where there is also a 16-pane sash (photo 6); two windows openings of similar proportions are set within the south-west side (photo 7). It is of one and a half storeys, and although nothing remains of its internal floors, it clearly once held three fireplaces or stoves (their chimneys removed above roof level), so was evidently habitable, probably as accommodation for servants (photo 8).

Photo 6: North-west side of rear outshut

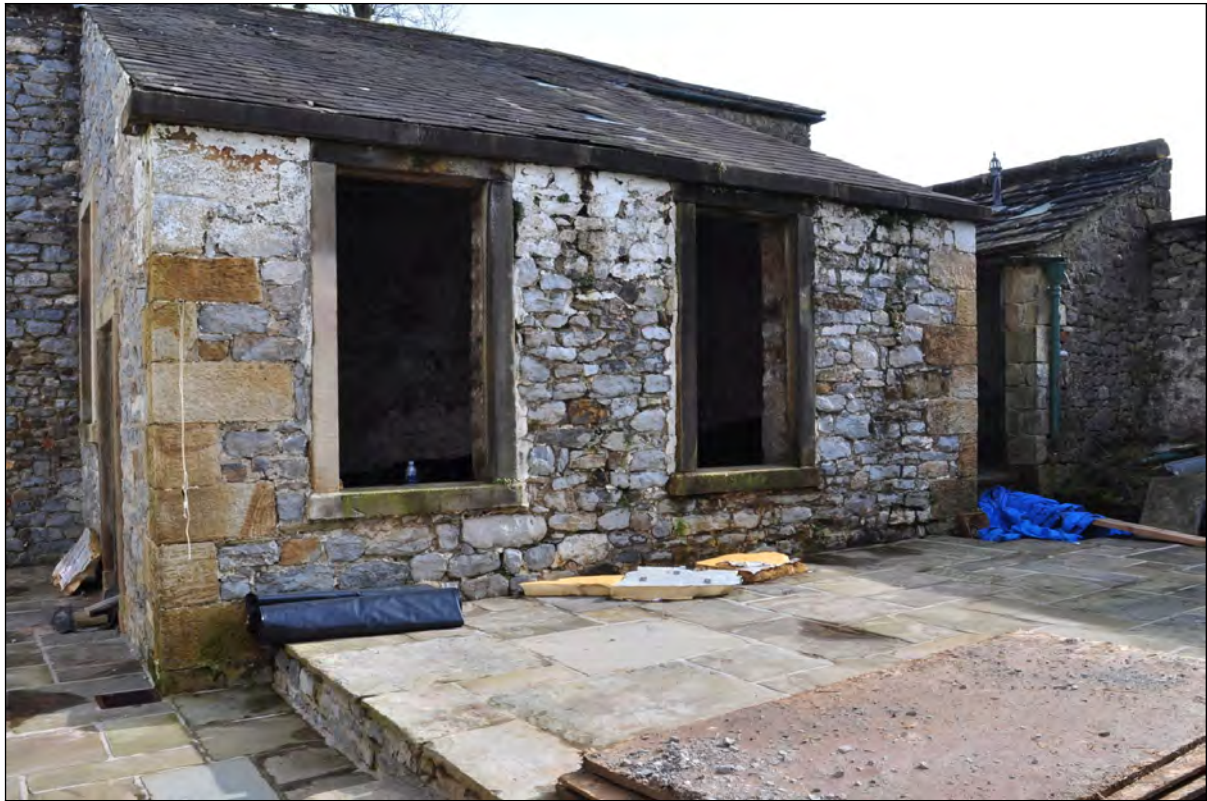
Photo 7: South-west side of rear outshut

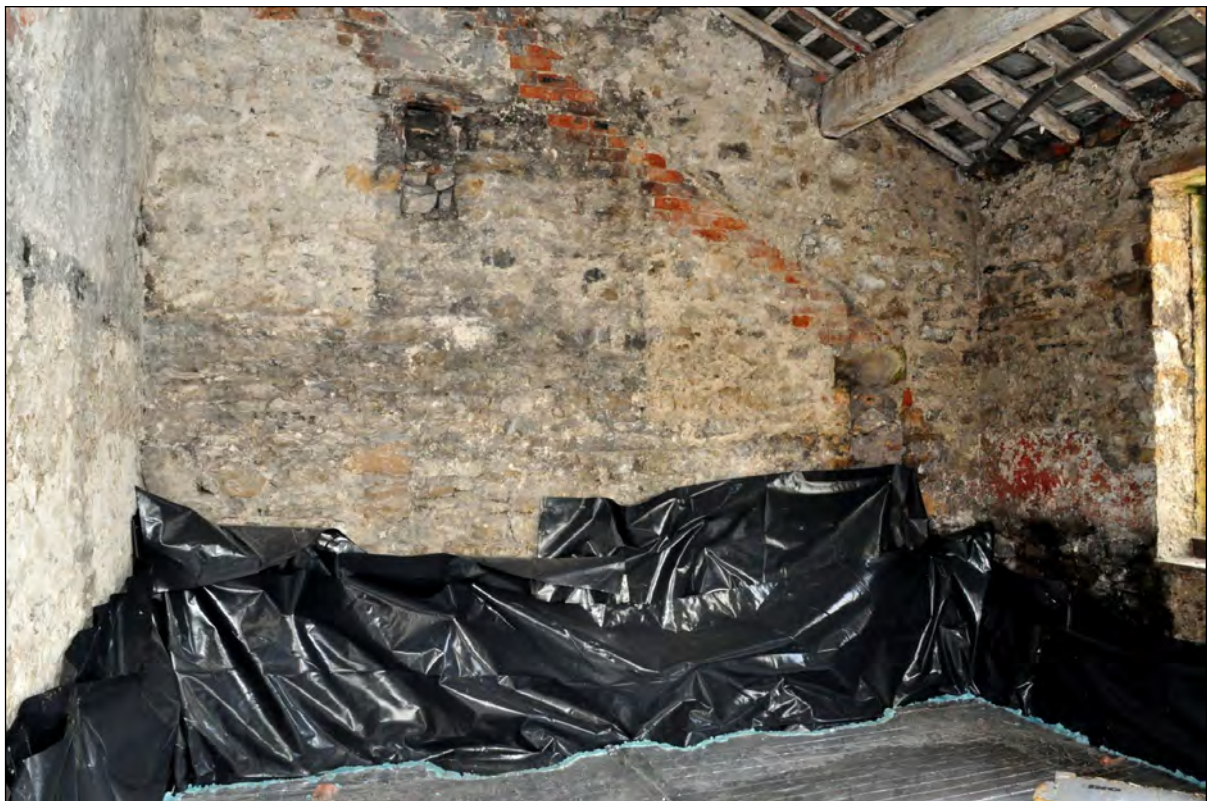
Photo 8: Interior of rear outshut

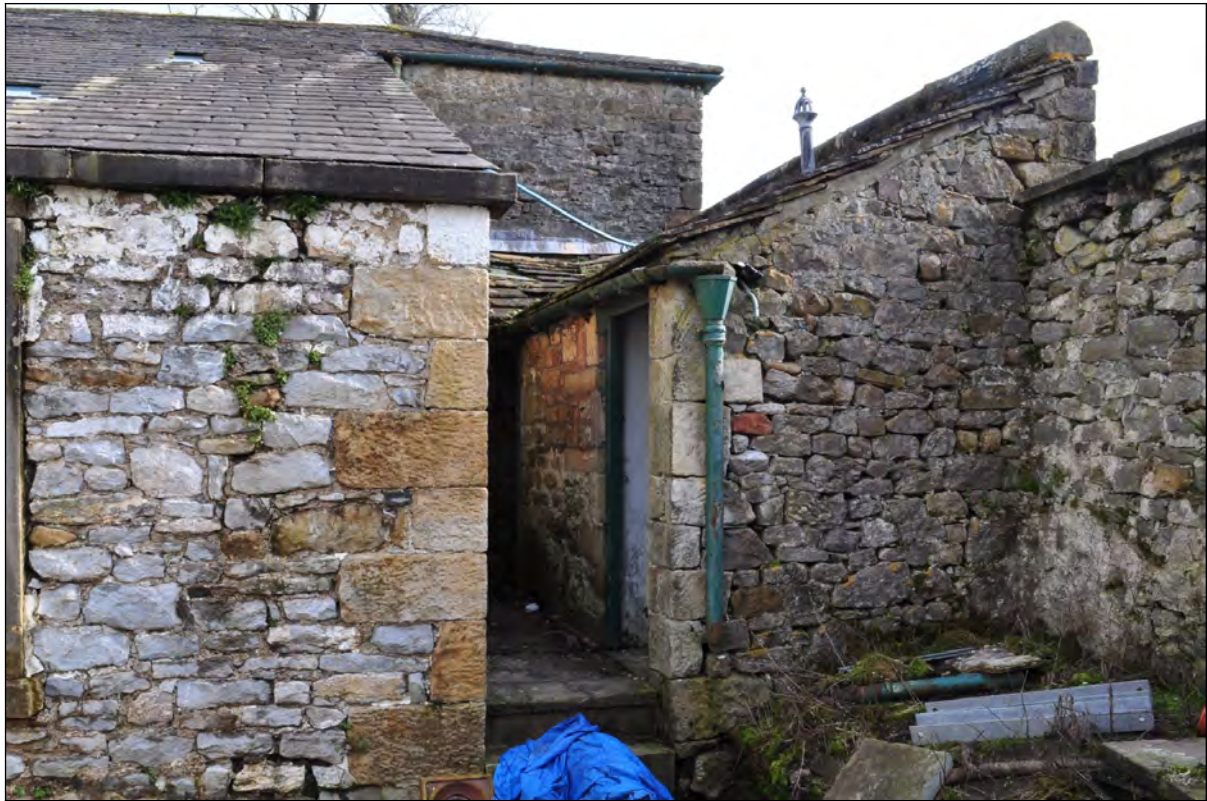
- 4.7 The smaller rear wing has as its south-east side a continuation of the boundary wall, heightened and finished with half-round coping. It contains two coal stores

and a privy, the former with filling holes in the south-east side, and the main access from the kitchen yard (photo 9). The privy has been adapted to a WC.

Photo 9: Privy and coal stores to rear of stables
