Preliminary Roost Assessment

Turner Fold, Ribble Valley
Reference: 81-933-R1
Date: July 24

A Preliminary Roost Assessment (PRA) was undertaken on the building on-site. No other buildings, structures or trees were present within the site boundary. Please see Appendix I for the Preliminary Roost Assessment Plan which details the location of the potential roost features.

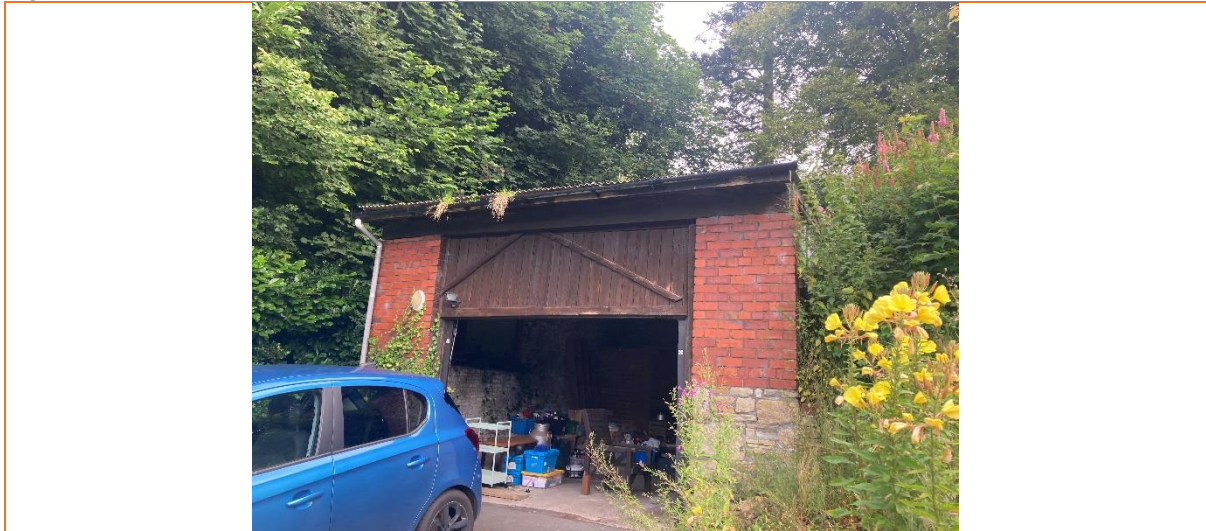
Figure 2 **Showing Southern Aspect**

The building was constructed of both stone and red brick. The structure had a mono pitched roof constructed from corrugated cement fibre sheets.

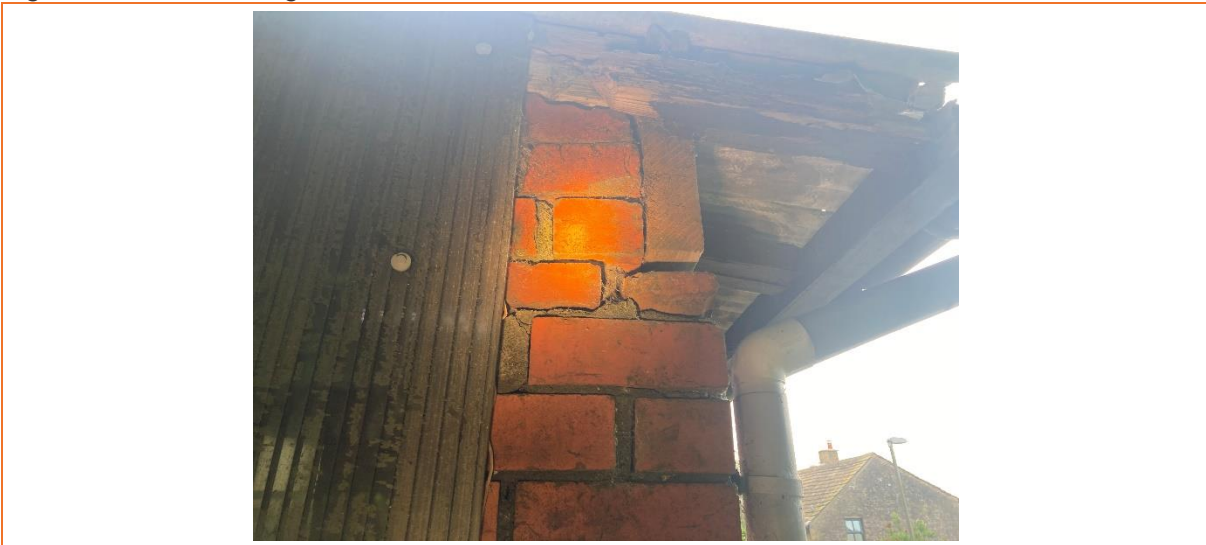
Figure 3 **Showing Crevices on the Western Elevation**

Multiple crevices between the stonework and mortar were present, these were identified within the interior and exterior of the building. These crevices have the potential to support a small number of roosting bats on a more regular basis.

Due to the presence of potential roost features for bats located within brickwork, the building was assessed as having Moderate bat roosting potential. The building was determined as being unsuitable for nesting birds, and no evidence of current or historic nests was noted.

Two Nocturnal Bat Surveys are required on the building between May and September (inclusive), with at least one survey undertaken between May and August. The surveys must be spaced at least 3 weeks apart following guidance from Collins (2023). If bats are identified roosting within the building, a further survey would be required to characterise the roost and a European Protected Species License (EPSL) will be required and with up-to-date surveys from the survey season prior to the application submission.

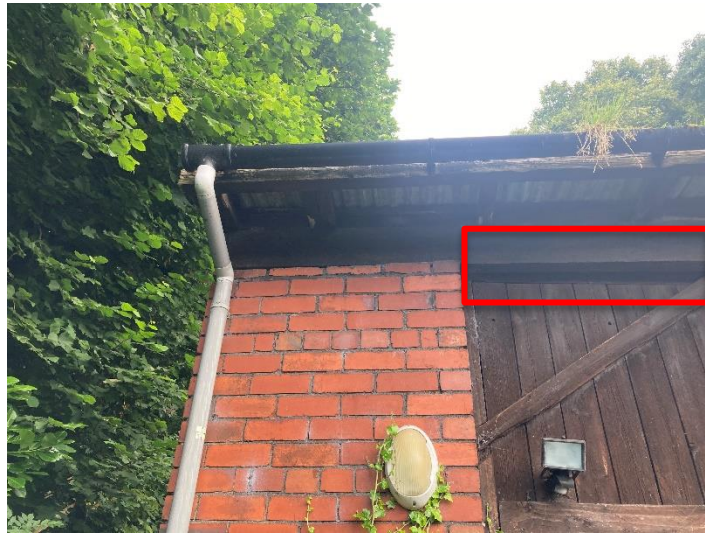
Figure 4 Showing Access Points on the Southern Elevation

Two access points were present allowing bats access into the building. Access point comprised two holes within the western window. With further gaps between the wooden fascias above the garage entrance on the southern elevation.

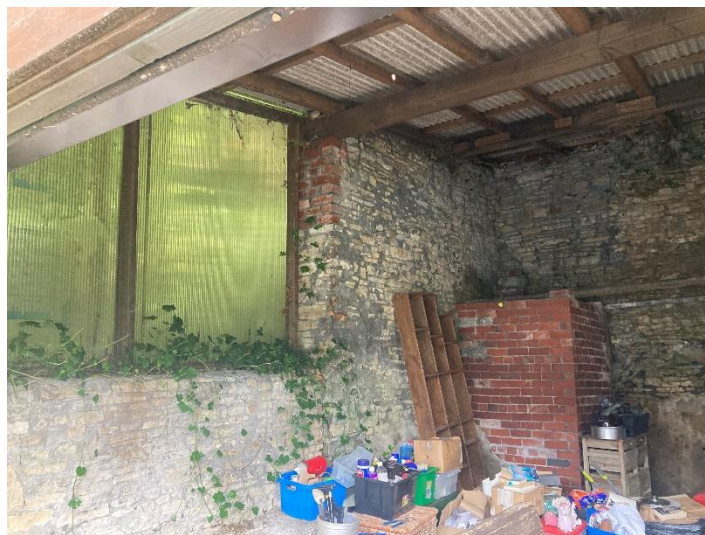
Figure 5 Internal View

Perspex windows were present on the eastern and western elevations, reducing the suitability for day roosts and hibernation, due to it being well lit, and subject to fluctuating temperatures.

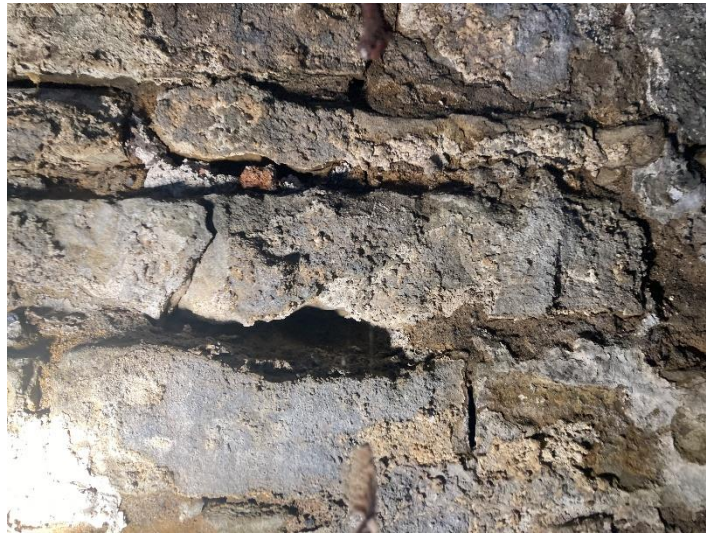
Figure 6 Showing Internal Crevices within Stonework

Crevices were present within the stonework internally and could provide opportunities for roosting bats on a regular basis. Although, no bat droppings, or staining was identified during the inspection.

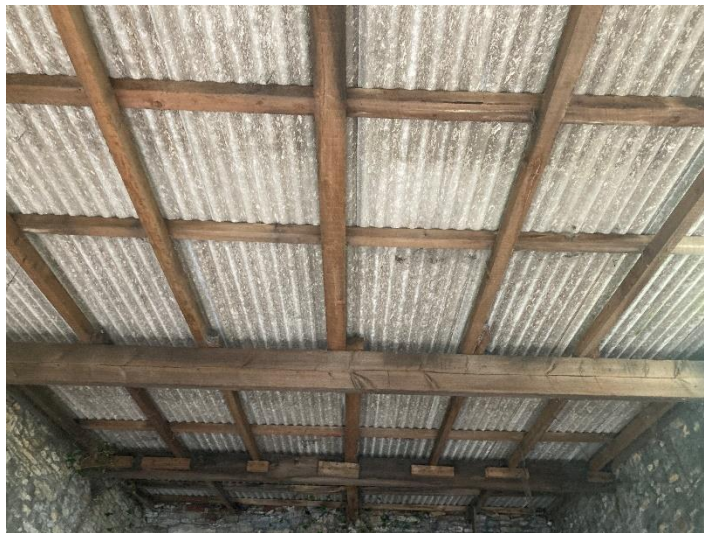
Figure 7 Showing Ceiling

The roof was supported by wooden beams, however these were well sealed and did not provide any opportunities for roosting bats.

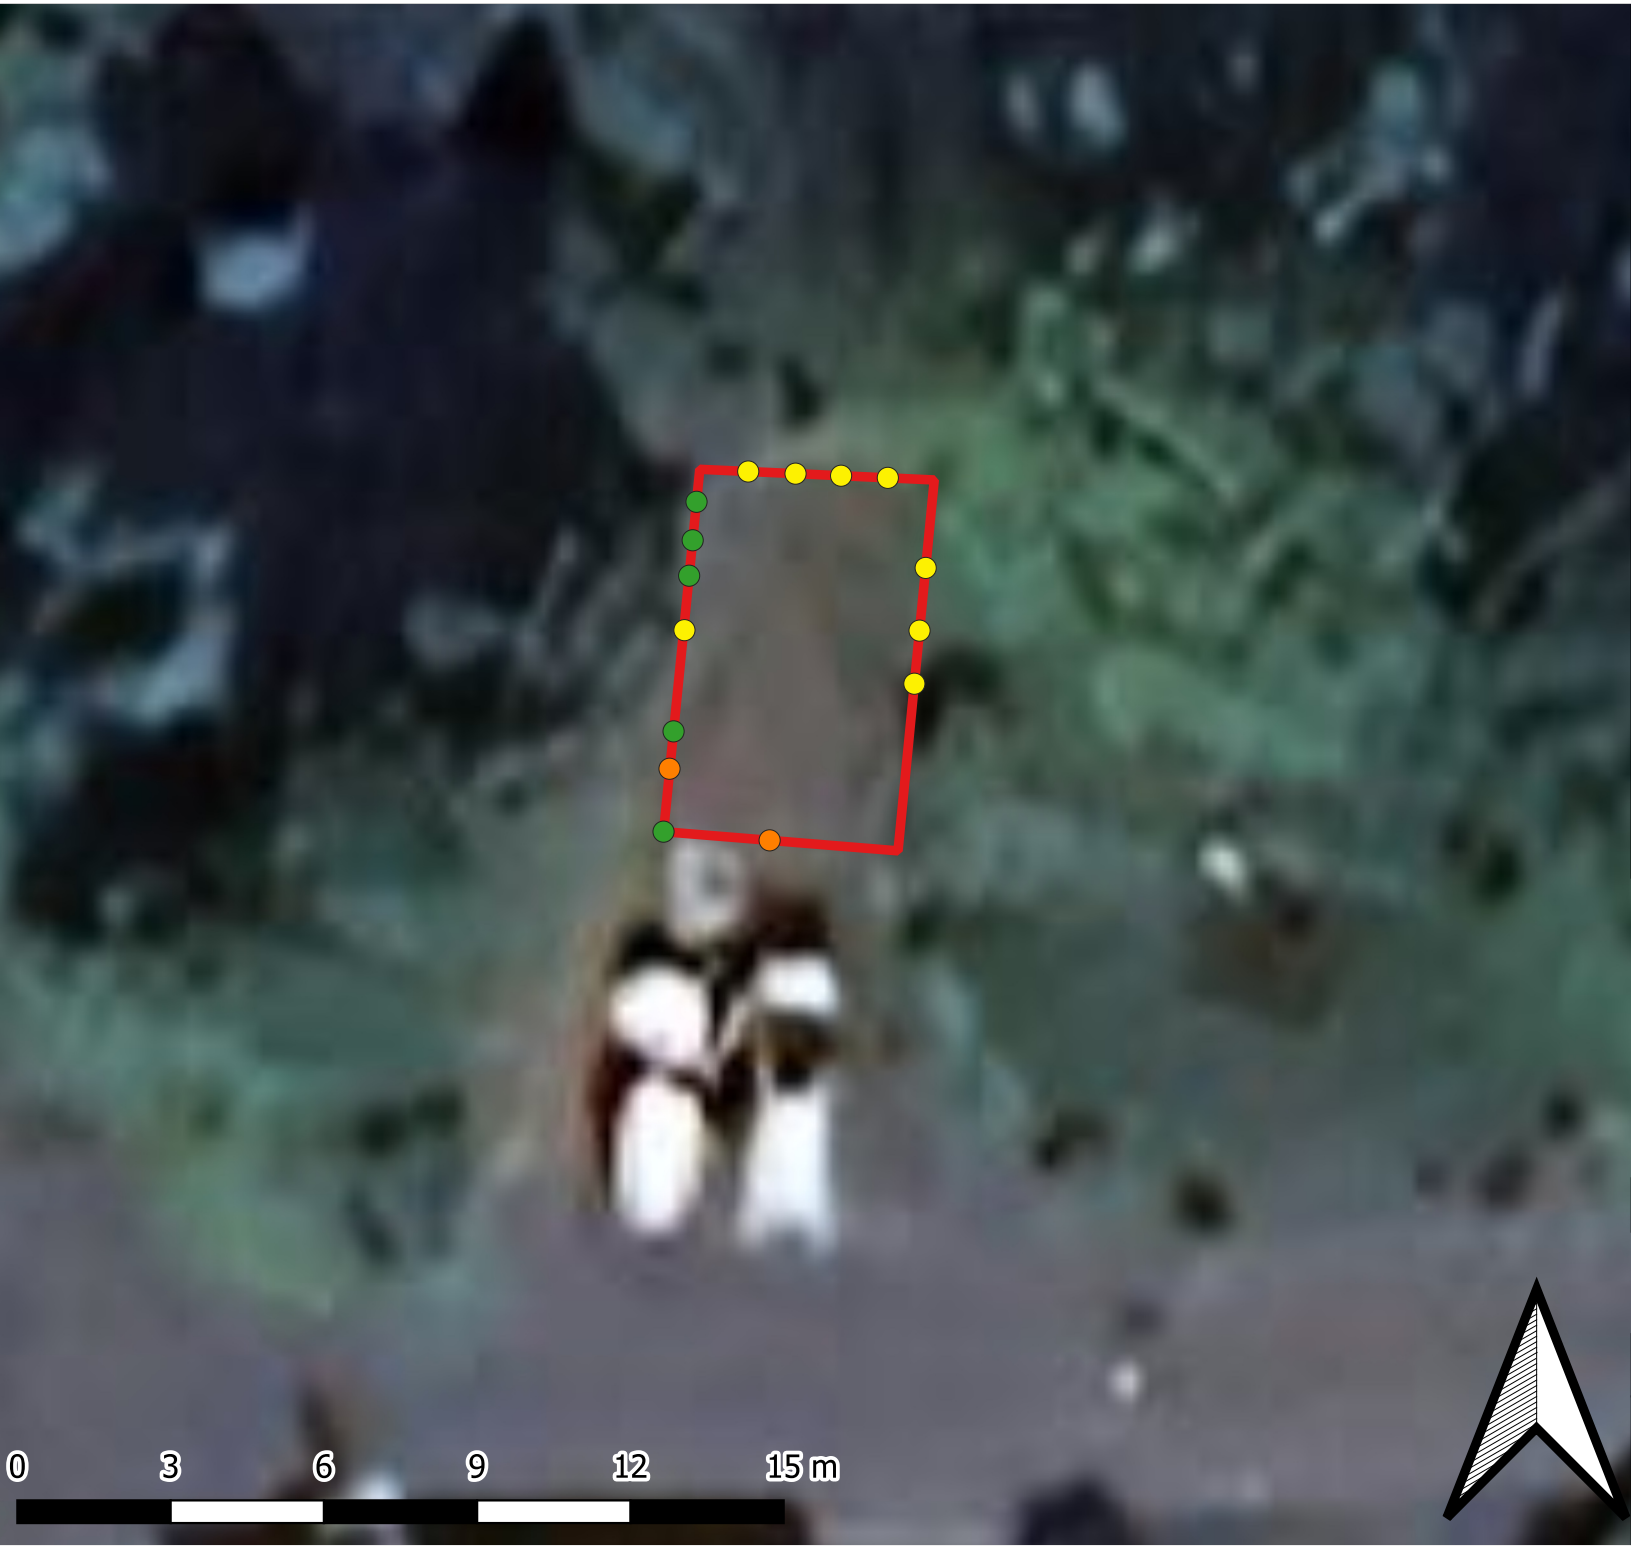
Issue: 1	Revision: 1	Date: 24/07/2024	Drawn: LS	Authorised: CK
Client: Rodger Hindle Finacial Services LTD			Job No. 81-933	Date: 24/07/2024
			Drawing No. 81-933-001	Scale: 1:250@A4
Job title: Turner Fold, Ribble Vally			Drawing title: Potetial Roost Feature Plan

The building lacked a cellar and loft void, and no features were found to be suitable to support hibernating bats or maternity colonies due to lack of stable temperatures and lighting. Overall, the building was assessed as having Moderate bat roosting potential.
