Large Barn at Written Stone Farm, Longridge

**PRELIMINARY BAT ROOST ASSESSMENT &
GENERAL ECOLOGY WALKOVER**

May 2024

Report Ref: 093_01

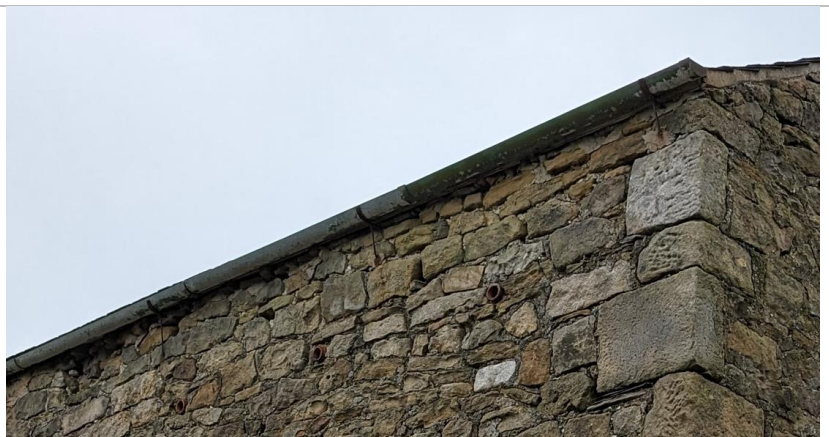
Photo 3.1

Gaps in the stonework under the eaves.

Externally, the stonework of the barn appeared in good condition overall. However, there were several small areas of the stonework in which the mortar had decayed which had resulted in gaps and crevices in the stonework in these locations. Gaps were particularly evident under the roof verge across the south-east facing aspect of the barn.

In accordance with good practice guidelines (Collins, 2023), it is recommended that further surveys are required in order to establish the presence or absence of a bat roost at the large barn. These surveys would comprise dusk emergence surveys which can be undertaken between May and August (inclusive).

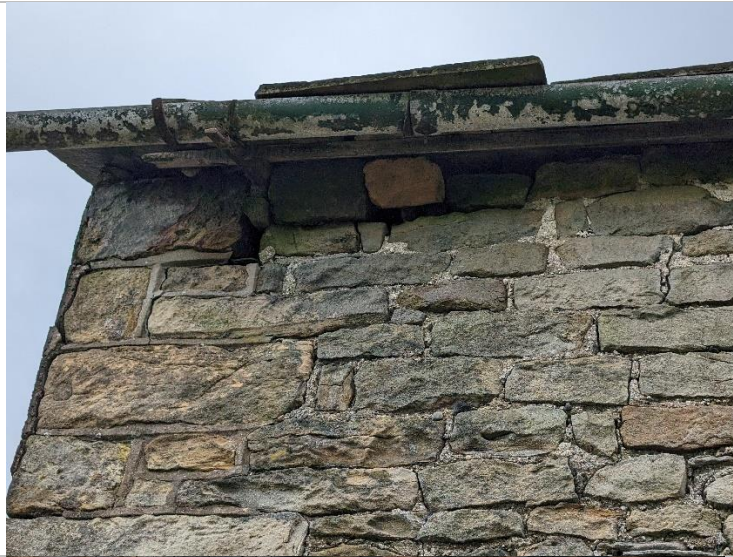
Photo 3.2

Large gaps on the south corner of the barn.

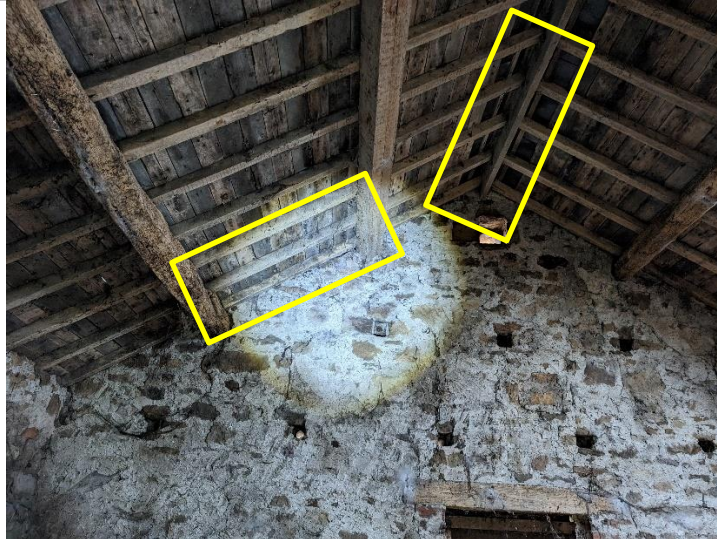
Photo 3.3

Gaps behind the sarking boards and the ridge and gaps under the rafter at the gable.

Internally, the underside of the large barn roof was lined with sarking boards. This sarking did appear to be in good condition. However, the sarking was missing at the ridge and there is likely to be a suitable gap for roosting bats between the sarking and the roof slates. There were also possible gaps between the gable walls and the rafters. The internal stone work of the barn appeared in good repair with no gaps identified.

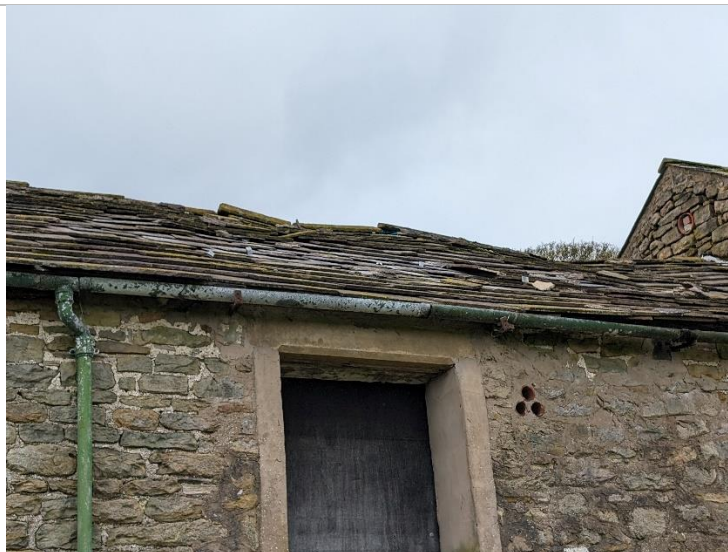
Photo 3.4

Gaps within the roof

The extended section of the barn comprised a part stone and part brick-built construction. The brick was rendered and this rendering was loose and falling away in places. As is typical of such roof types (i.e., traditional stone tiles), there were several gaps in the roof due to misshapen, missing and slipped tiles. This results in potential roost locations within the roof and access into the internal space of the barn.

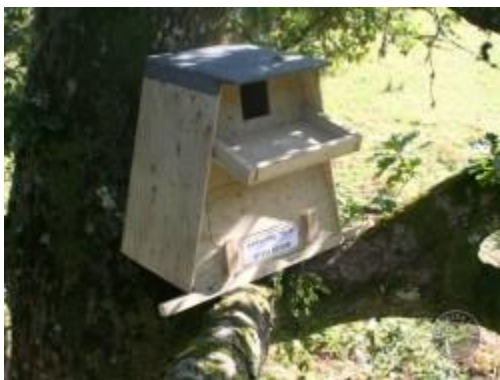
Figure 5.1. Example of barn owl (tree) box design

It is recommended to install a barn owl nest box on one of the mature trees located to the immediate north of the barn. Barn owl boxes can be bought ready-made (<https://www.nhbs.com>) or can be built using specific guidance. Figure 5.1 shows a box installed on a tree. Box specifications and an installation guide can be found via <https://www.barnowltrust.org.uk/barn-owl-nestbox/owl-boxes-for-trees/>.

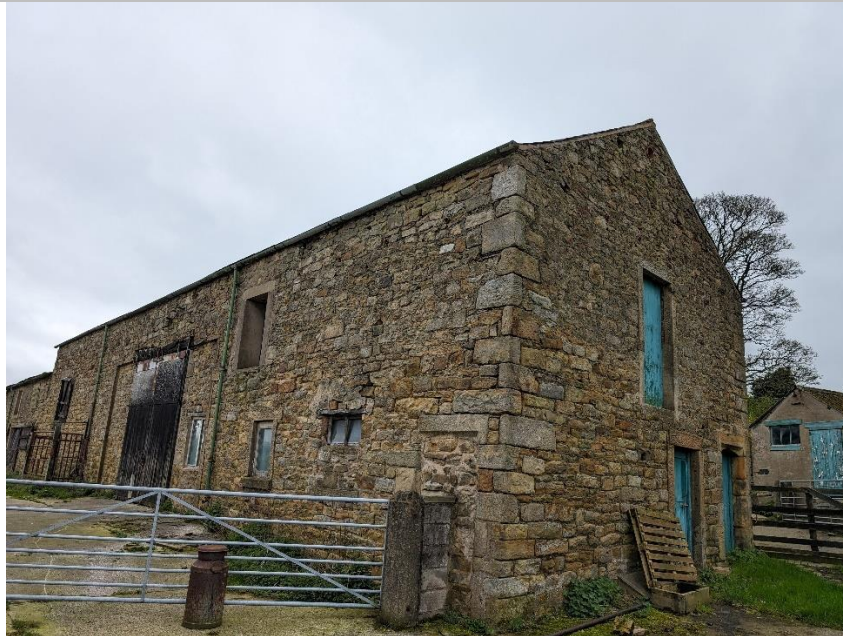
Photo 1.
South-east and
north-east
elevations.

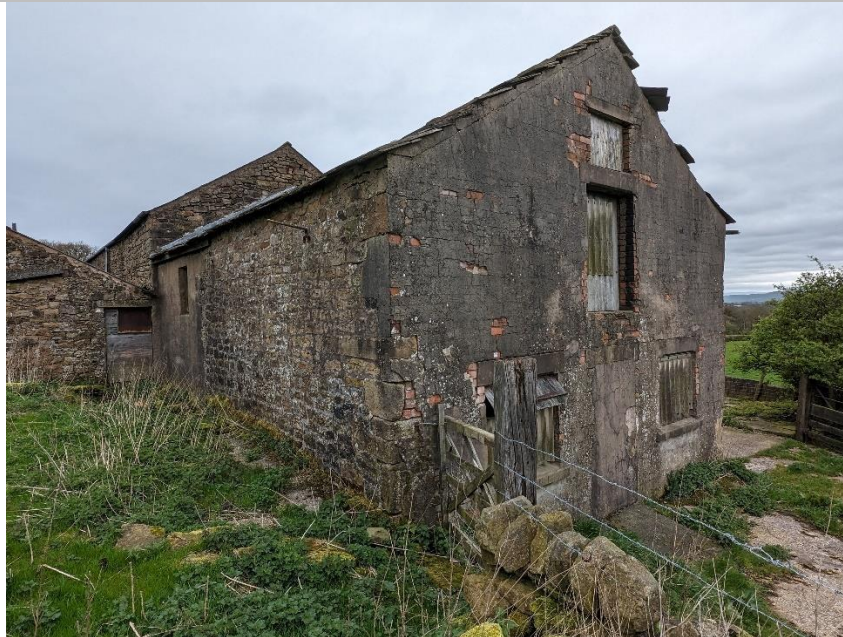
Photo 2.
Extended
section. West /
south-west
elevations.

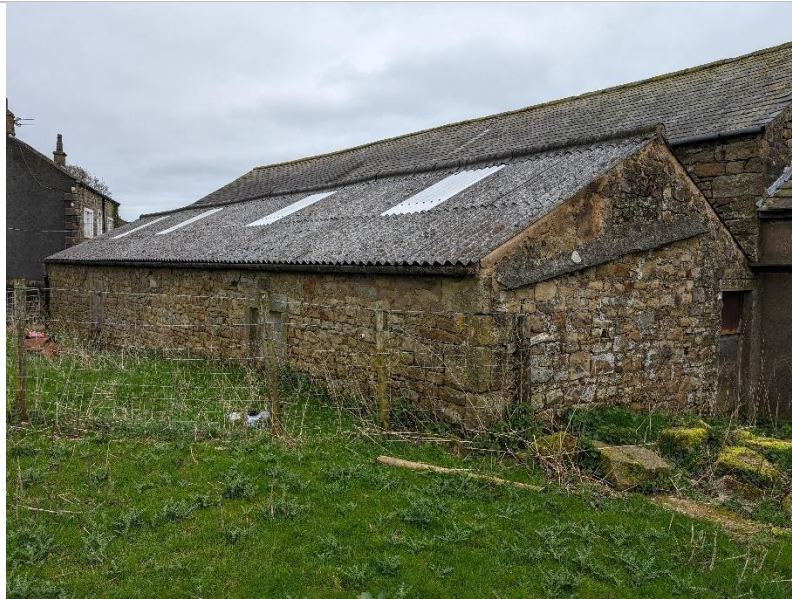
Photo 3
Attached
building with
livestock pens.

The livestock pen featured rendered internal walls and no potential roost features for bats were observed in this section. The internal walls of the extended section were a mix of stone, brick and concrete block. The roof did not have an underlining and the timbers and roof appeared in very poor repair with numerous gaps for rain ingress.

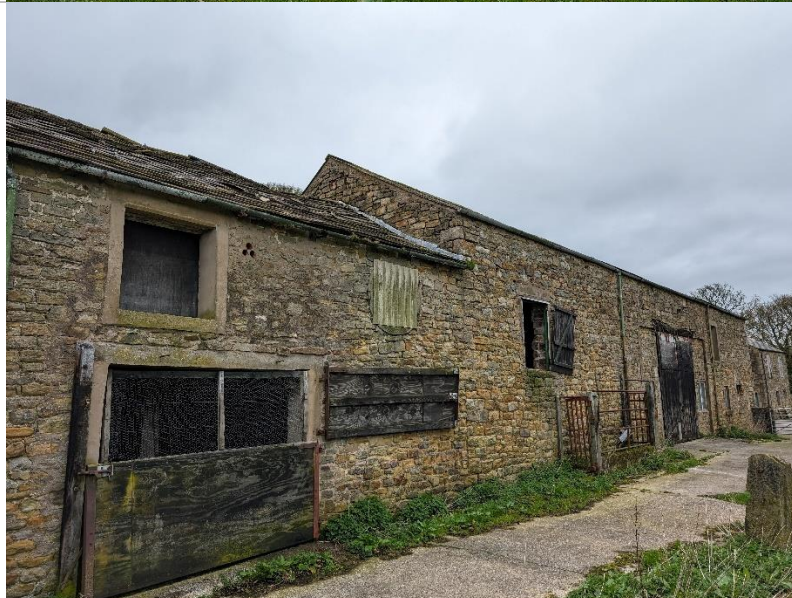
Photo 4.
South-east
elevation.

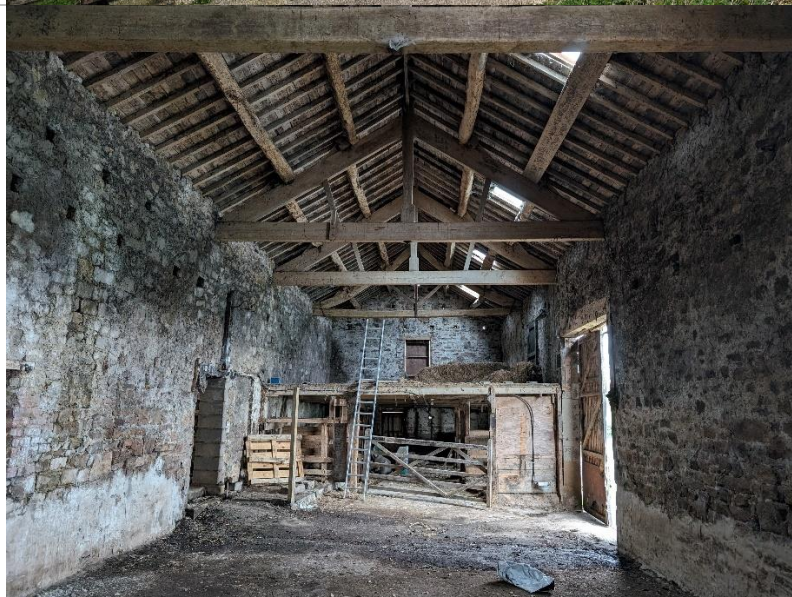
Photo 5.
View of inside
of barn.

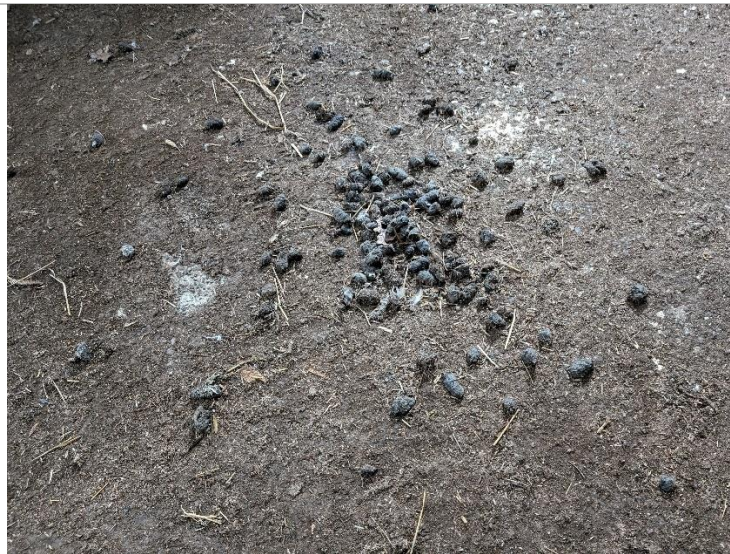
Barn owl pellets were observed in the large barn with numerous pellets on the floor and several pellets in hayloft and in the livestock pen. These pellets were likely to be associated with an occasional to frequently used roosting site. No suitably sized ledges for use as potential breeding sites were observed.

Photo 6.
Barn owl
pellets on barn
floor.

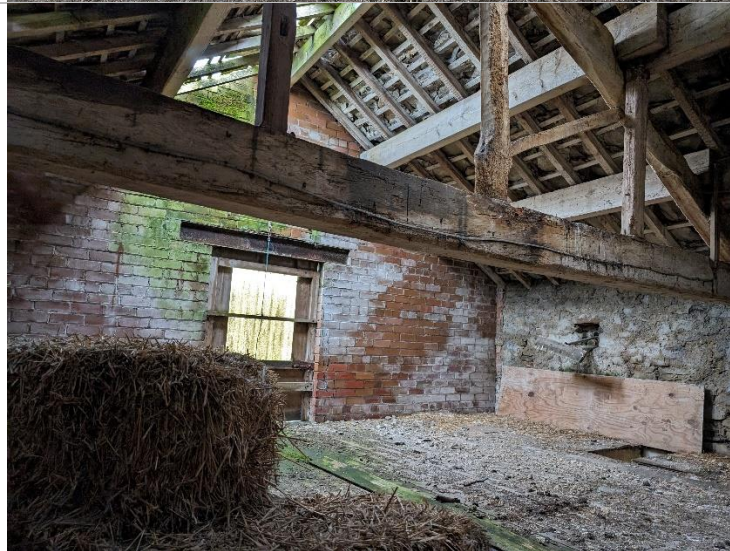
The upper floor (hayloft) of the extended section of the barn was rotted and structurally unsound. It was accessed from the side with ladders only. The upper walls of the large barn were also outside of standard ladder height and were not closely viewed. Binoculars were used to gain a better view of any potential roost features.

Photo 7.
Upper floor of
barn extension.

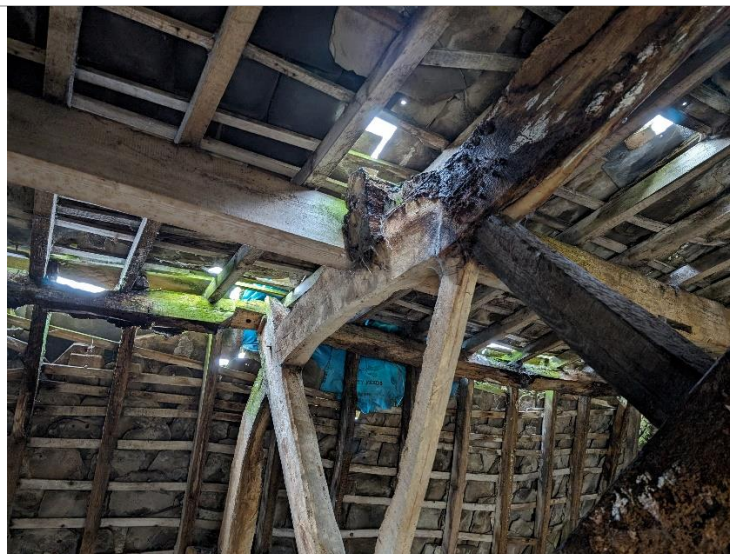
Photo 8.
Roof of
extension.

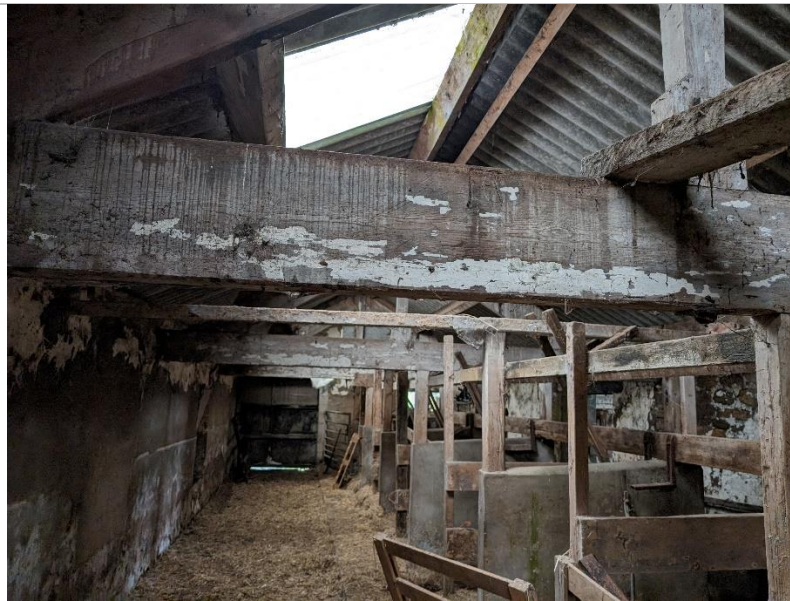
Photo 9
Internal view of
livestock pens.

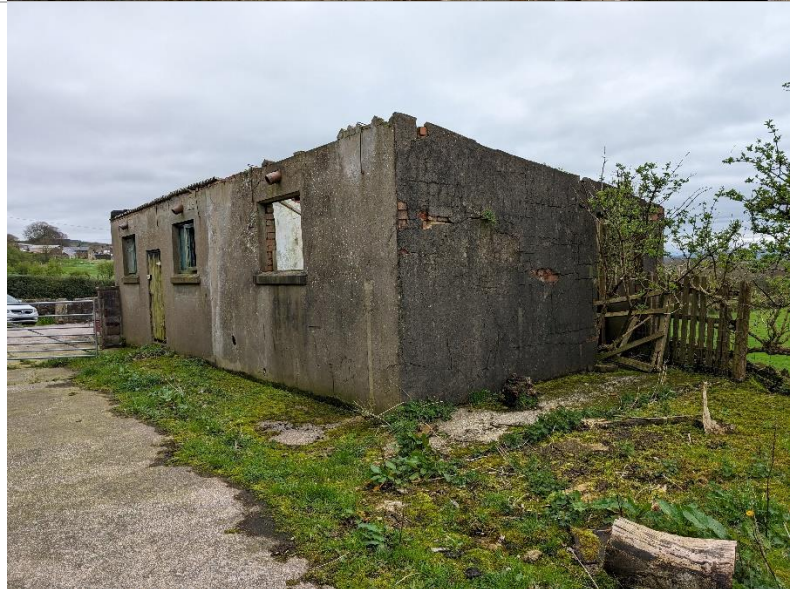
There was a small, rendered brick outbuilding facing the south-east elevation of the large barn. This outbuilding featured a single pitched, corrugated roof. Half of the roof had collapsed. The internal walls were also rendered. No potential roost features were identified.

Photo 10
Outbuilding.

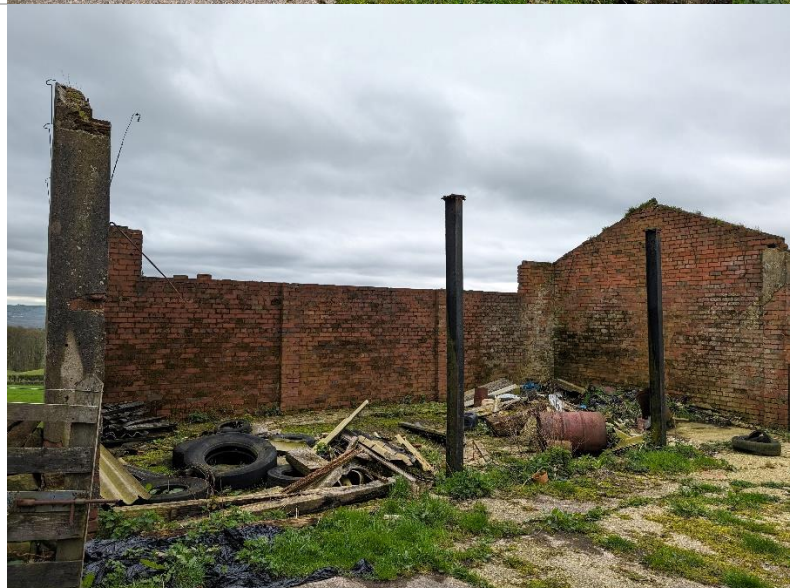
There was also a further outbuilding on the south corner of the large barn. However, this structure did not have a roof and only three brick walls remained. As a result, this structure was unsuitable for bats.

Photo 11
Remains of
other
outbuilding.
