Large Barn at Written Stone Farm, Longridge

BAT SURVEY REPORT

July 2024

Report Ref: 093_03

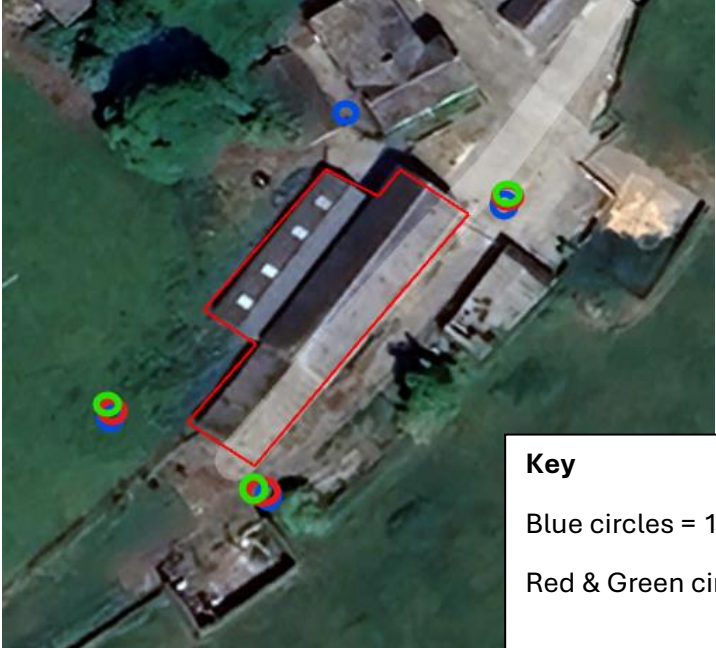
Survey Positions

With respect to the potential roost features identified during the preliminary bat roost assessment, four survey positions were used to gain clear sightlines of all the elevations of the barn during the first survey. Three survey positions were used on the second and third surveys as the fourth survey position on the north corner of the barn was not deemed to be required as this elevation included features of low suitability only.

<div> <p>Key</p> <p>Blue circles = 15th May</p> <p>Red & Green circles = 6th & 26th June</p> </div>

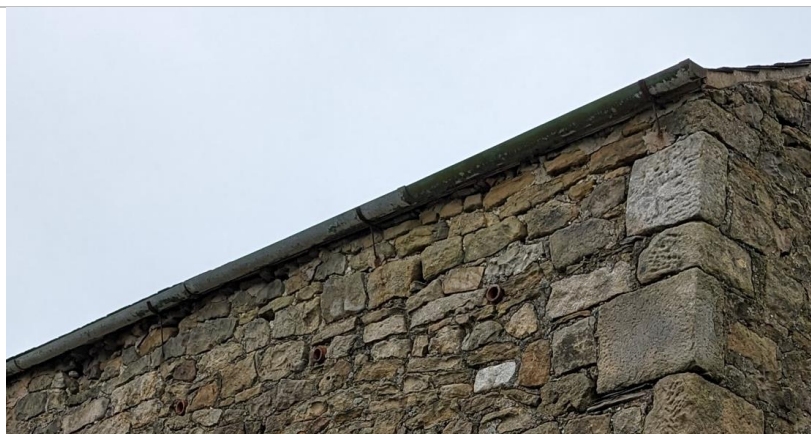
Photo 3.1

Externally, the stonework of the barn appeared in good condition overall. However, there were several small areas of the stonework in which the mortar had decayed which had resulted in gaps and crevices in the stonework in these locations. Gaps were particularly evident under the roof verge across the south-east facing aspect of the barn.

Gaps in the stonework under the eaves.

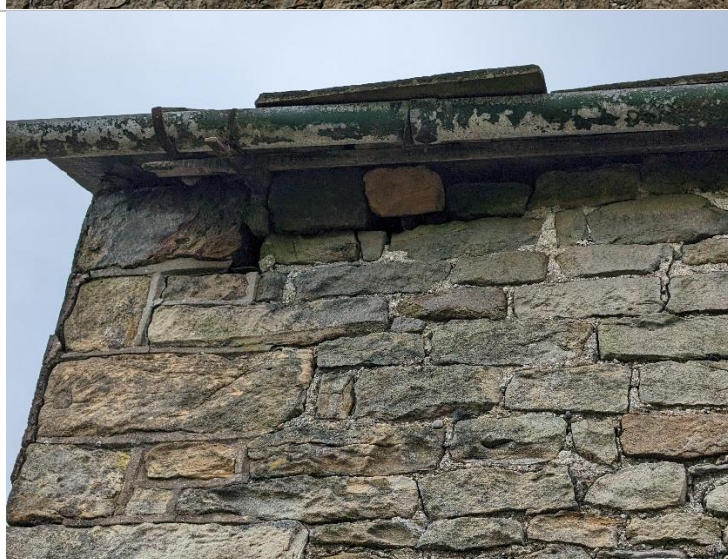
Photo 3.2

The extended section of the barn comprised a part stone and part brick-built construction. The brick was rendered and this rendering was loose and falling away in places. As is typical of such roof types (i.e., traditional stone tiles), there were several gaps in the roof due to misshapen, missing and slipped tiles. This results in potential roost locations within the roof and access into the internal space of the barn.

Large gaps on the south corner of the barn.

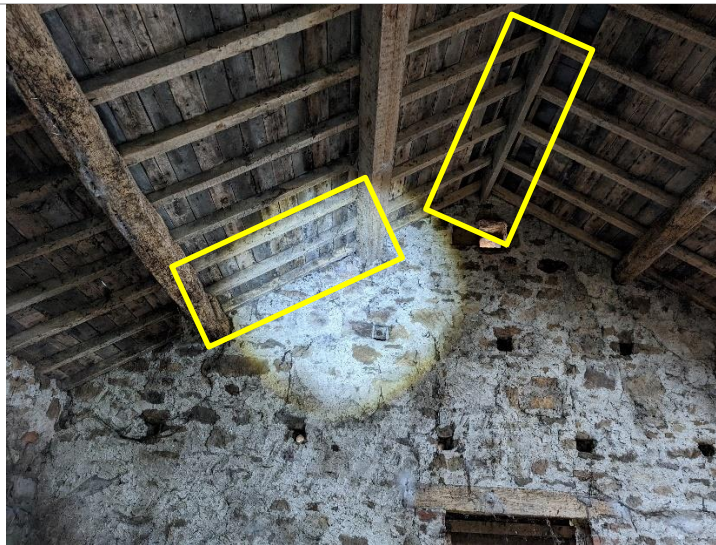
Photo 3.3

Internally, the underside of the large barn roof was lined with sarking boards. This sarking did appear to be in good condition. However, the sarking was missing at the ridge and there is likely to be a suitable gap for roosting bats between the sarking and the roof slates. There were also possible gaps between the gable walls and the rafters. The internal stone work of the barn appeared in good repair with no gaps identified.

Gaps behind the sarking boards and the ridge and gaps under the rafter at the gable.

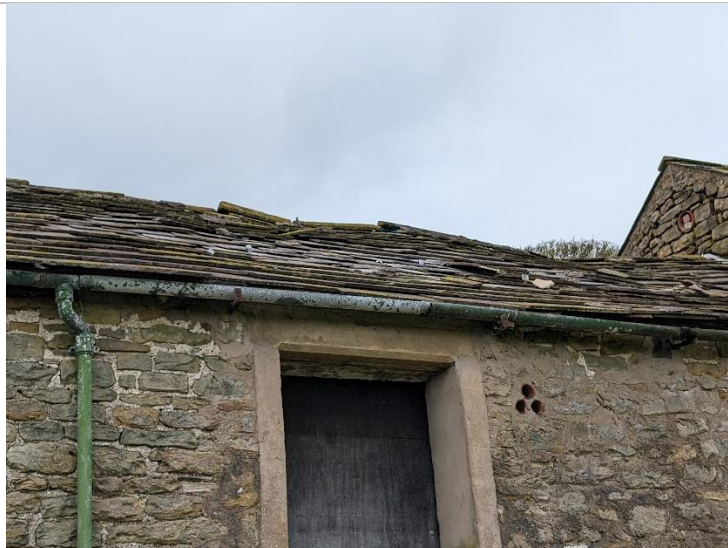
Photo 3.4

Gaps within the roof

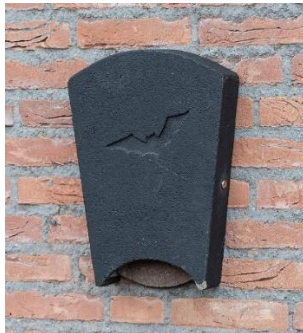
<p>These boxes are manufactured from WoodStone, a breathable and insulating material made from concrete and FSC Certified wood fibres. Woodstone is designed to be robust and hard-wearing, providing a warm and stable temperature for summer bat roosts.</p> <p>Available from: https://www.nhbs.com/</p>
	Beaumaris Woodstone Bat Box

<p>This bat box is also made entirely from WoodStone. The Beaumaris box has a single narrow cavity which makes it suitable for crevice roosting bats such as common pipistrelle.</p> <p>Available from: https://www.nhbs.com/</p>

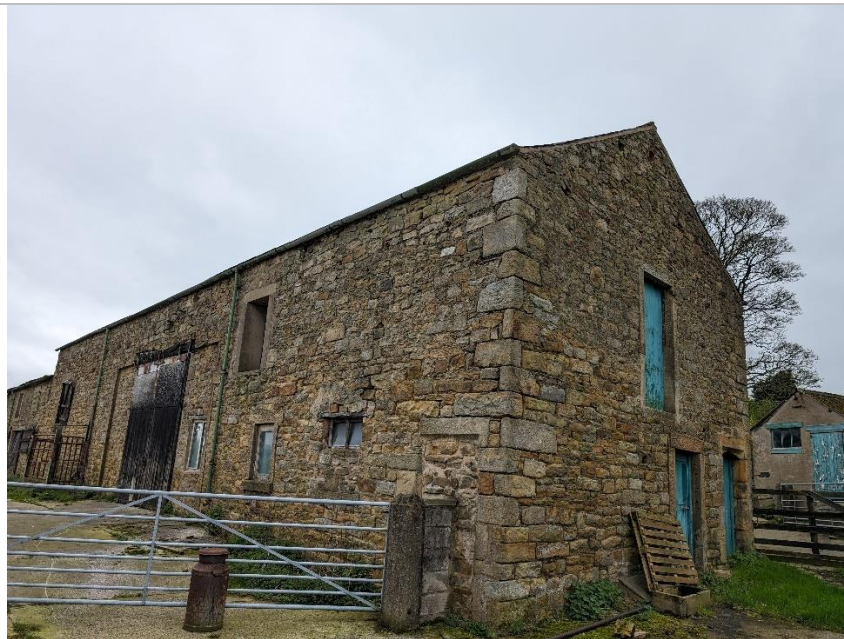
Photo 1.
South-east and
north-east
elevations.

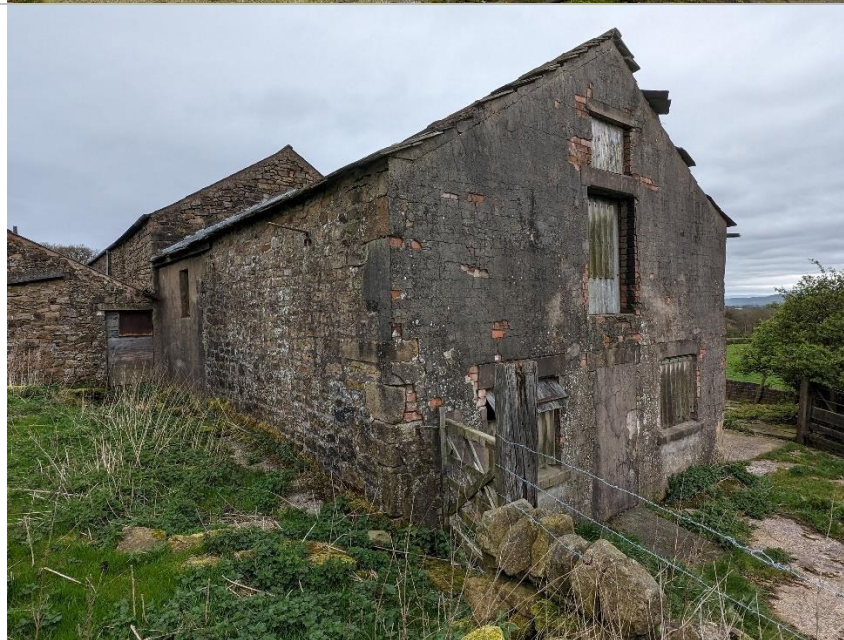
Photo 2.
Extended
section. West /
south-west
elevations.

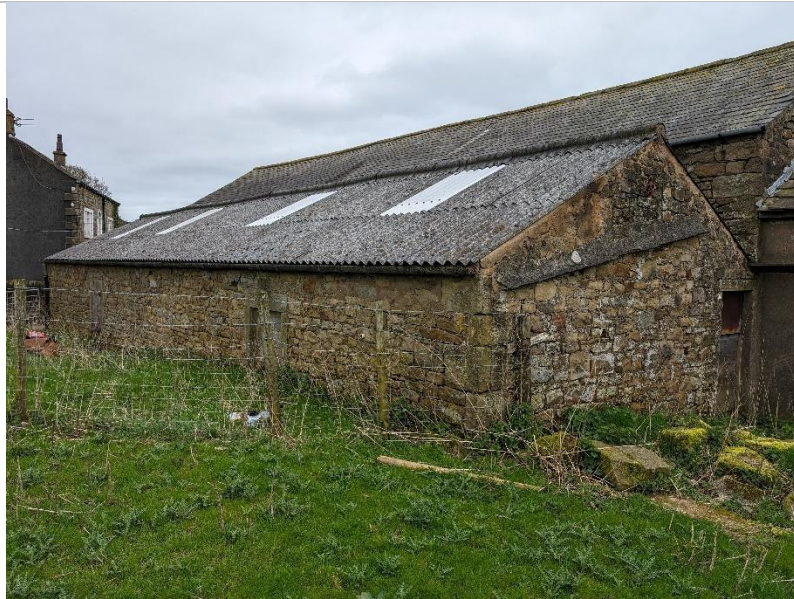
Photo 3
Attached
building with
livestock pens.

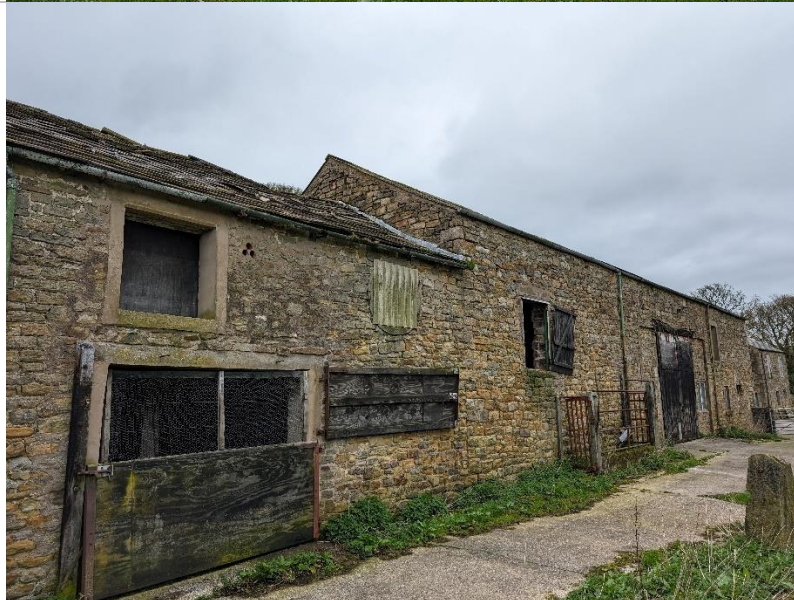
Photo 4.
South-east
elevation.

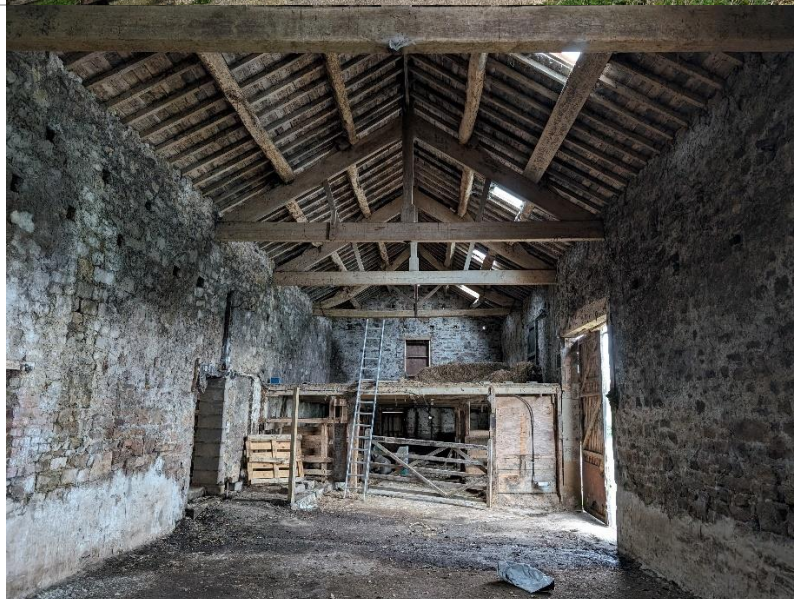
Photo 5.
View of inside
of barn.

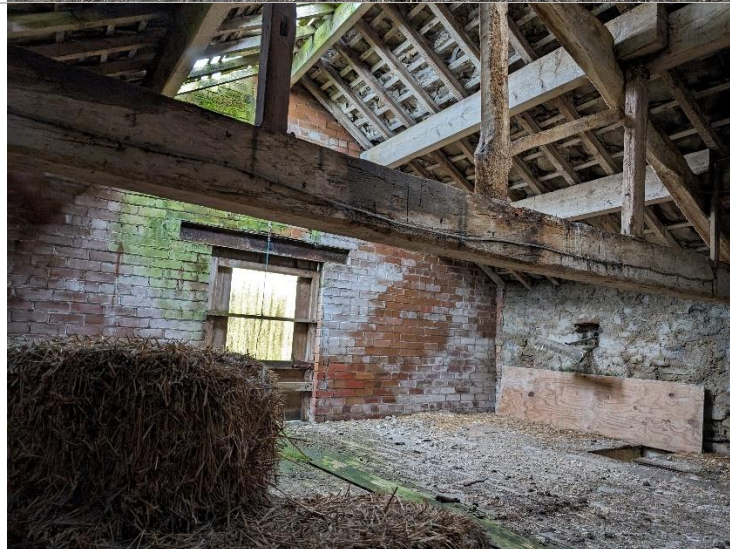
The livestock pen featured rendered internal walls and no potential roost features for bats were observed in this section. The internal walls of the extended section were a mix of stone, brick and concrete block. The roof did not have an underlining and the timbers and roof appeared in very poor repair with numerous gaps for rain ingress.

Photo 7.
Upper floor of
barn extension.
