**BAT SURVEY AT -
High Lea Cottage,
Whins Lane.
Simonstone.**

REFERENCE NO. 7040

In conjunction with the submission of an application for planning approval, this survey was commissioned to identify if bats are currently present in the building, to assess if it has been used in the past or if there is any potential for future use of the building.

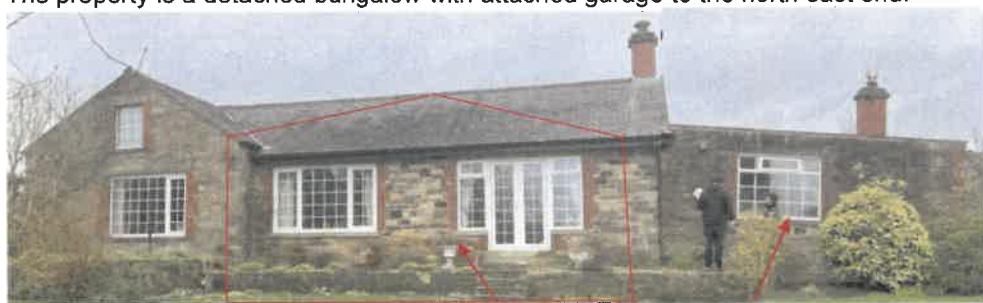
Rear Elevation

Location of the extension

Section to be removed

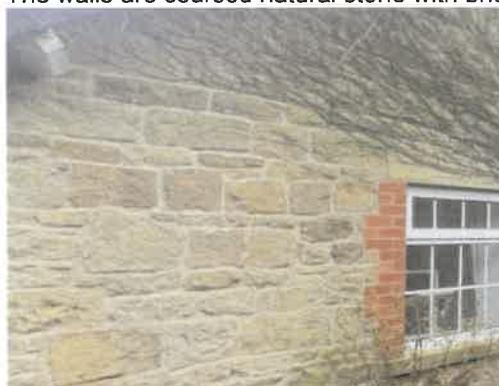
The walls are coursed natural stone with brick quoin effect detail to corners and windows

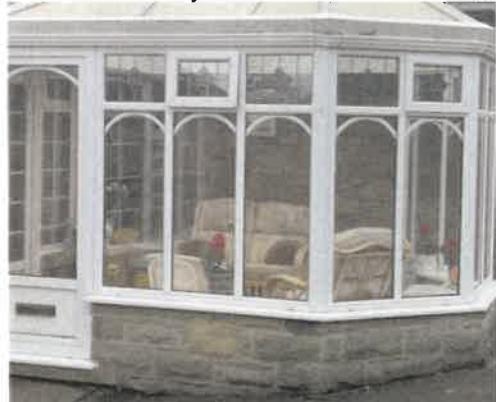
The conservatory base wall is natural stone. Upvc glazed frame above.

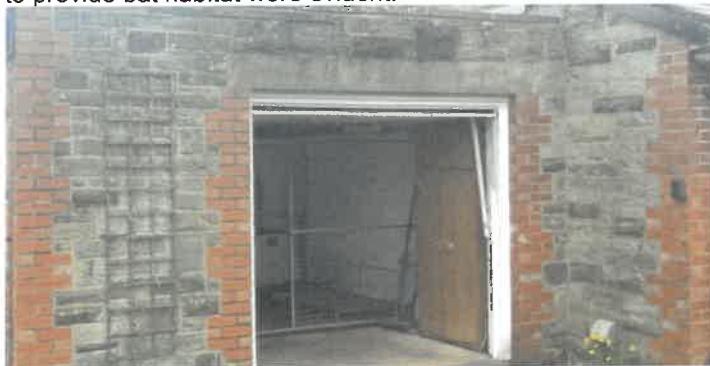
The walls are in good condition all the pointing is present and no cracks or crevices with the potential to provide bat habitat were evident.

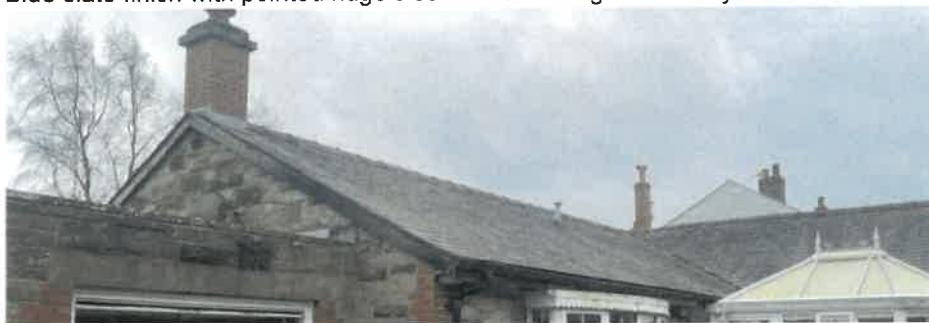
The main roof was pitched with valley gutters at the abutments. Timber barge boards and fascia's. Blue slate finish with pointed ridge tiles. Lead flashing to chimney.

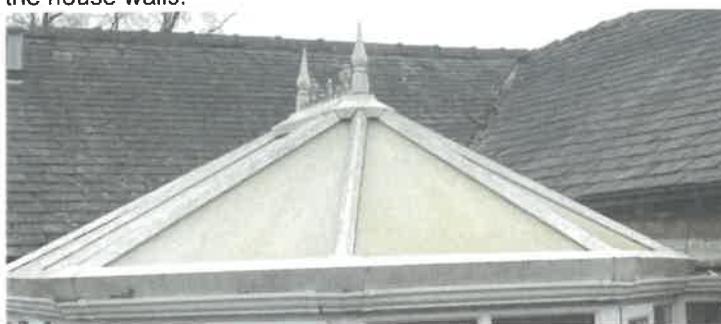
The conservatory roof is clear polycarbonate with white upvc frame, lead flashing at abutment with the house walls.

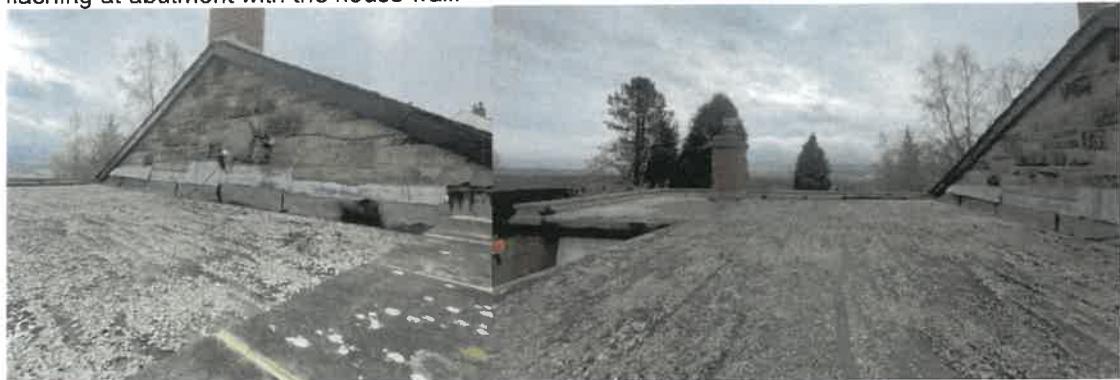
The flat roof over the garage is Asphalt. with a small parapet wall to 3 sides. Felt upstand and lead flashing at abutment with the house wall.

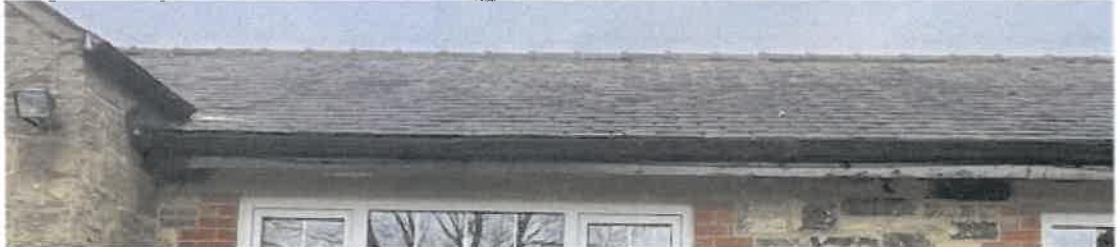
The roof was in reasonable condition. All slates were in place and tight fitting. The ridge tiles were all In situ and the pointing was present. The gutters and fascia's were in reasonable condition and did not provide any suitable crevices for Bat ingress.

The conservatory roof did not provide any roost habitat for bats and the abutment flashing was tight fitting.

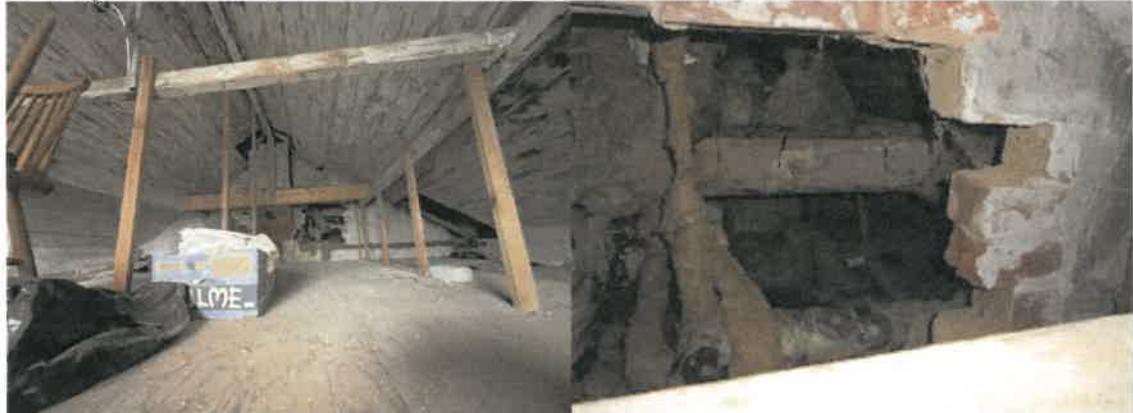
The roof space is divided into 2no sections the west end has a boarded floor, the gabled projection to the front elevation was probably an extension as it is divided by a wall from the main void .it was however possible to inspect from an opening broken out in the wall. The main void had timber boarding fixed to the underside of the rafters.

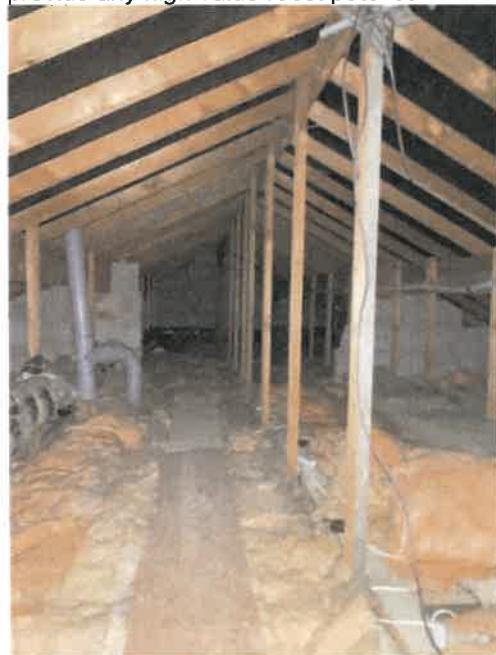
The pitch to the East appears to have been re roofed the rafters and felt were in very good condition the insulation quilt present between the ceiling joists was clean with no evidence of droppings or insect remains. Bats were not present nor were any signs of current or historic use. The space did not provide any high value roost potential.

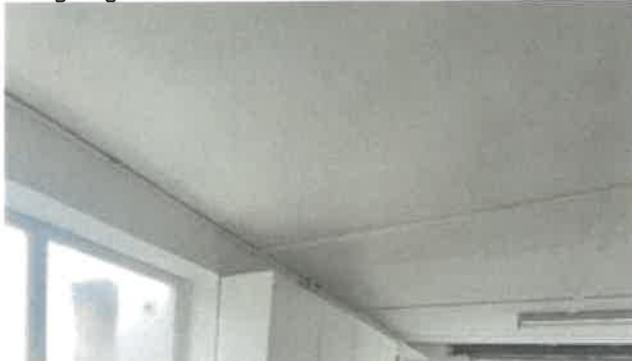
The garage roof is boarded to the underside with no roof void.

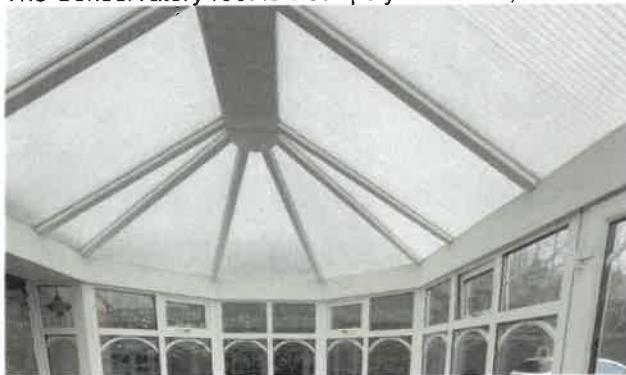
The Conservatory roof is clear polycarbonate, it did not provide any potential bat roost habitat.

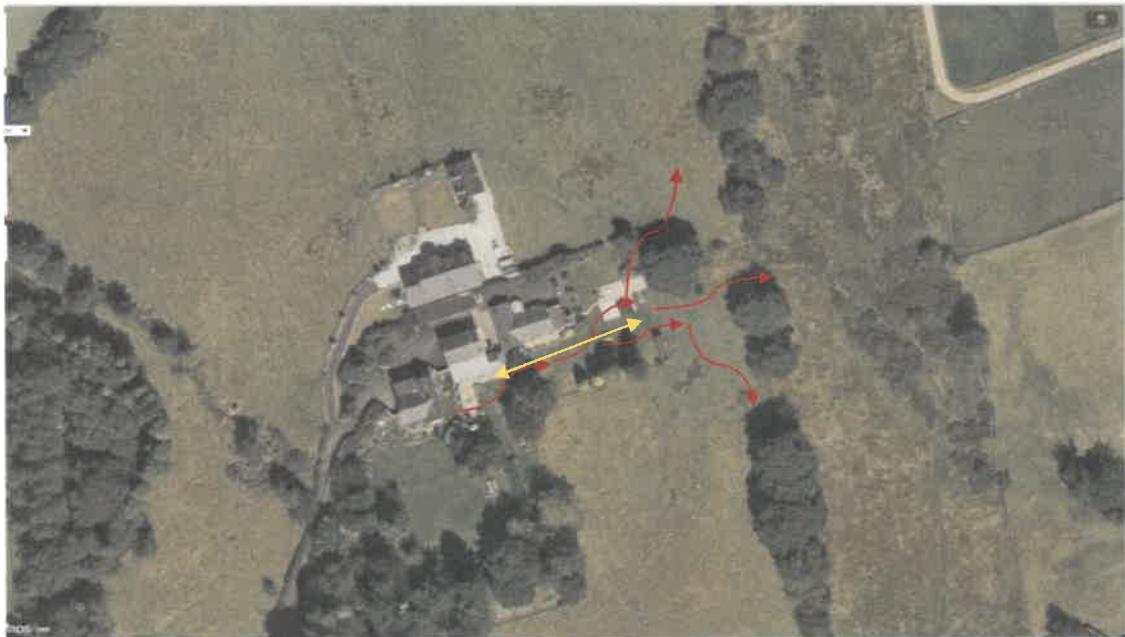
Throughout the survey the point of emergence / roost was not determined being obscured by mature, All activity emerged from the houses/ gardens to the west of Lea View.
The rear garden was a commute route for a small local bat population. To the extensive forage potential in the greater locality to the east of the site.
There was no bat emergence from Lea View.

Indicates commute route

Flight route

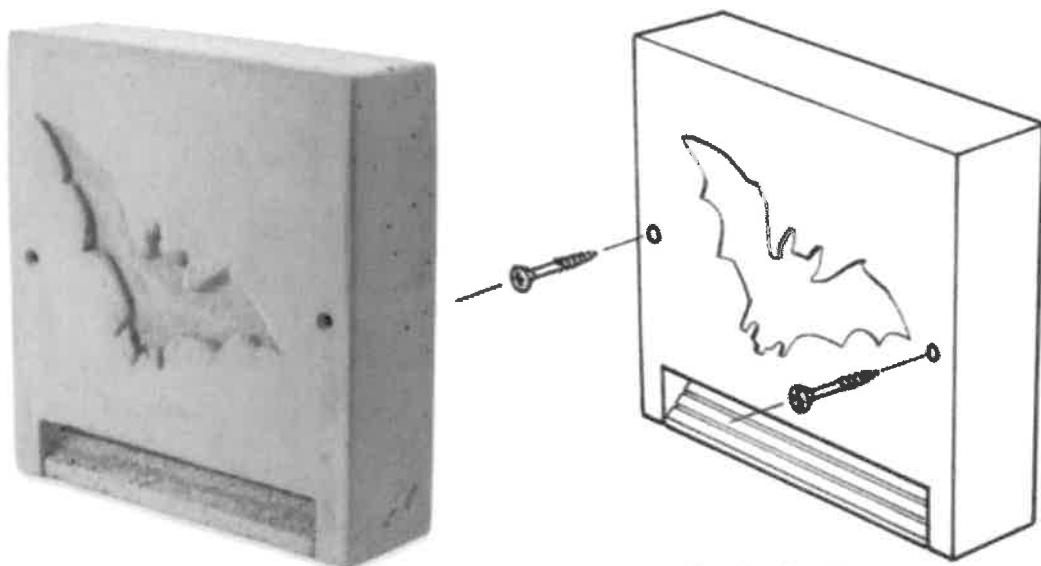
Bat Access Panel 1FE

Built in or surface mounted

Min 1 no Schwegler or similar Bat panel to be incorporated in the south east elevation of the rear extension at high level .
