**BAT SURVEY AT -
MEADOWCROFT
CLOUGH LANE
THORNLEY**

UPDATE 2024

REFERENCE NO. 6895

Removal of the existing glazed Conservatory prior to the construction of replacement Garden Room.

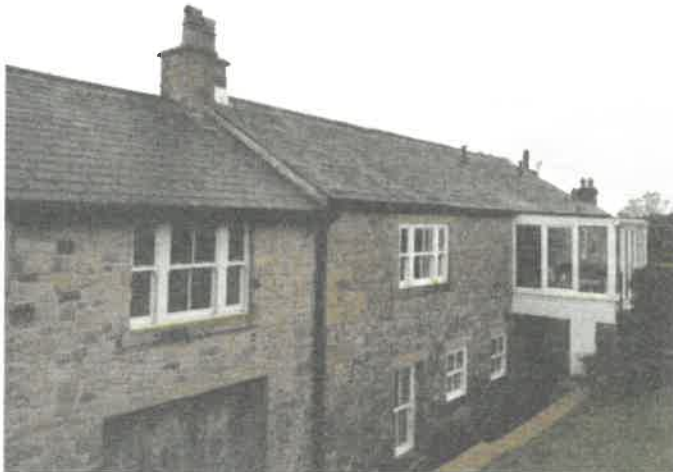
Rear Elevation

The property is a detached converted house and barn with a rear conservatory /garden room extension.

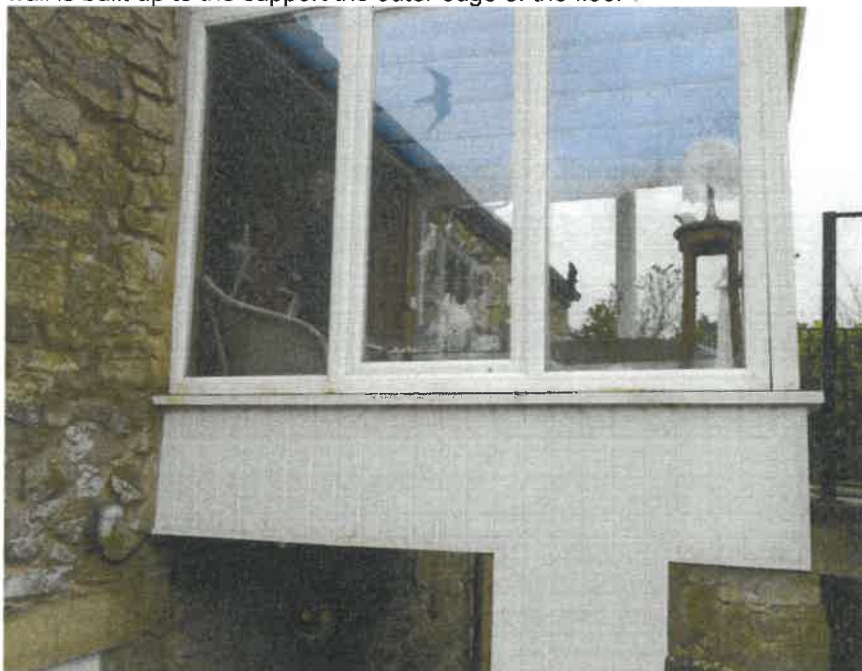
The walls of the conservatory are white Upvc boarded effect with Upvc glazed frames above. The adjacent house wall is random natural stone with recessed pointing. The natural stone garden wall is built up to support the outer edge of the floor.

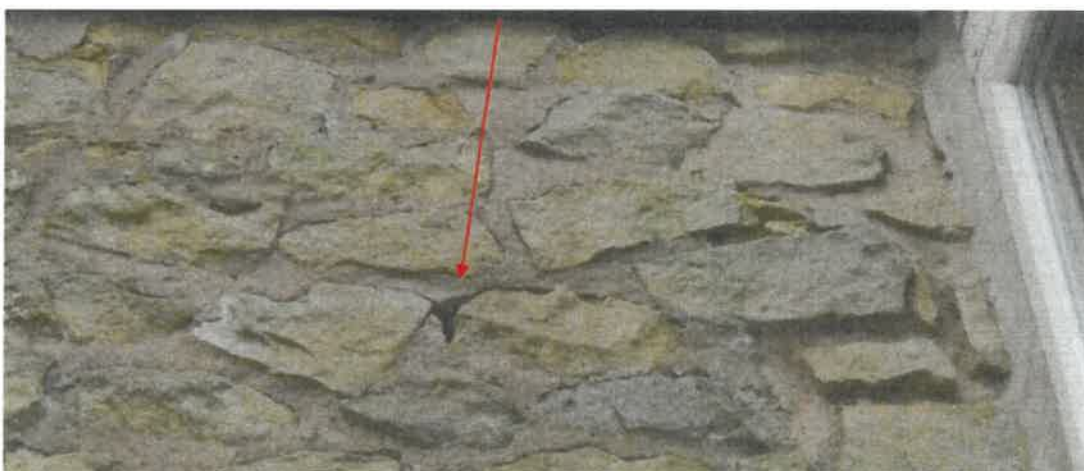
The walls are in very good condition and devoid of cracks or crevices the exception being a small crevice to the left hand side of the conservatory. It was not possible to inspect internally this said external inspection did not reveal any staining or grease marks which may indicate Bat ingress.

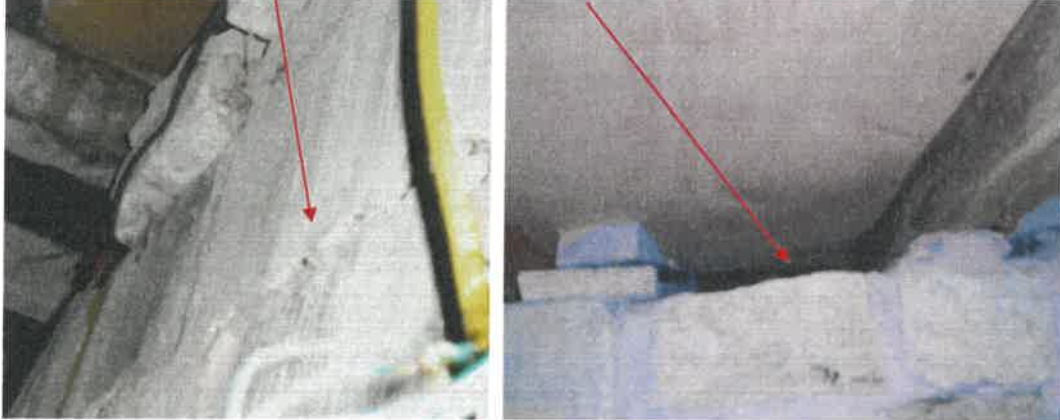
Inner leaf of garden / supporting wall and void behind

The built up garden wall had an inner leaf of blockwork. There were no cracks or crevices noted however a small void was formed between the garden slope the wall and the conservatory floor above. The void was fully visible and no presence of current or historic bat presence was found.

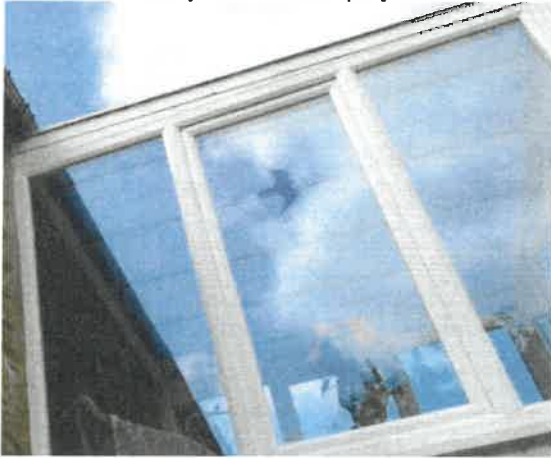
The conservatory roof is clear polycarbonate.

The conservatory roof was in good condition with no access points. The roof was well flashed to the wall with no gaps or crevices suitable for Bat ingress.

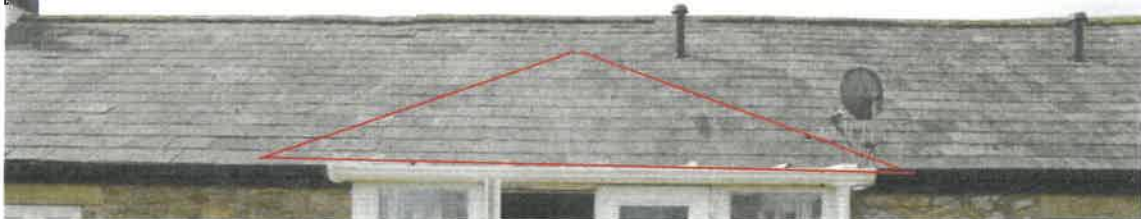
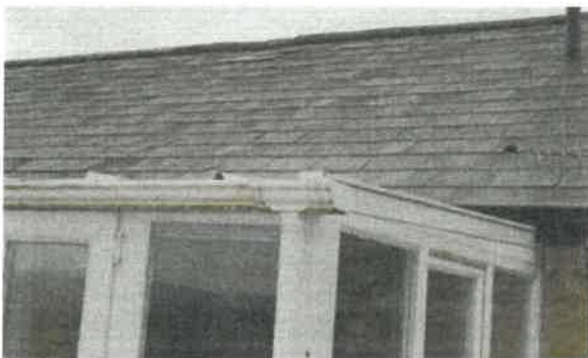
The main rear roof pitch being disturbed by the proposal is Blue slate with pointed ridge tiles. The timber fascia's are flush fixed to the walls.

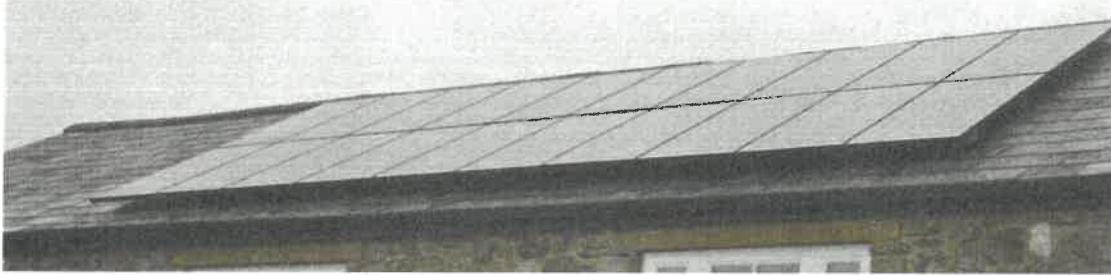
The front blue slate pitch has a large section of solar panels.

The visible slates on the front pitch of the main roof were in good condition and no potential access points were noted.

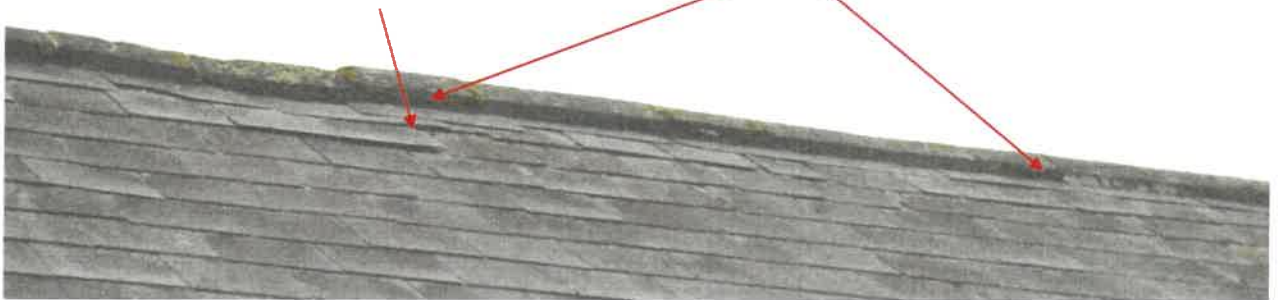
The main roof rear pitch was in reasonable condition with no obvious slipped slates and all appeared tight fitting, the exception being some missing pointing to the ridge tiles
And a couple of lifted slates adjacent to the ridge.

The roof voids and all exterior surfaces did not reveal any signs of bat presence. However the construction of the new garden room will involve the removal of some slates on the rear pitch of the existing roof and as the scoping survey found some lifted slates, missing ridge pointing and gaps behind the fascia adjacent to the new roof position, it was not possible to completely discount the presence of bats. It is therefore recommended that prior to commencement of construction works on site an emergence survey be carried out during the activity period (April - Sept) to confirm that no bats will be disturbed/ uncovered.

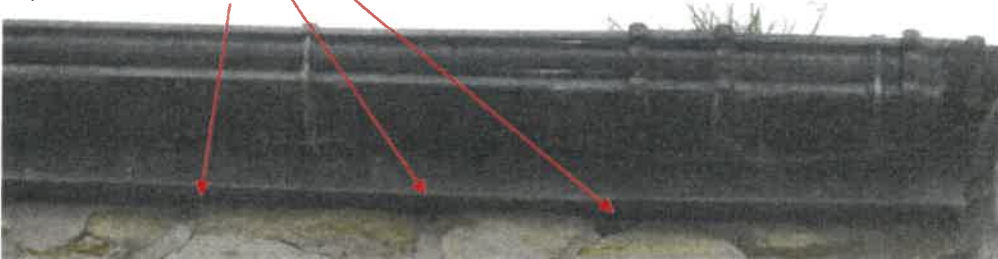
The timber fascia on the section of roof affected had some gaps behind which may have the potential to provide roost habitat.

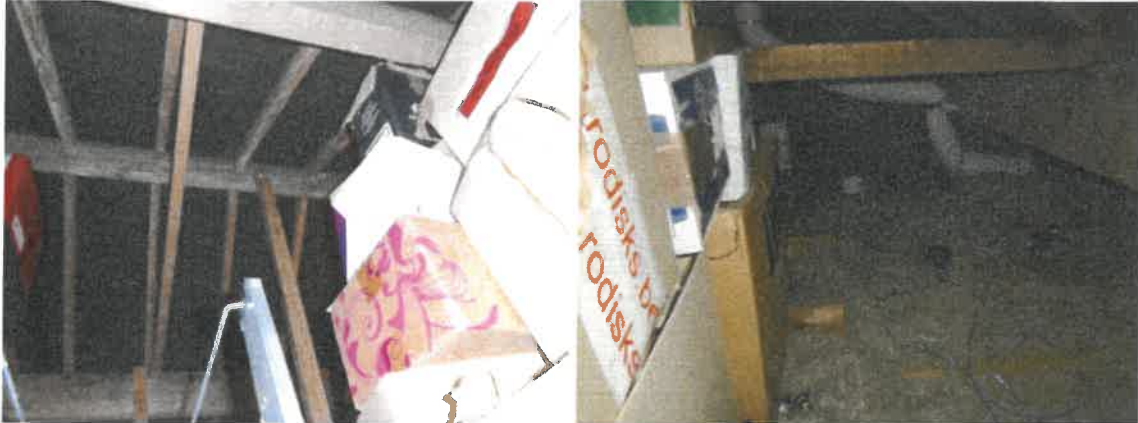
Void 1 - is the section that will not be affected by the proposed work at the south east end of the house, it is currently used for storage. The space was clean with no dropping or insect remain evidence present. The timbers were in reasonable condition with no cracks or crevices suitable for bat ingress. The space provided sub optimal roost potential and no evidence of current or historic bat presence.

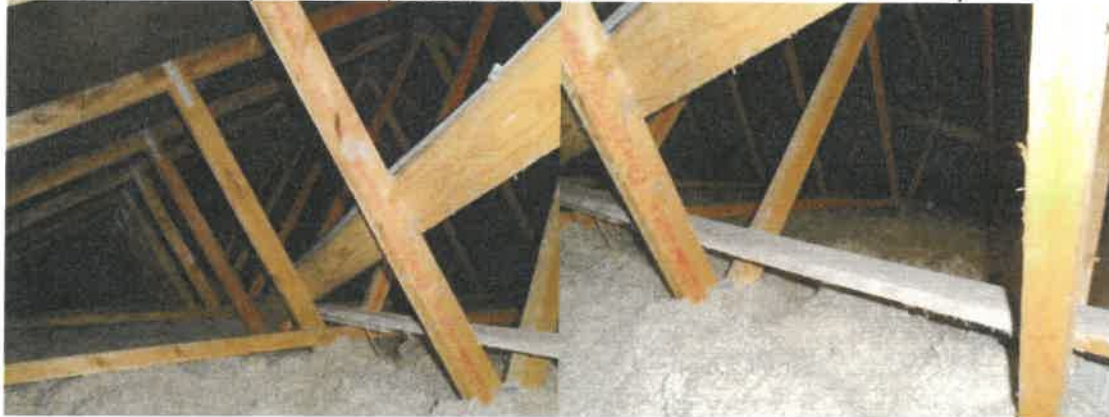
Void 2 – Has a truss rafter roof, all timbers are in good condition as is the felt underlay. Insulation is present at ceiling level. The space was clean with no dropping or insect remain evidence present. The timbers were in reasonable condition with no cracks or crevices suitable for bat ingress. The space provided sub optimal roost potential and no evidence of current or historic bat presence.

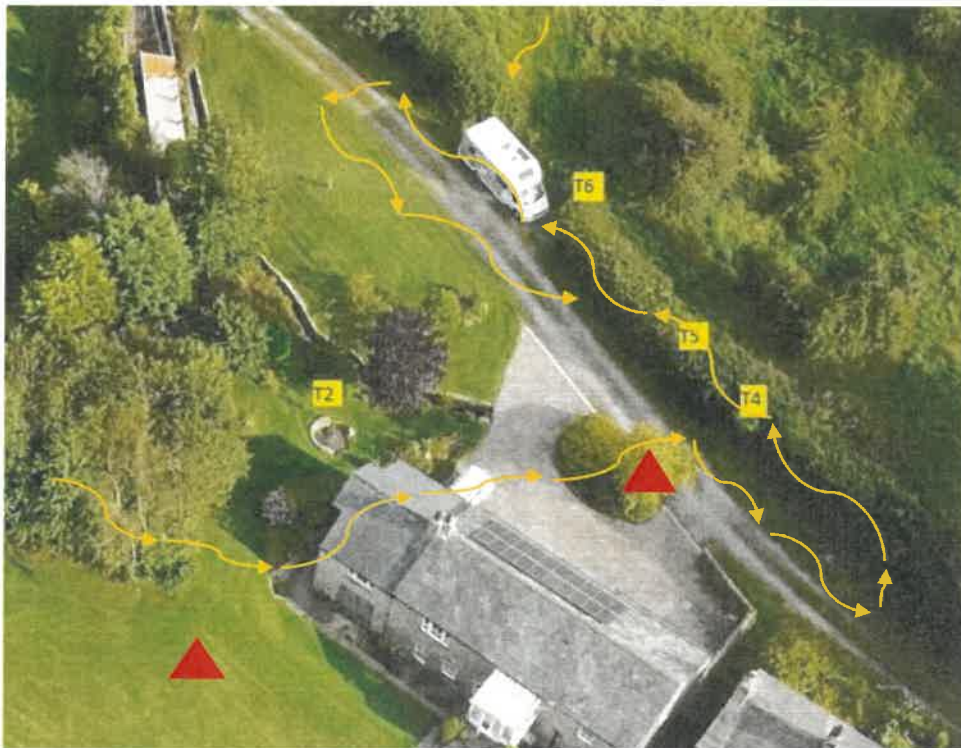
Surveyor locations indicated by red triangle.

Bat activity routes. Indicated by yellow arrows.

9.40 pm Emergence of 1 no bat from the small plantation adjacent to the north west end of the house, headed over the house no further emergence, forage activity or fly past on the south west side of the house was recorded.

9.40 pm Emergence of bats from the north to commence forage activity along the hedgerow lining the track to the front north east elevation. This activity continued throughout the survey.

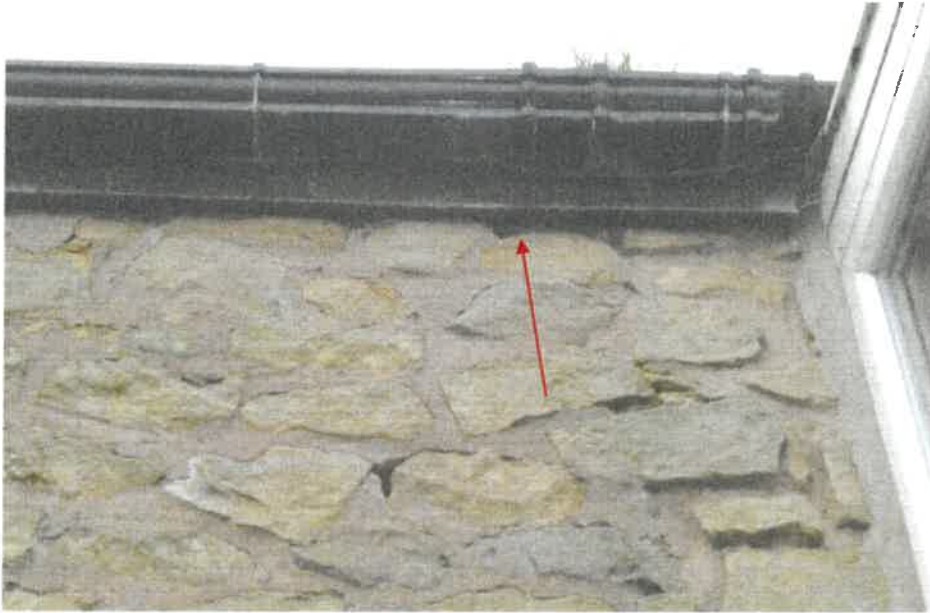
A Blue tit is currently nesting in the hole behind the fascia next to the conservatory. South west elevation.

This said **Mitigation is Required** to protect nesting birds;- Work should not commence until the nest has been vacated (from the end of September) Once the nest has been vacated the nest can be removed and the opening blocked to prevent any future ingress prior to commencement of the build. (.July 24 The Blue tit has vacated the nest .)

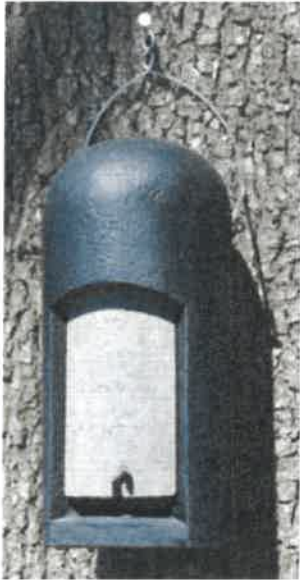
Small Bat Box 3FN

Although Bat mitigation is not required it is recommended that the Bat roost habitat be enhanced within the garden plantation by fixing min 2no' Schwegler' or similar bat boxes to the trees. See below;
