RE: CROW TREES FARM CROW TREES BROW CHATBURN BB7 4AA

Planning condition 18, of consent 3/2022/0966 refers

Surveys for bats were undertaken on 5th May and 23rd June 2022.

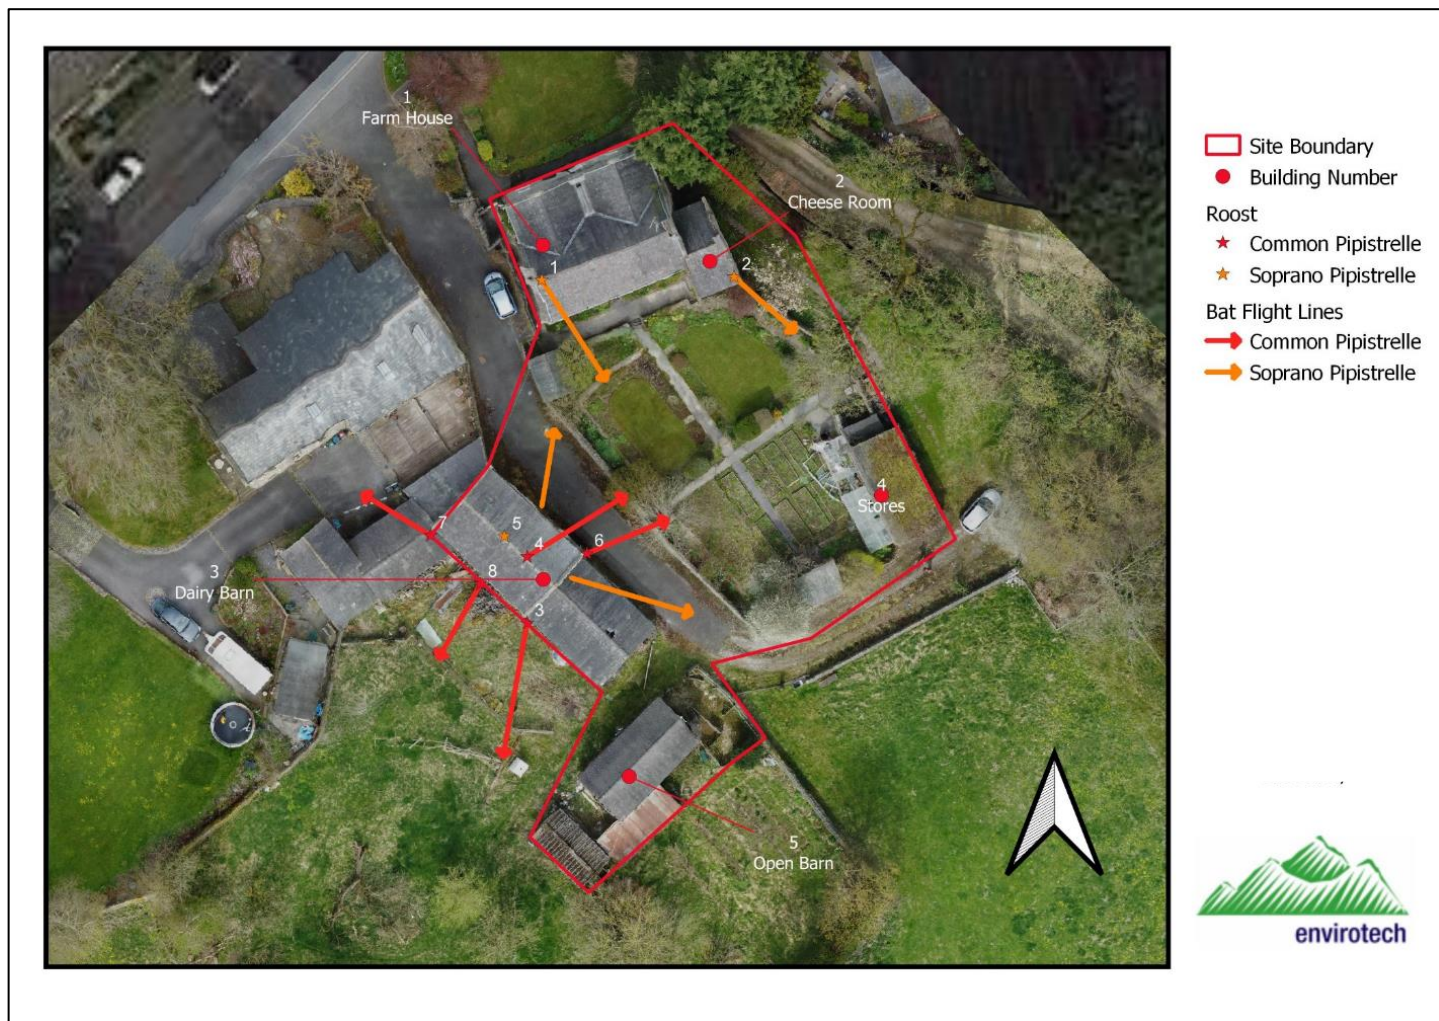
The farmhouse and cheese room, Building 1 and 2 and store Building 4 are subject to LBC. The adjacent barns Buildings 3 and 5 are not.

Survey results found one bat roost in Building 1 and one bat roost in Building 2. Both roost sites are in the roof structure.

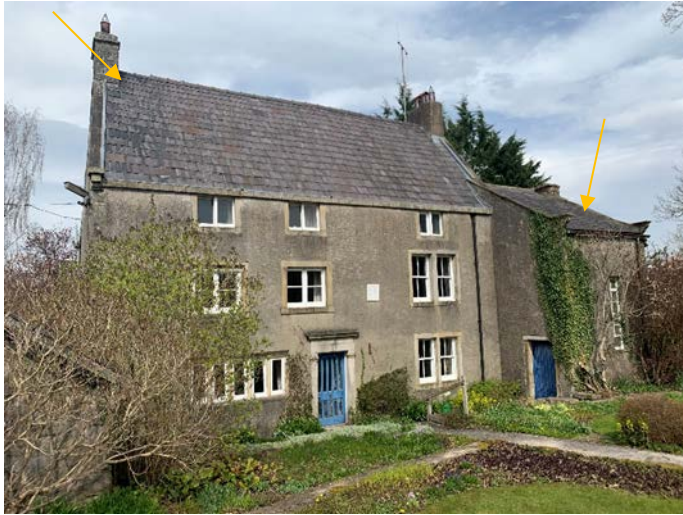
Table 2- Location of roosts as existing

Bat Emergence Survey Photos

First survey six soprano pipistrelles emerged from Roost 1 to the side of the chimney on Building 1 and two soprano pipistrelles emerged from the roof of Building 2 (Roost 2)

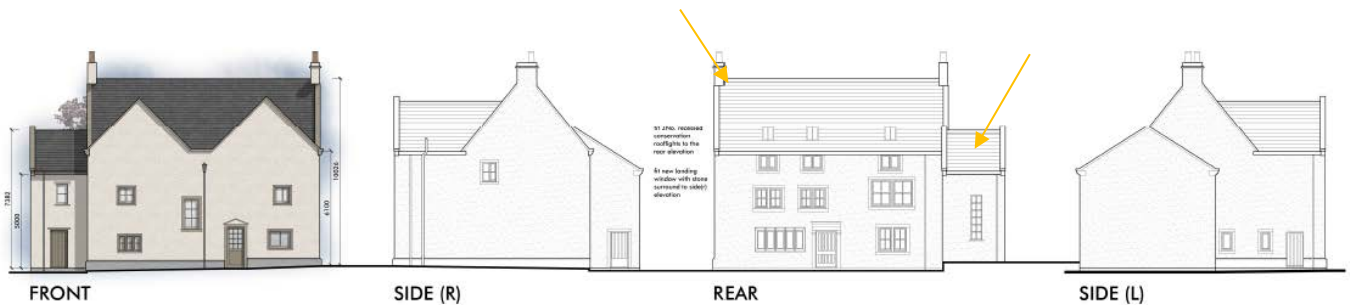
Figure 2- Location of roosts as proposed

The location of these roosts is shown on Table 2 along with the location on the proposed plans, Figure 2.

The location the roosts are in are not subject to alteration. In respect of the Habitat Regulations the work will not “Obstruct, damage or destroy” resting places.

In this case all building work is isolated from the roosts in the roof structure. None of the construction work is likely to result in a level of disturbance which may result in any offence.

- Remove all roof coverings for the new roof lights by hand only.
- Scaffold should not extend up above eaves level so as to maintain open flight lines to the roosts in the upper roof structure.

- A pre-start inspection by an ecologist will be undertaken before work on the roof lights commences to reconfirm the absence of bats.
