Our Ref: BEK-23127-240802-PH (Rev A)

PRINGLE HOMES

Land at Crow Trees Farm, Chatburn - Ground Gas Risk Assessment

BEK Enviro (BEK) has been commissioned by Pringle Homes to carry out a ground gas risk assessment for the proposed commercial development of the land located at Crow Trees Farm, Chatburn.

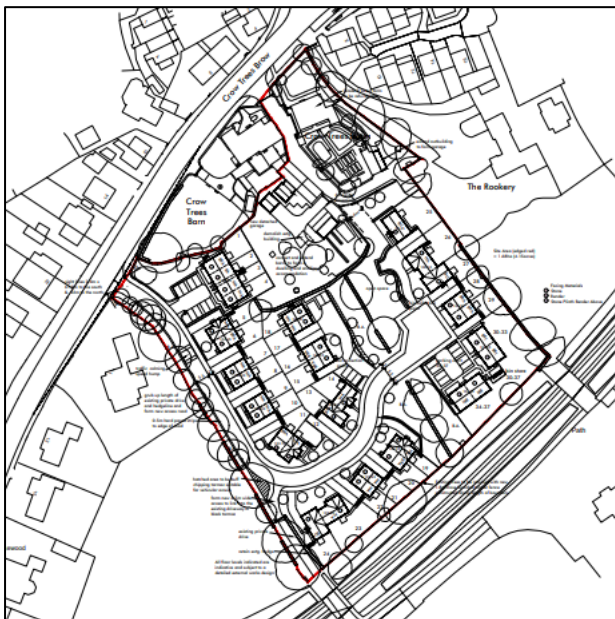
Figure 1: Proposed Development

The report has been prepared to support a planning application for the construction of 37 residential dwelling, alongside the refurbishment of the Grade II listed farmhouse and conversion/extension of the existing dairy building. An extract of the proposed development is shown below:

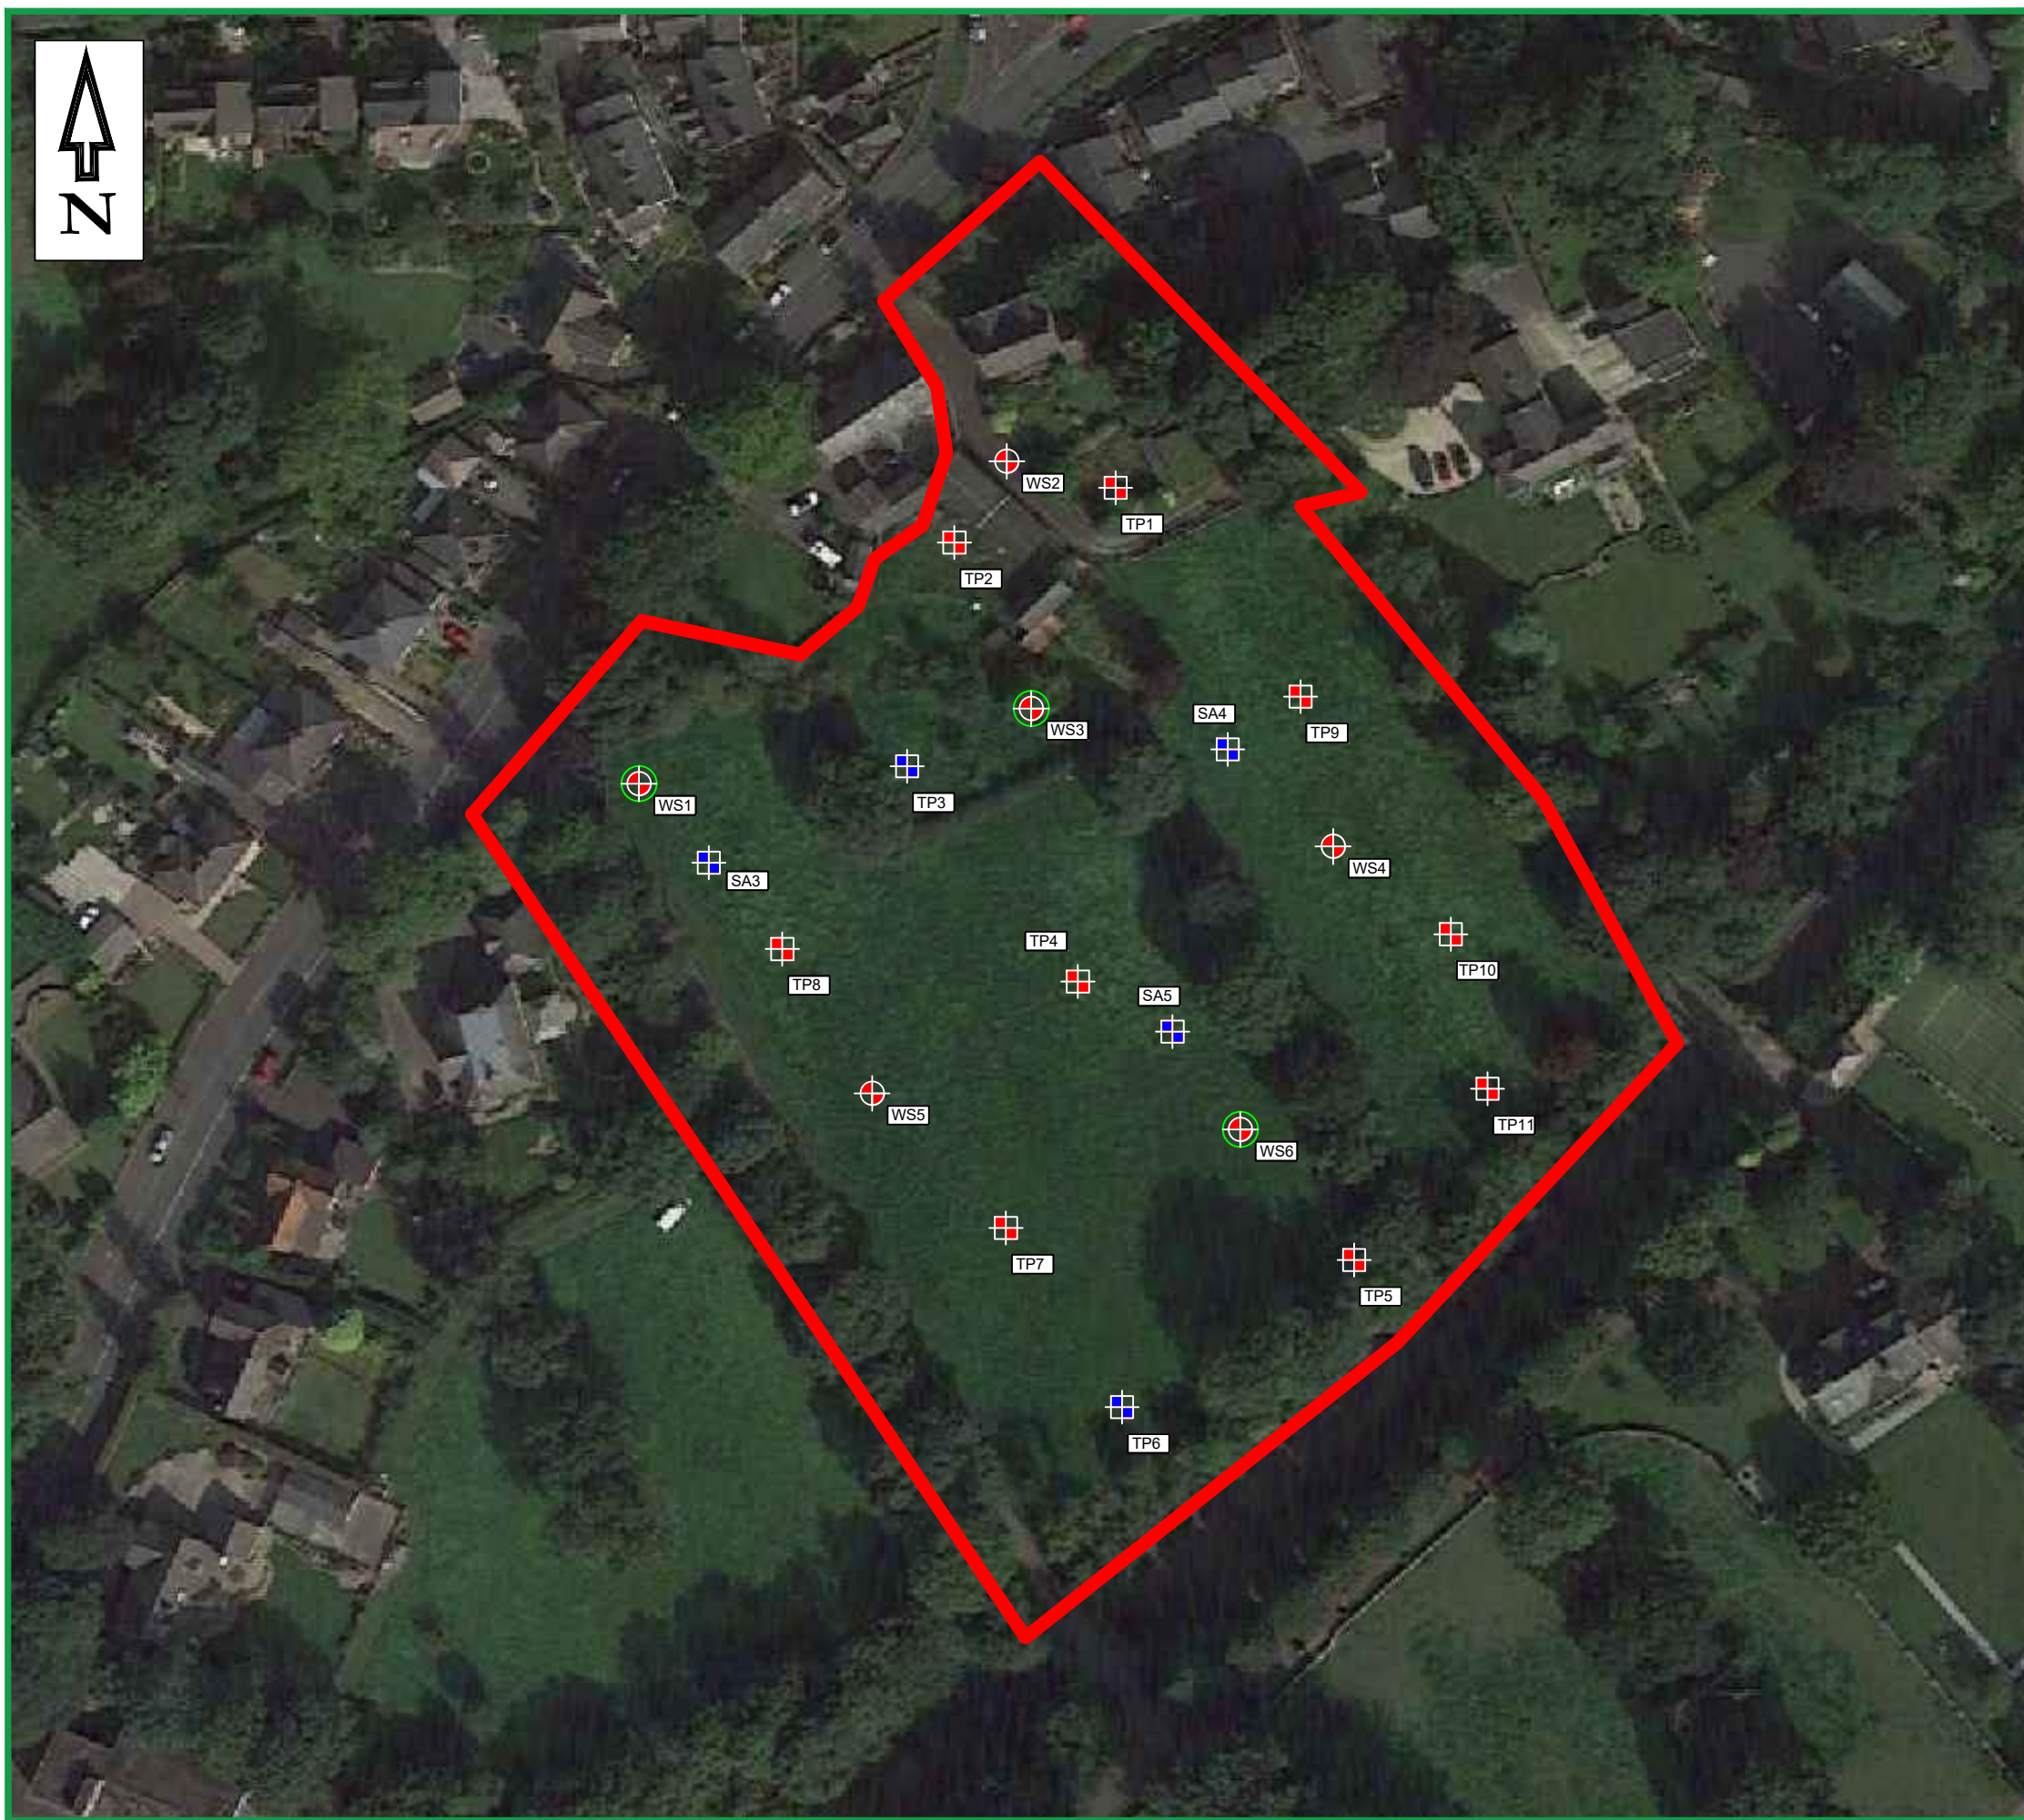
To characterise the shallow ground conditions and facilitate the assessment of potential risks associated with contamination and ground gas as well as provide geotechnical information to support foundation design, BEK carried out site investigation work which included the drilling of six window sample boreholes drilled to a maximum depth of 2.8 m bgl and the excavation of eleven machine excavated trial pits to a maximum depth of 2.1 m. The exploratory locations are presented on BEK Drawing No 23127-3, a copy of which is presented in Annex C.

Following a review of ground conditions, gas monitoring probes were installed in three of the boreholes (Boreholes WS1, WS3 & WS6).
