# LAND AT CROW TREES BROW, CHATBURN

## Site Investigation & Ground Assessment

Report Ref: BEK-23127-1

October 2023

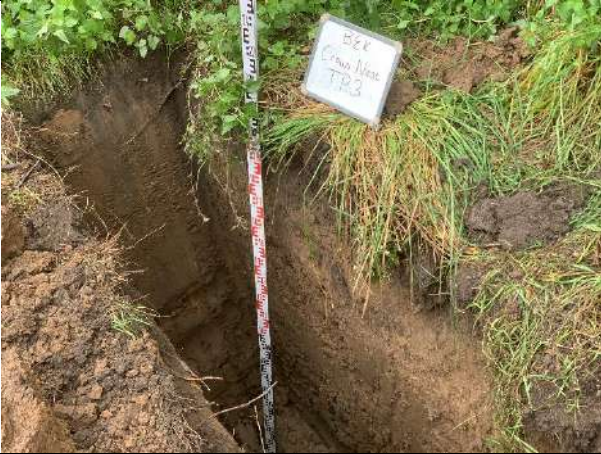
**P3: Trial Pit No 3**

- 3.7.4 The water within the Trial Pit TP3 (SA1) failed to reach 75% effective depth after approximately 5 hours of the test. Therefore the test within Trial Pit TP3 is considered to have failed and discharge of surface water from the proposed development via infiltration methods is not considered to be viable at this location.

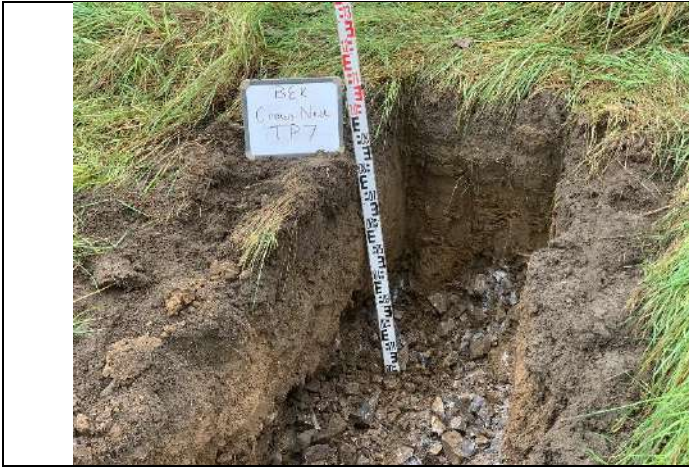
**P7: Trial Pit No 7**

5.7 At formation levels at the majority of locations, stiff clay soils have been encountered. At Trial Pit TP7, formation level is below the top of the bedrock boundary. Generally, the underlying clay soils will provide a bearing capacity in excess of 100 kN/m<sup>2</sup>, however there are a couple of anomalies. At 0.9 m in Trial Pit TP4 there is a thin band of peat, this is unsuitable to found structures on, so formation level at this location must be beneath the peat. In Trial Pit TP8 a low shear reading was encountered at 1.4 m below the surface. This reading suggests that a maximum bearing capacity of 85 kN/m<sup>2</sup> is present. For continuity, the 85 kN/m<sup>2</sup> value should be taken over the site.

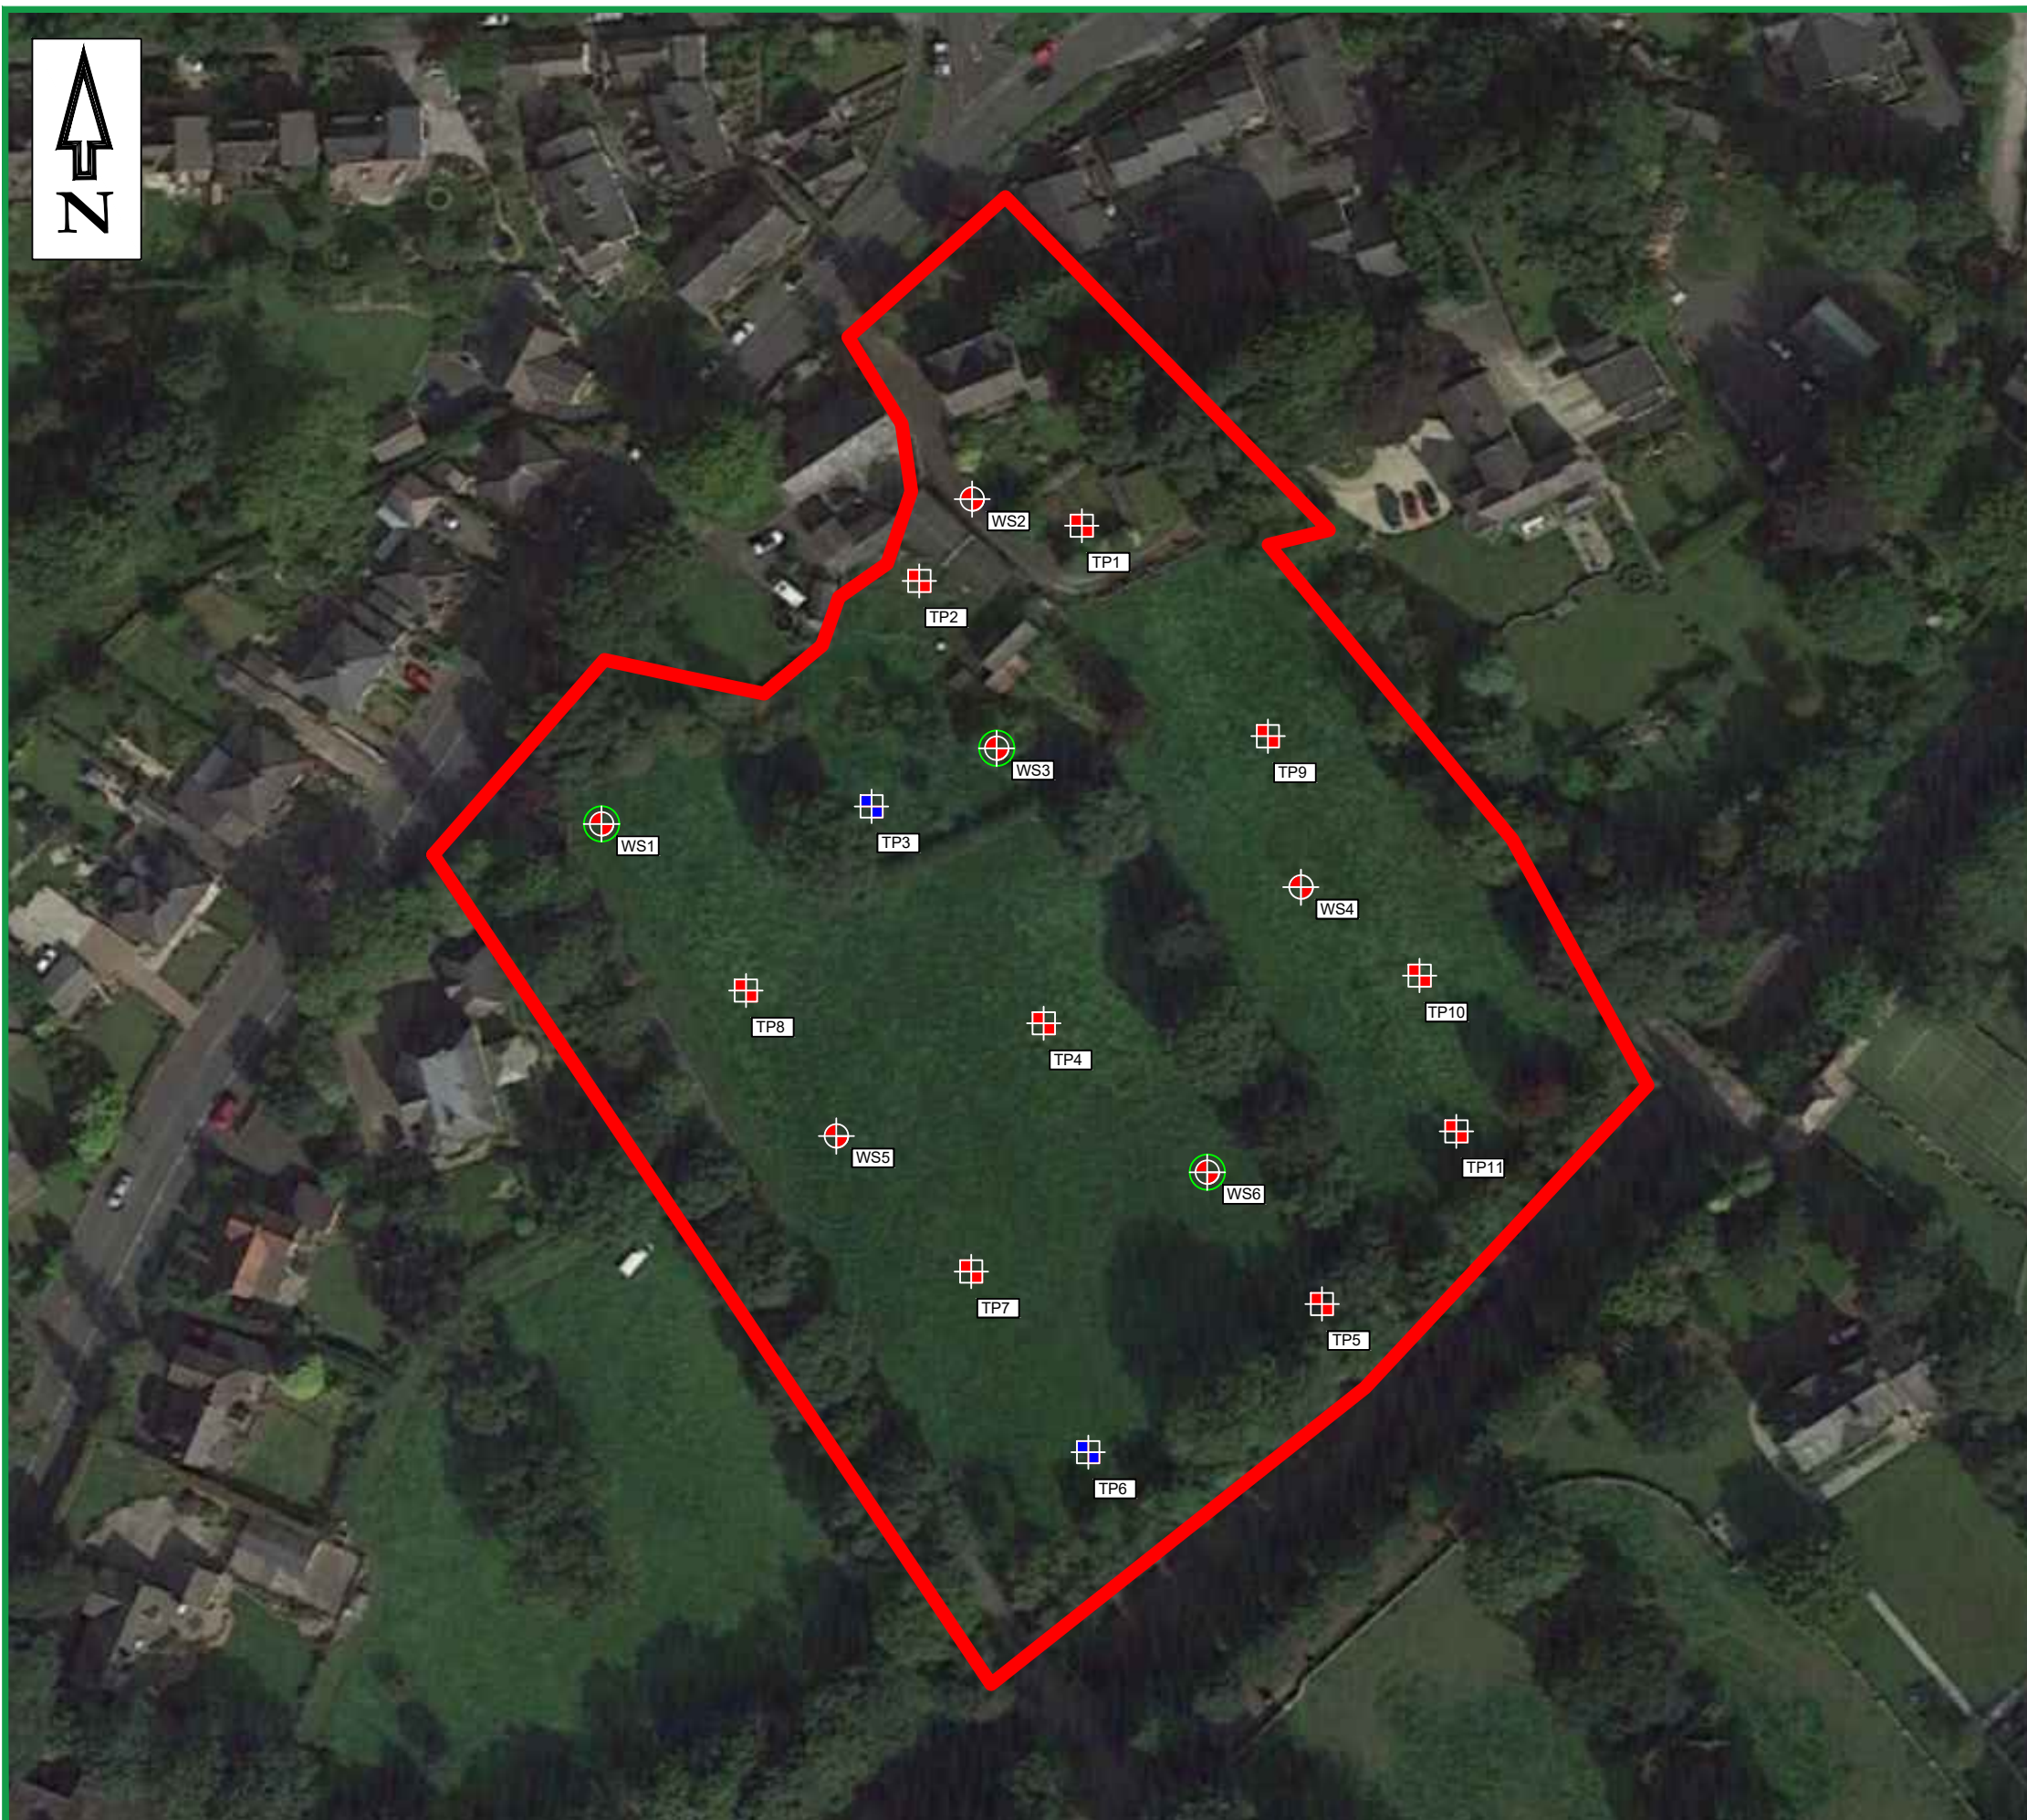
DRAWING No. 23127-3	REV. -
------------------------	-----------

3.1.3 All exploration locations were set out by the site engineer in order to establish representative conditions at the site. The exploratory locations are illustrated on BEK Drawing No 23127-3, presented in Appendix F.
