**ARCHAEOLOGICAL EVALUATION REPORT:
TRIAL TRENCHING ON LAND AT CROW TREES FARM, CROW TREES BROW, CHATBURN,
LANCASHIRE**

Planning References: 3/20022/0966 and 0967
NGR: SD 76780 43955
AAL Site Code: CCTB 23
OASIS Reference Number: allenarc1-522582

Report prepared for Pringle Homes

By
Allen Archaeology Ltd
Report Number AAL2024019

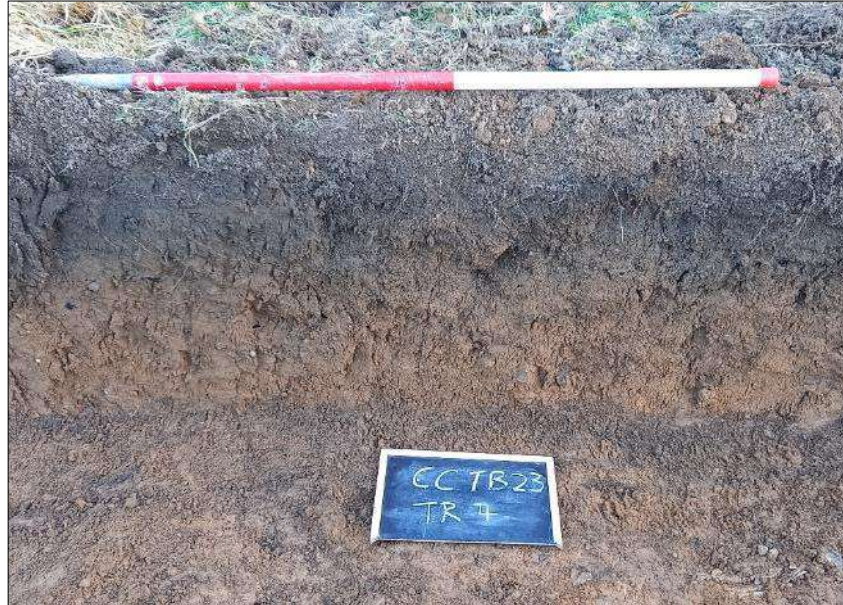
Plate 1: Trench 4, general stratigraphic sequence, looking southeast, scale 1m

- 7.1 The general stratigraphic sequence was consistent throughout the site (Plate 1) and is recorded in Appendix 1. The earliest deposit was a natural geology of mid-yellowish brown silty clay with frequent limestone fragments. This was sealed by a mid-brown silty clay with occasional small stones, possibly a former ploughsoil, between 0.06m and 0.17m thick. Above this was a dark greyish-brown silty sandy clay topsoil, which varied between 0.20 and 0.26m in thickness.

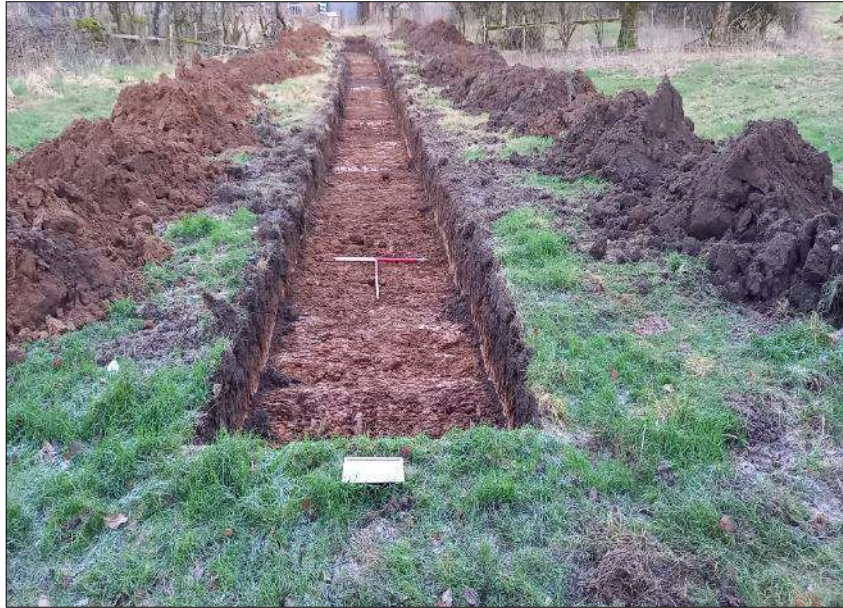
Plate 2: Trench 1 looking northeast, scales 1m

- 7.2 A single linear feature was exposed in Trench 1. This ditch, [106] was 2.11m wide and 0.38m deep and had concave side and base (Plates 2 - 4). It contained two deposits, an initial silting of mid-greyish brown silty clay with occasional small stones, 105, and a mid-grey silty clay upper fill, 104. No finds were recovered from either fill.

- 8.1 Only a single feature was recorded, a linear ditch in Trench 1. This is shown on historic maps and survives as a tree lined boundary (See plate 2).

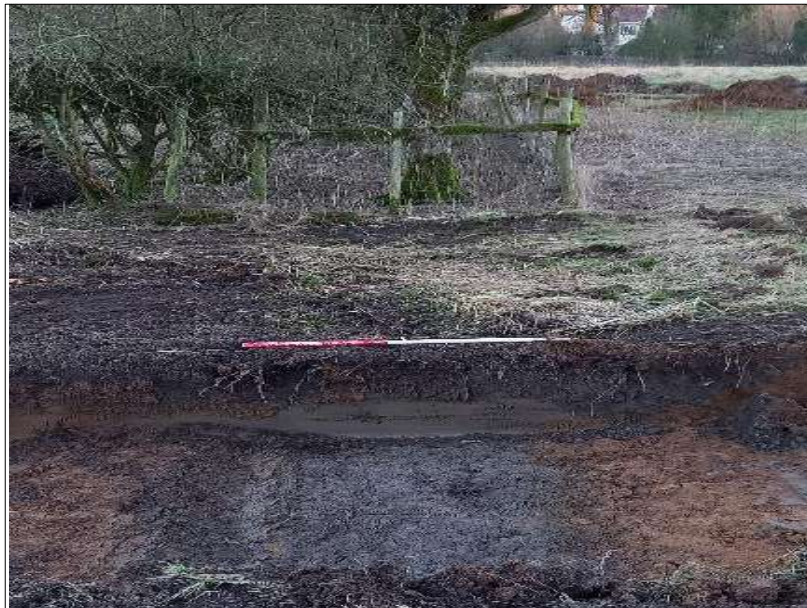
Plate 3: Trench 1, boundary ditch [106], looking south-southeast, scale 1m

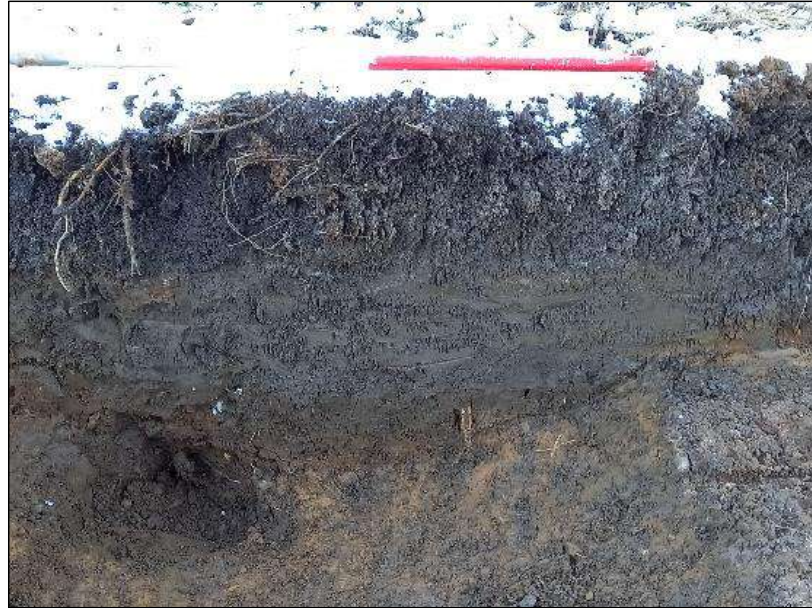
Plate 4: Trench 1, section of boundary ditch [106], looking south, scale 1m
