Preliminary Bat Roost Assessment & breeding birds survey

Site: Avenue Farmhouse, Hurst Green

29th May 2024

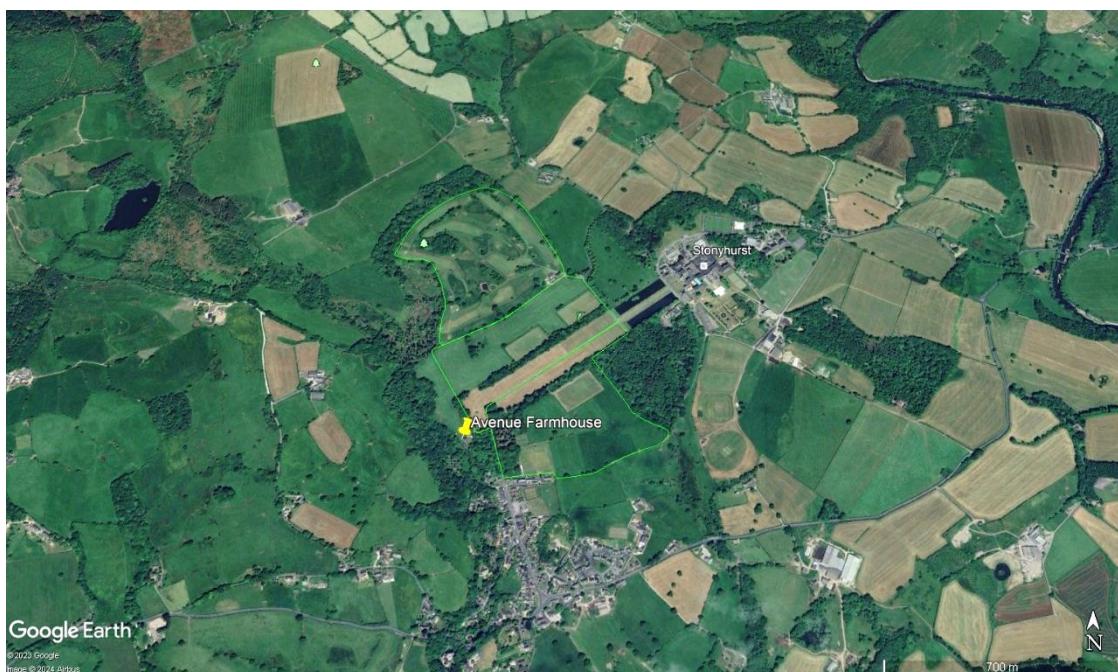
Figure 1: Aerial photo of site, showing surrounding landscape structure.

A review of the designated sites, aerial photographs (Figure 1), the Magic database (App. 3) and OS maps has been carried out. The Site and its surrounding landscapes' relevance to bat habitat is described as being located to the north of the village of Hurst Green on the edge of the grounds of Stonyhurst college, adjacent to deciduous woodland and Dean brook connecting the site through the surrounding farmland to the woodland pockets in the wider landscape. These features along with the wider rural landscape of pasture and meadows with hedges, and small areas of deciduous woodland form good quality commuting and foraging habitat for bats.

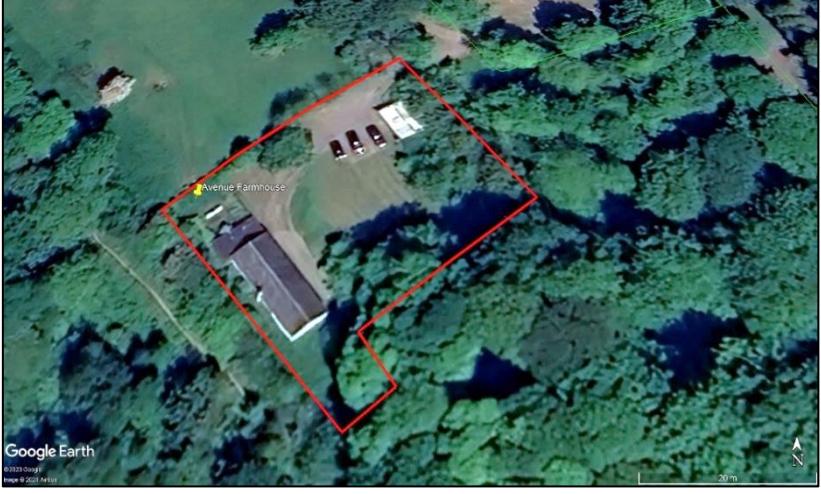
<p>Building Description</p> <p>The main survey building (B1) is a detached former farmhouse with mature gardens, within a woodland setting. Traditional stone built, with dual pitched blue slate roof. The lean-to shippen is a low gradient single pitch roof of blue slate.</p> <p>An additional building (B2) is a former car port/wood shed with corrugated roof sheets, and sides.</p>

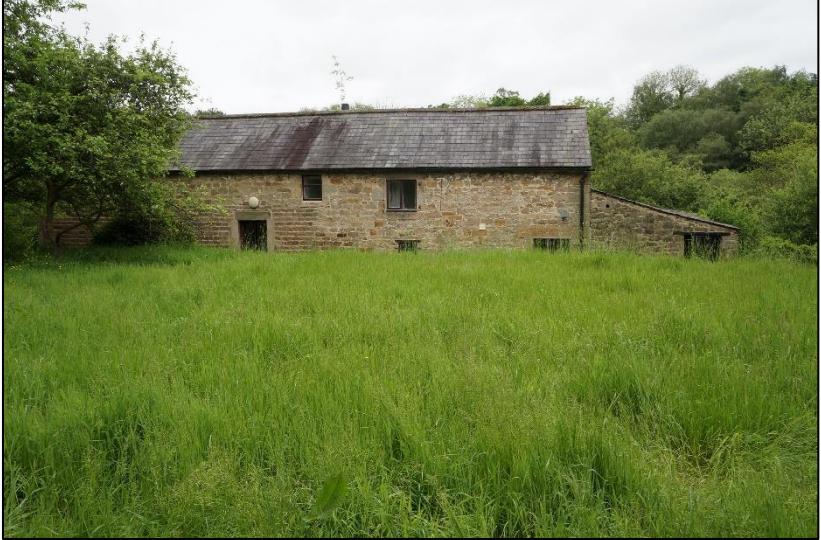
<p>Potential roosting features:</p> <p>The main farmhouse building was in a reasonable state of repair with no gaps to the wall or cracks that could be used by bats for roosting. The fascia and barge boards were all close fitting, with no suitable roosting features.</p> <p>The roof slates were all close fitting with no gaps or slipped tiles. The ridge tiles were well sealed with no access gaps visible.</p>

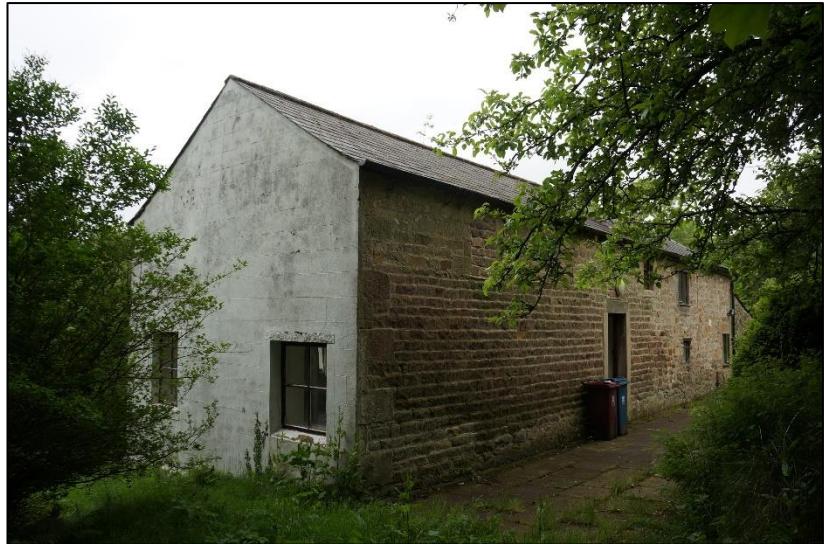
Photo 3: Southeast gable end showing eaves, roof tiles and ridge in good order.

The timber window frames are well weathered, but all glass was intact, and frames close fitting.
The gable end eaves were well sealed and in good order with no gaps or cracks.

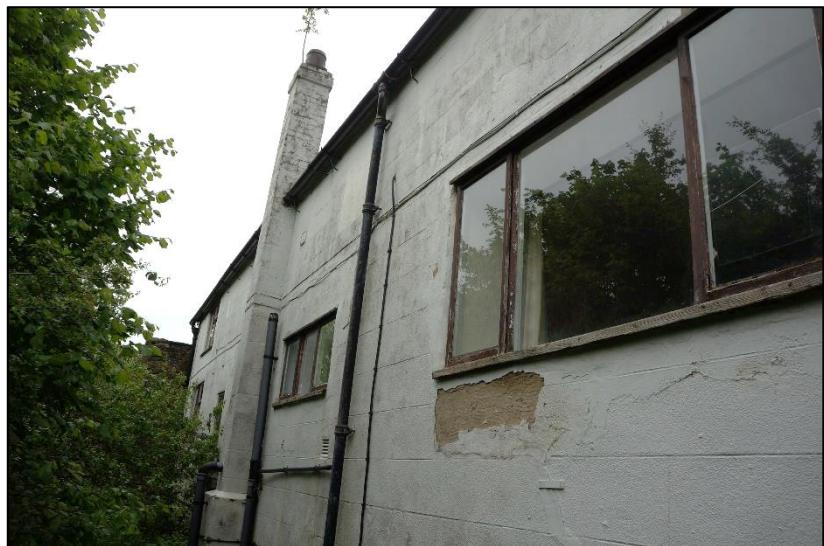
Photo 4: Southwest elevation showing timber framed windows.

Overall, there were no gaps or crevices that could be used by bats for roosting in the main building.

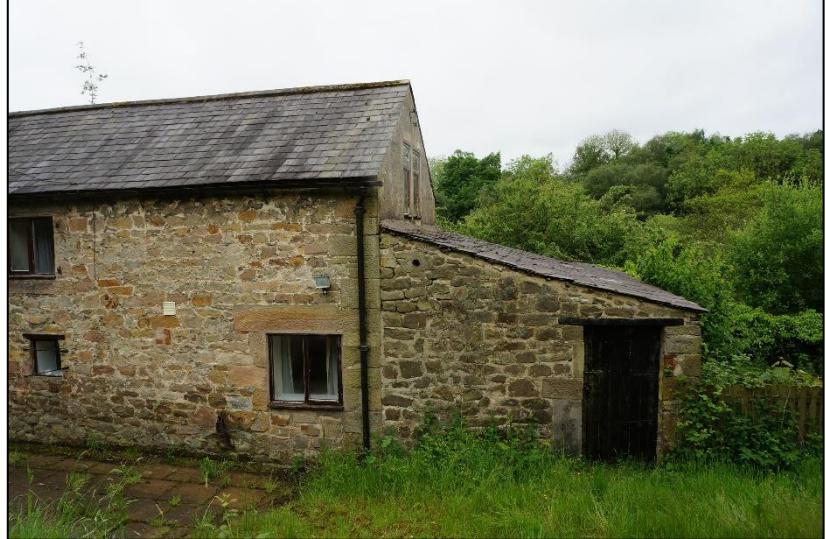
<p>Single storey lean-to shippen:</p> <p>The low pitched single storey lean-to on the northwest elevation had some missing mortar to the rear elevation, but on examination by endoscope did not provide deep enough crevices suitable for any bat species. A couple of roof tiles had slipped, but again were not forming suitable gaps for use by bats and taken into account with the shallow gradient of the roof, were not considered suitable bat roosting features.</p>

<p>Photo 5: low-angled single pitched roof on the northwest gable end lean-to..</p>
<p>Internally:</p> <p>There was an accessible roof space off the landing to approx. 50% length of the building to the south east gable end.</p> <p>There were no signs that bats had used this space for roosting or feeding i.e no droppings, urine stains or feeding remains.</p> <p>The ceiling was underdrawn and plastered, with the occasional hole.</p>

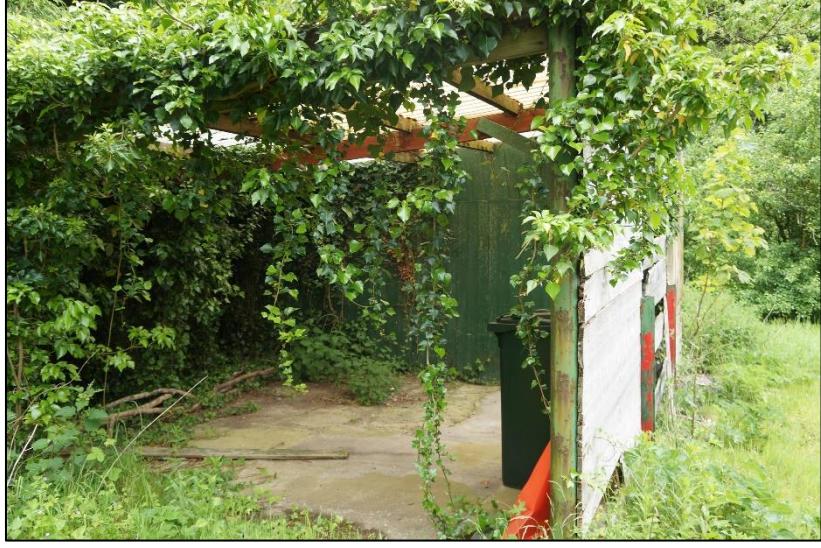
<p>Carport (B2)</p> <p>Located just inside the entrance and off the driveway was a timber framed car port, clad in corrugated plastic and metal sheets. This has become overgrown with ivy, and although there were no suitable roosting spaces for bats, the ivy could be used by small birds as a nesting place.</p>

Photo 7: Timber framed carport, clad in plastic and aluminium corrugated sheets and overgrown with ivy.

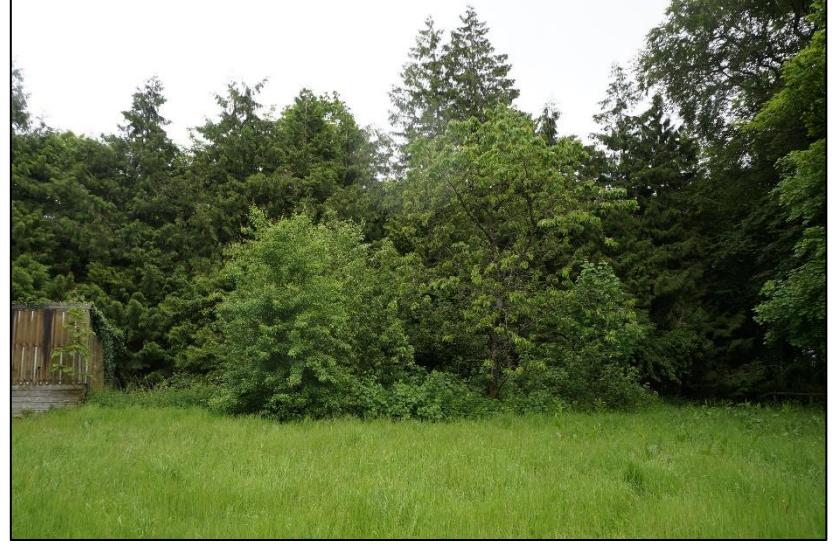
<p><i>Breeding birds and other incidental observations</i></p> <p>The garden provides good quality nesting habitat for birds in the surrounding hedges and shrubs, and mature trees on-site.</p>

Photo 8: Hedgerow and shrubs providing good bird nesting habitat in the garden of Avenue Farmhouse.

Survey assessment conclusions	The site surroundings include suitable habitat for nesting birds, but none within the impacted building.
Foreseen impacts	Active nests could be destroyed during building/vegetation removal. Any works which affect The Site could have an impact on nesting birds.
Recommendations	Any building/tree and scrub removal should be undertaken outside the period 1st March to 31st August. If this timeframe cannot be avoided, a close inspection of the building and scrub to be removed should be undertaken by a suitably qualified ecologist, immediately prior to clearance. All active nests will need to be retained until the young have fledged. Clearing the Site outside this timeframe avoids delays and further costs.
Enhancements <i>The Local Planning Authority has a duty to ask for enhancements under the NPPF and circular 06/2005: Biodiversity and Geological Conservation. Para.99</i>	Install a minimum of 2 bird boxes on site, on an existing tree or building e.g. <ul style="list-style-type: none"> • Good quality timber nesting box with hole protection • Schwegler 1B nest box • Schwegler 2H Robin box Regular nest boxes should be positioned approximately 3m above ground level where they will be sheltered from prevailing wind, rain and strong sunlight. House martin/swallow/swift boxes should be placed under the eaves with clear entrance/exit paths, ideally on the west elevation.
