Heritage assessment to inform planning application
for replacement of existing dwelling
at Avenue Farm, Avenue Road, Hurst Green

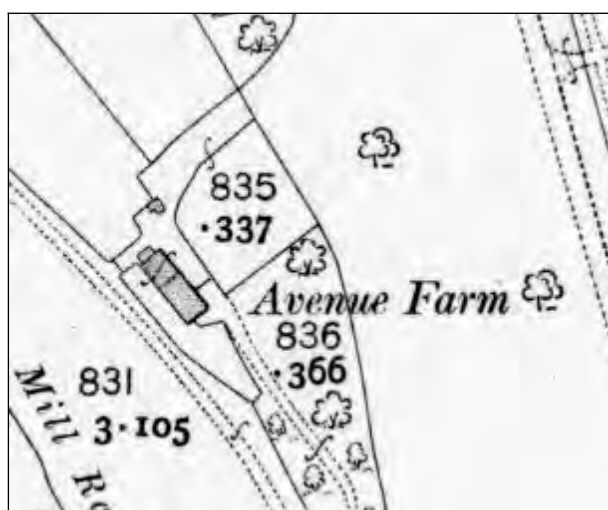
Figure 1: OS 1:2500 map, 1912

- 4.1 The building is not known to have any significant documented history. It is shown with its present proportions, unnamed, on the Ordnance Survey 1:10,560 map of 1847, and similarly but with the name Avenue Farm, on the 1895 edition and later maps¹.

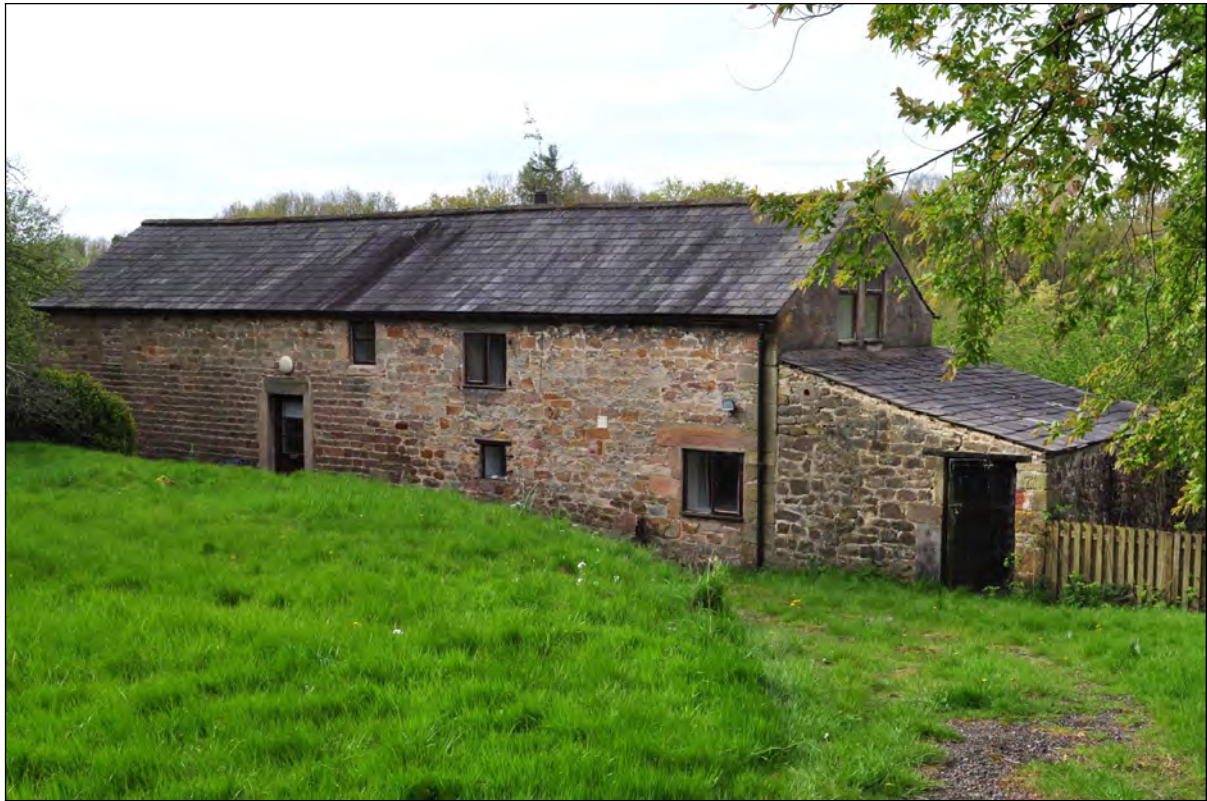
Photo 1: The present house, looking south

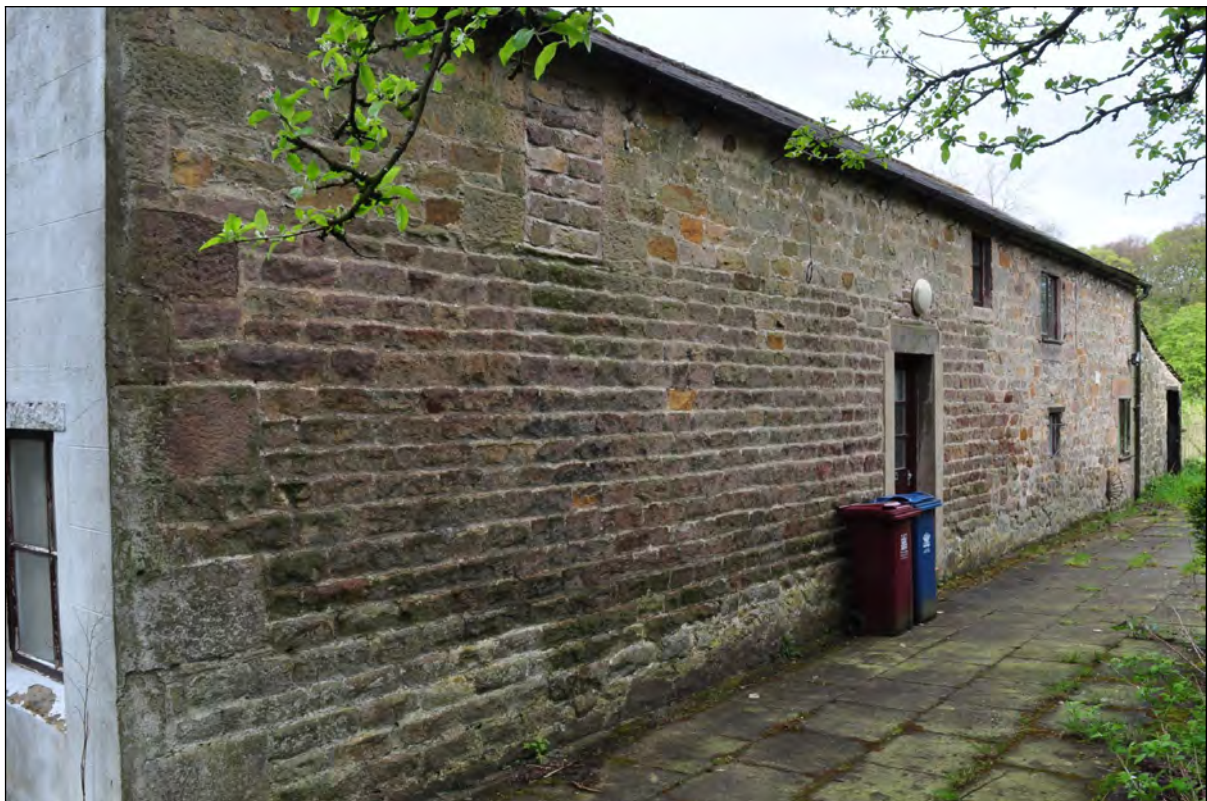
Photo 2: North-east front

- 5.1 The building has a simple rectangular footprint and is of two storeys (the upper one partly within the roof), except at the north-west end, where there is a single-storey lean-to.
- 5.2 The north-east side is the front and is of exposed sandstone masonry, which varies in its character. The stonework at the south-east end (photo 2) is coursed and watershot in style, up to about 2.5m, while above this and throughout the

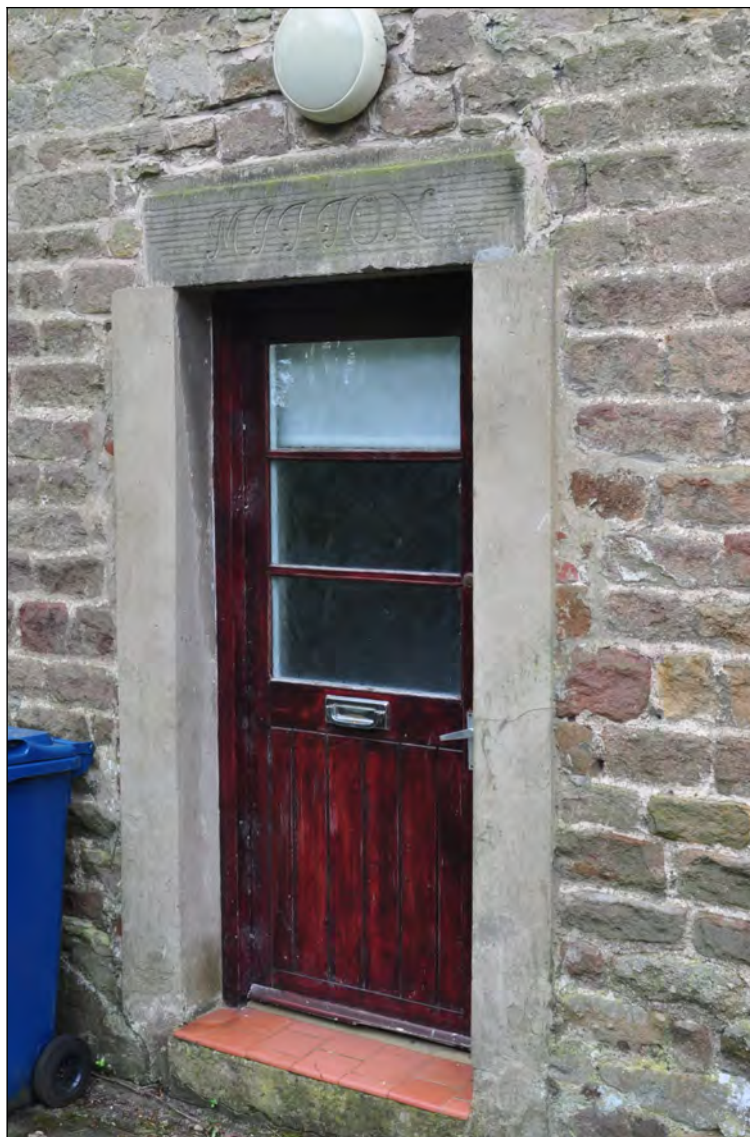
Photo 3: Present entrance, with re-used lintel, no jambs

north-west part the wall is of largely random rubble, albeit with well-finished dressings and quoins. The house entrance is within the coursed stonework (photo 3), where it seems to have been inserted: it has mortared jambs and a re-used lintel, inscribed with the word "Mitton" in a 19th century style. The other openings in this front are all within the random stonework and appear to be original to it: they include a former doorway at the right-hand end, and a forking hole at first floor level (photo 4).

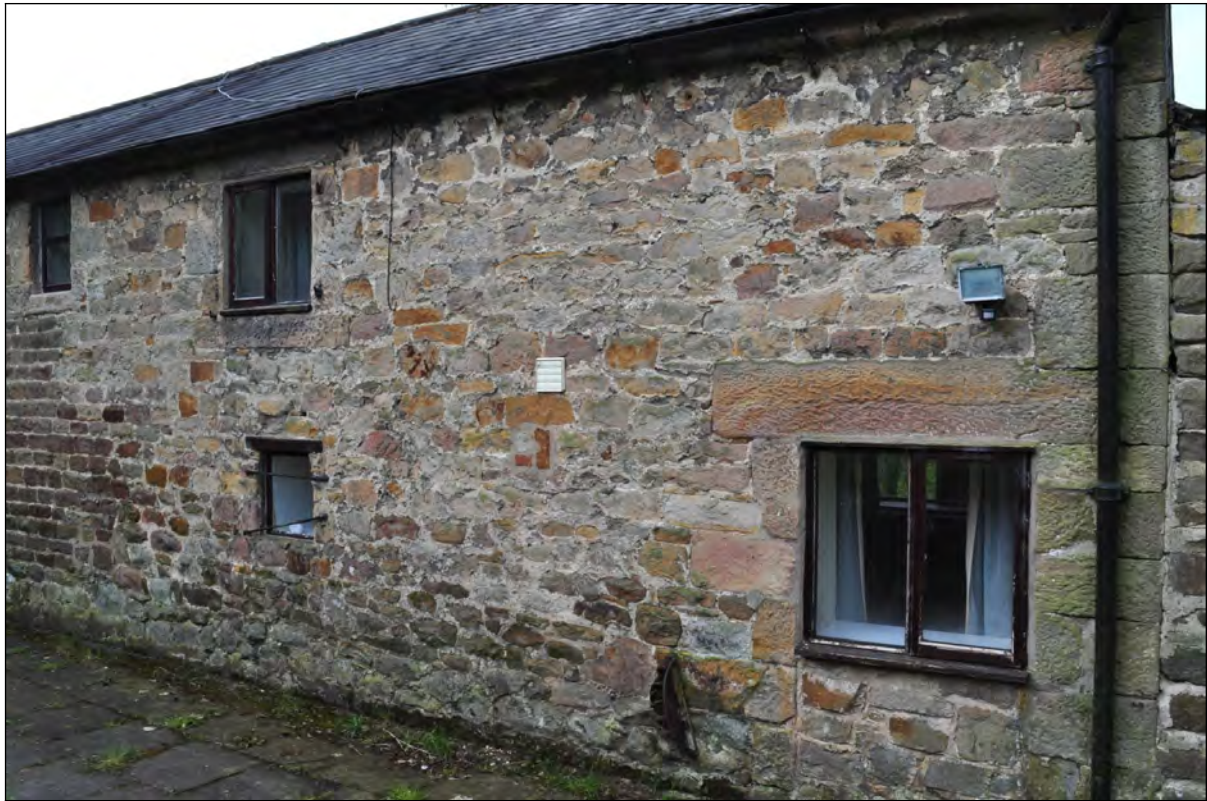
Photo 4: North-east front: agricultural openings within rubble wall

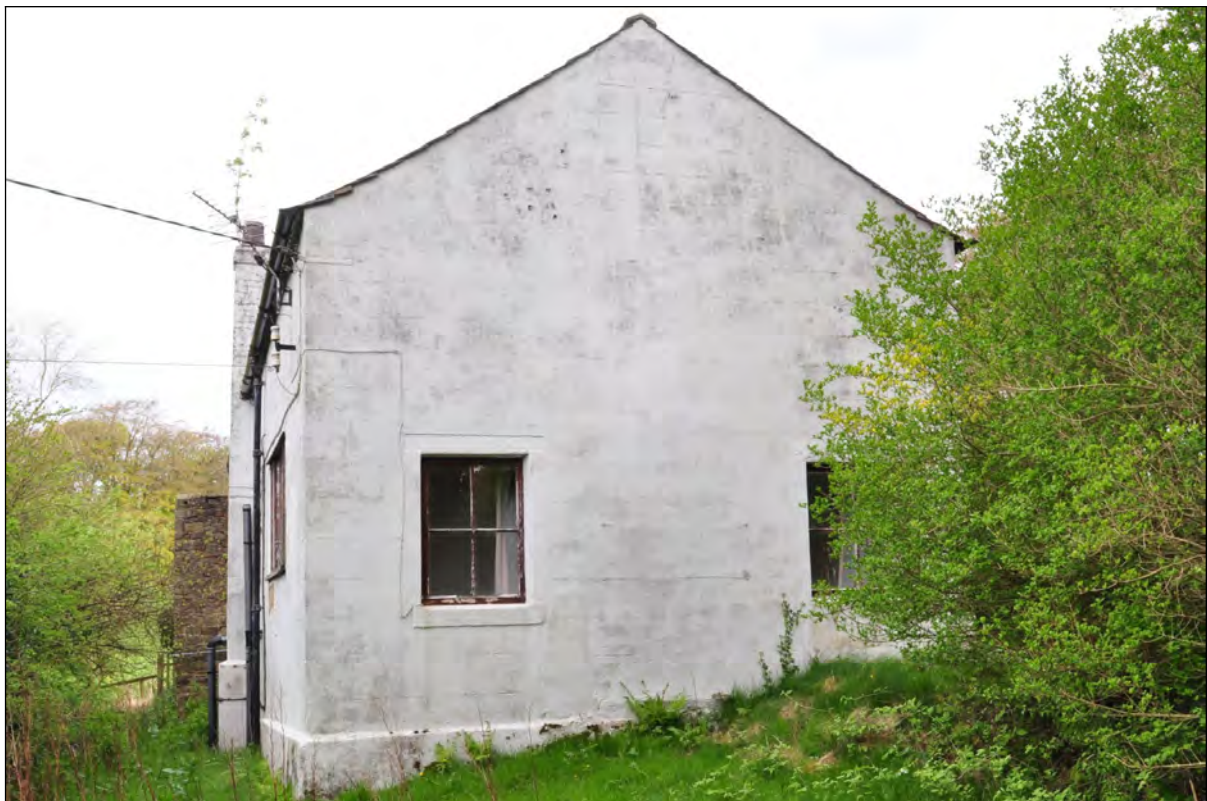
Photo 5: South-east gable

- 5.3 The south-east gable and south-west rear (photos 5 & 6) are both covered with modern, scored render, meaning little can be deduced regarding their underlying character, but one of the two ground floor gable windows is a former doorway, and within the south-west wall a number of window openings are clearly 20th century, to judge from their size and proportions. The north-west gable is not rendered, but has a large, two-light window to the upper floor, which also appears to be 20th century.

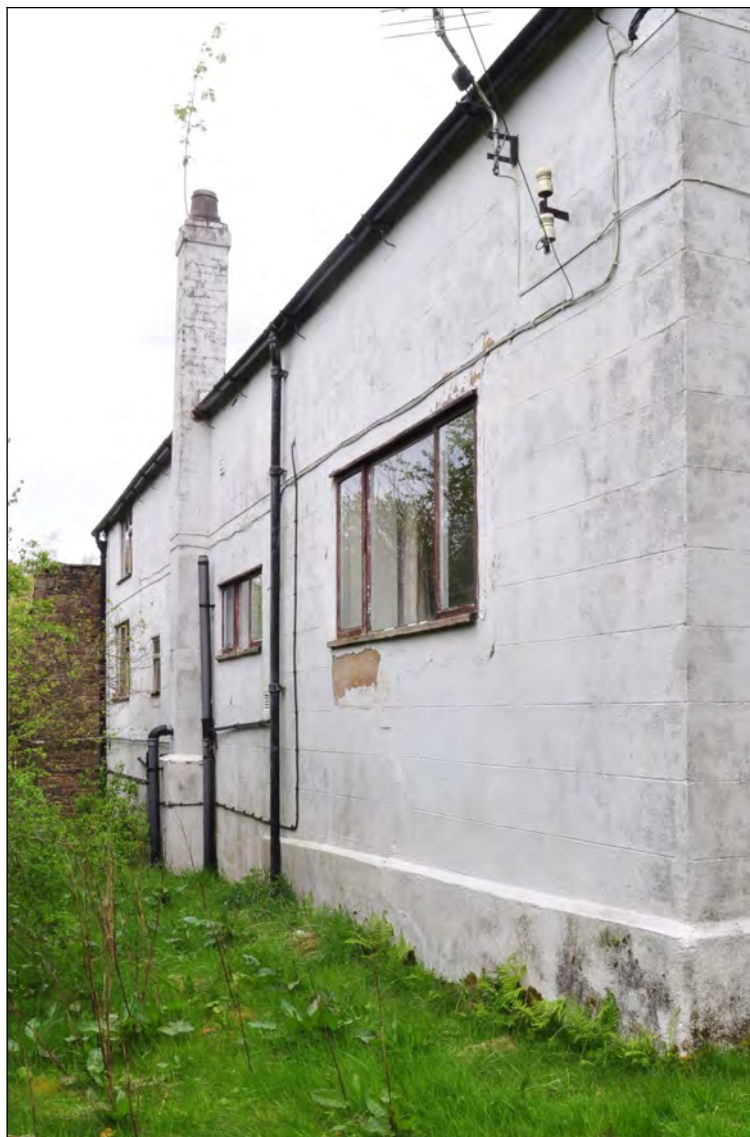
Photo 6: South-west elevation (rear)

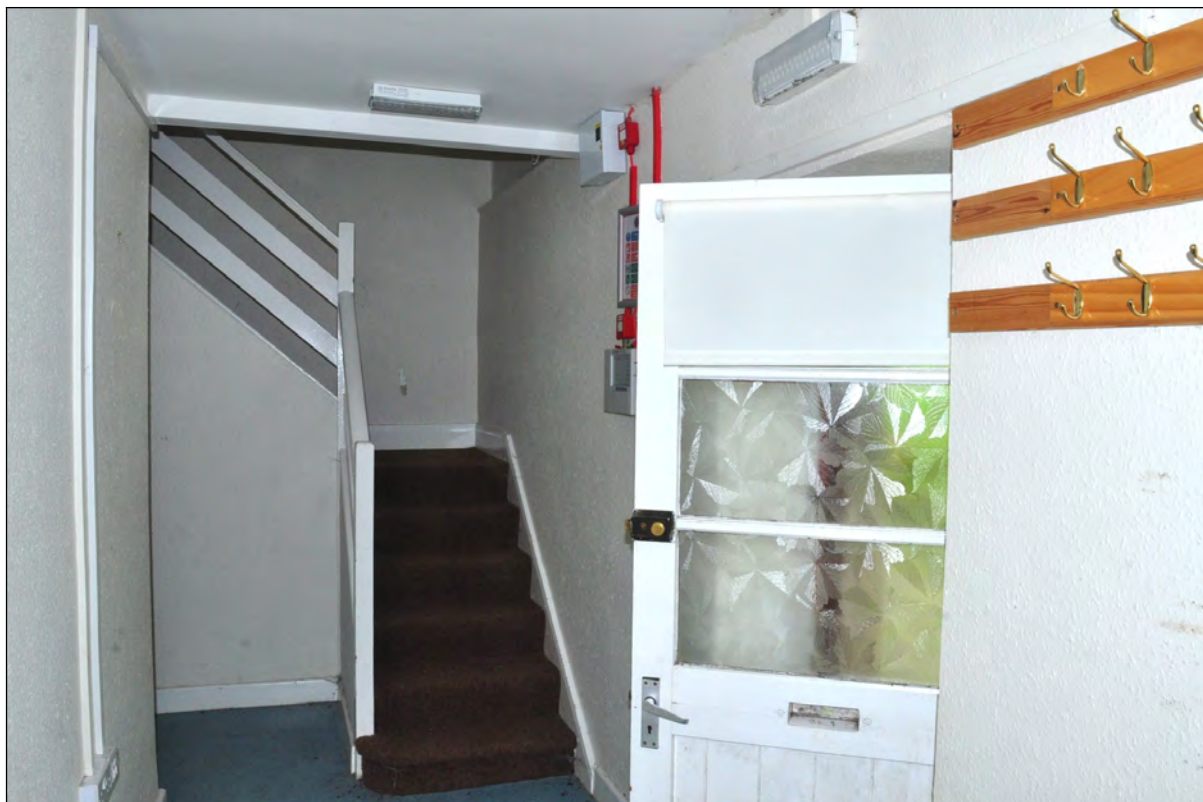
Photo 7: Entrance lobby and staircase

- 5.5 The interior of the house allows very little deduction regarding its origins or development, as its subdivision and fittings are almost entirely those introduced as part of the change of use, circa 2014. There are two cross-walls which divide the house into three roughly equal parts, and which appear to support the roof purlins; these are partly exposed within the north-west end, and are a mixture of softwood and hardwood. The upper floor is confined to this end, and rises into the roof; at the south-west end there is only a roof void at first floor level.
