Bat Survey Report and Method Statement European Protected Species (Bats)

Reasonable Avoidance and Mitigation Measures

**Outbuildings at Parsonage Farm,
Church Street,
Ribchester,
PR3 3ZR**

23.08.2024

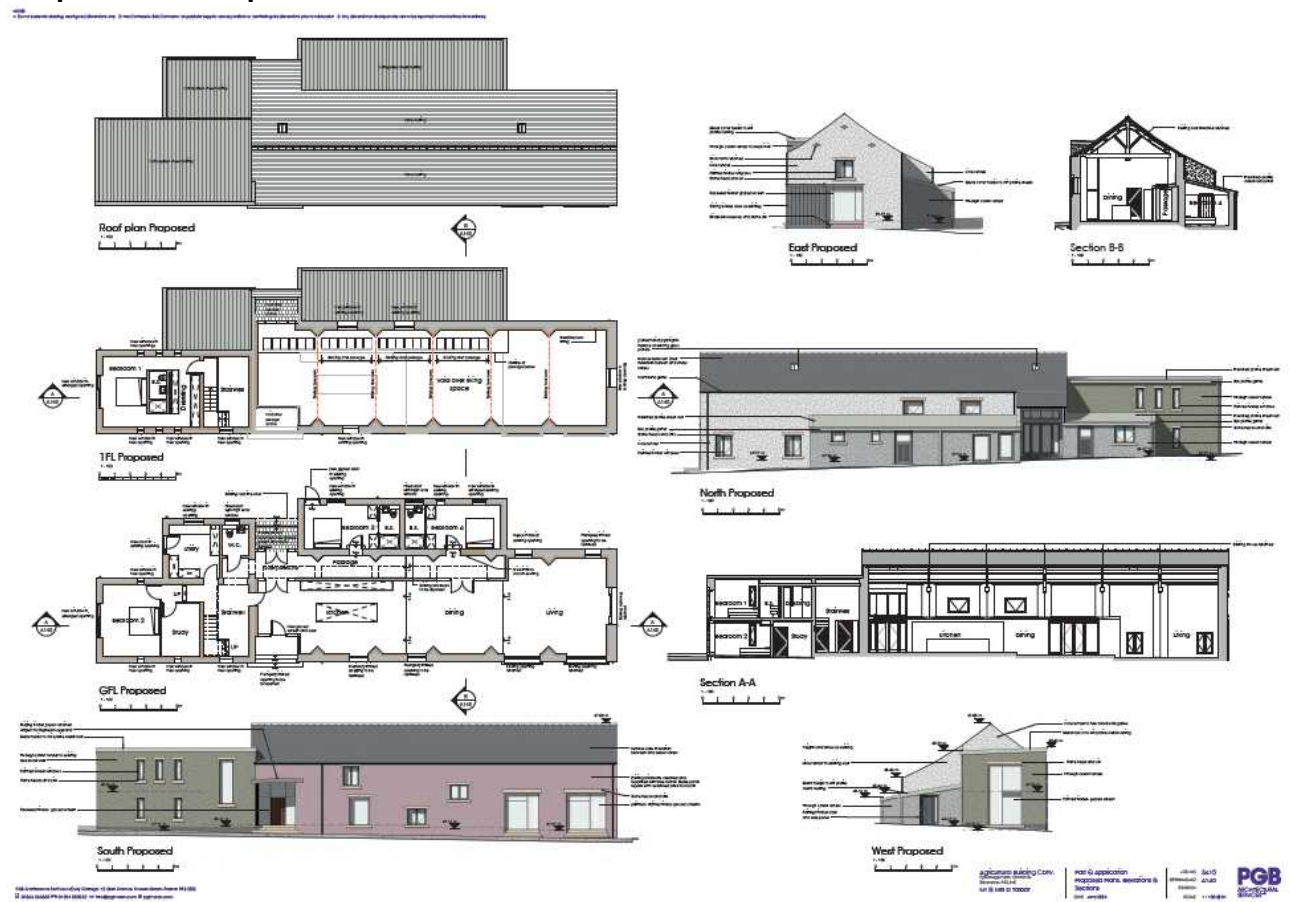
Proposed Development

The proposed development consists of the residential conversion of Barn 1 and removal of outbuilding 2.

Outbuildings 1,3 and 4 are to be retained.

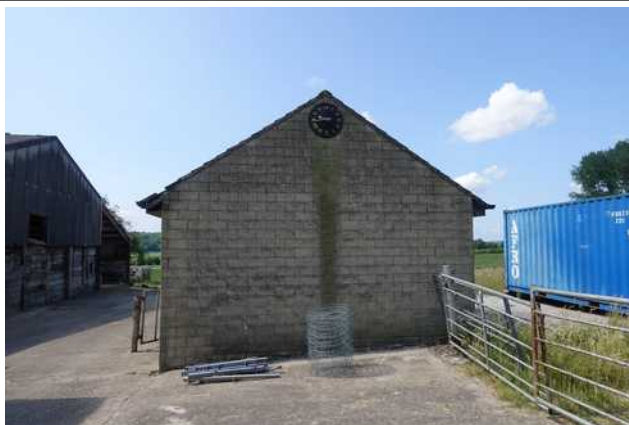
Outbuilding 1 North Gable End

A single storey stone faced block built outbuilding with a double pitched slate roof. External walls are generally well pointed with no obvious cracks, gaps or crevices, however internally gaps are present at wall tops.

Roof slates are generally close fitting with no lifted, slipped or missing slates present. Gaps in pointing are present on gable ends allowing access below slates. Roof slates are lined with a bituminous roofing felt.

The building was assessed as offering moderate bat roosting potential.

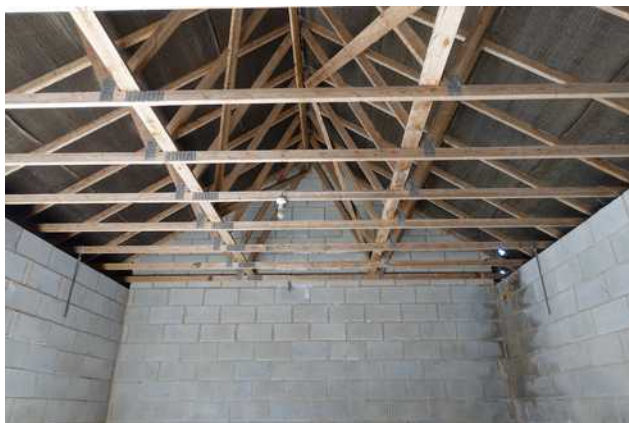
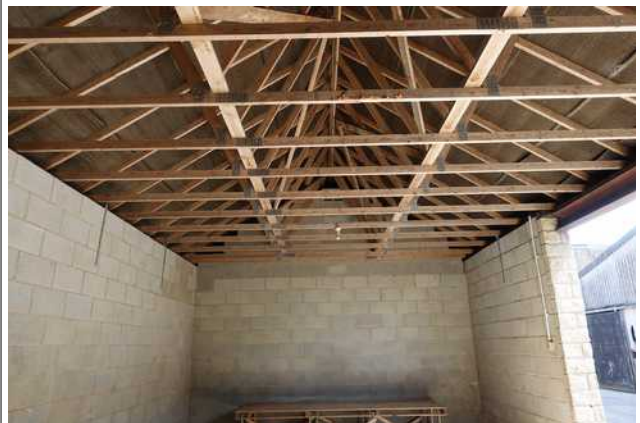
Outbuilding Internal

Scattered droppings were observed within the south western bay of outbuilding 1.

Droppings were consistent with pipistrelle bats emerging from and returning to roost within the building.

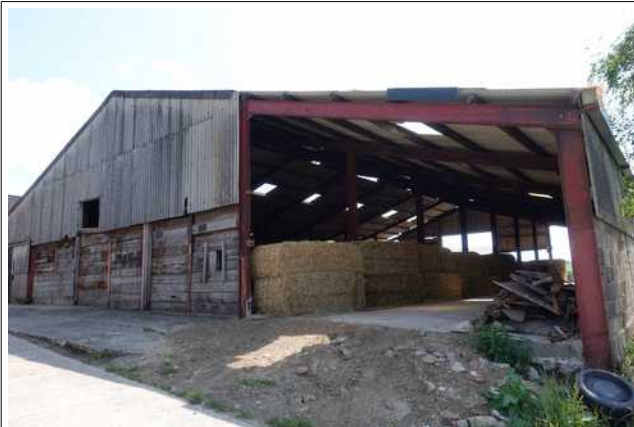
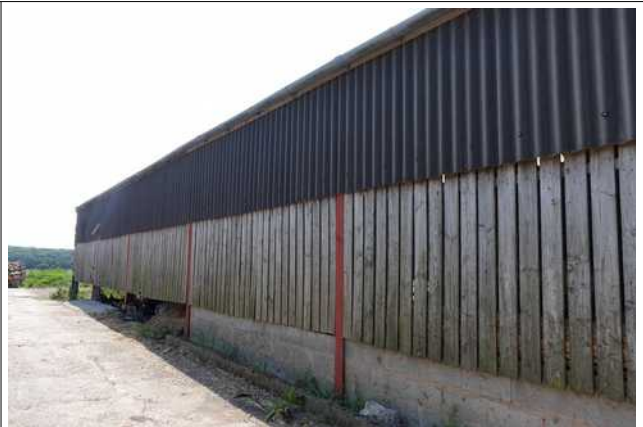
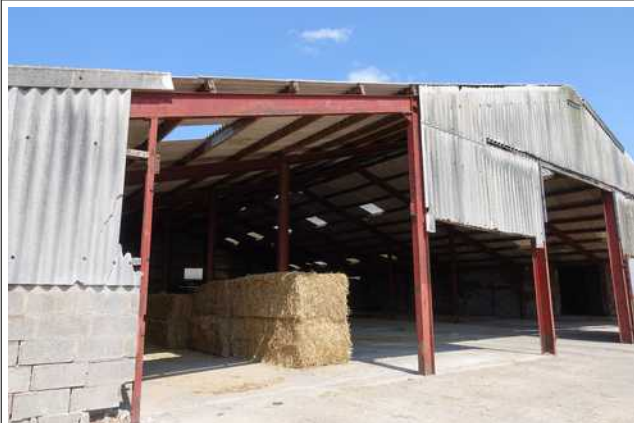
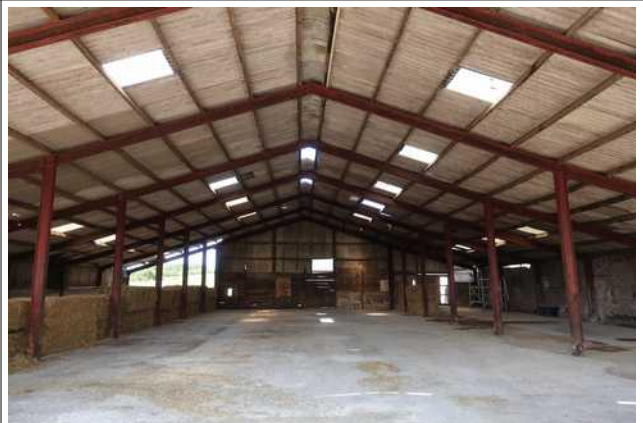
Outbuilding consists of a steel portal barn with single skin timber and corrugated metal external walls. Then building has a double pitched single skin corrugated fibreboard roof.

The building was assessed as offering negligible bat roosting potential.

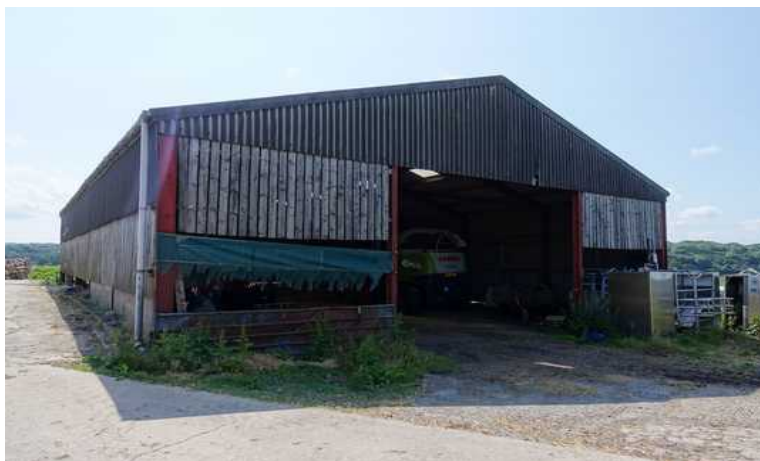
Outbuilding 3 Northern Gable

Outbuilding 3 consists of a steel portal barn with single skin timber and corrugated metal external walls. Then building has a double pitched single skin corrugated fibreboard roof.

The building was assessed as offering negligible bat roosting potential.

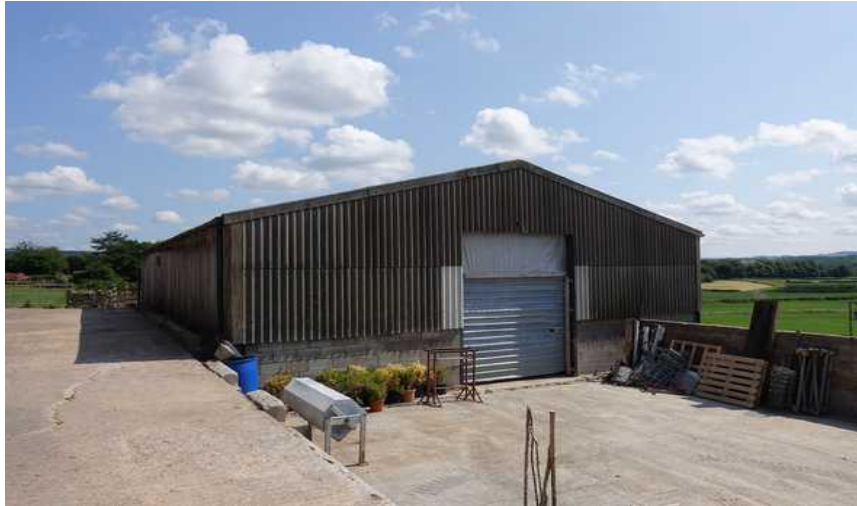
Outbuilding 4 consists of a steel portal barn with single skin concrete block, timber and corrugated fibreboard external walls. The building has a double pitched single skin corrugated fibreboard roof.

The building was assessed as offering negligible bat roosting potential.

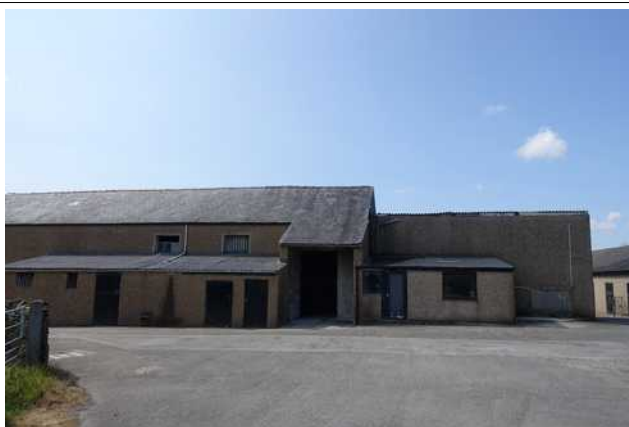
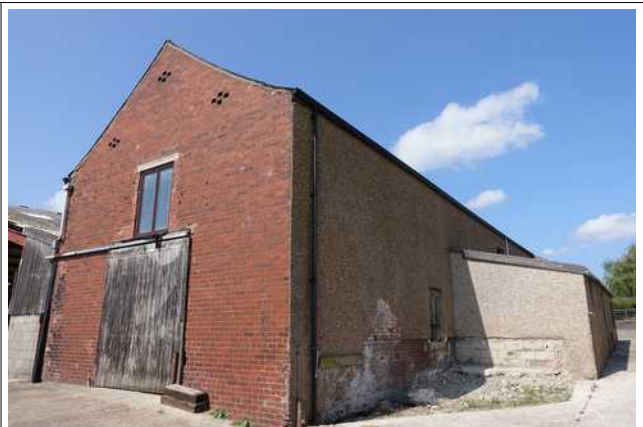
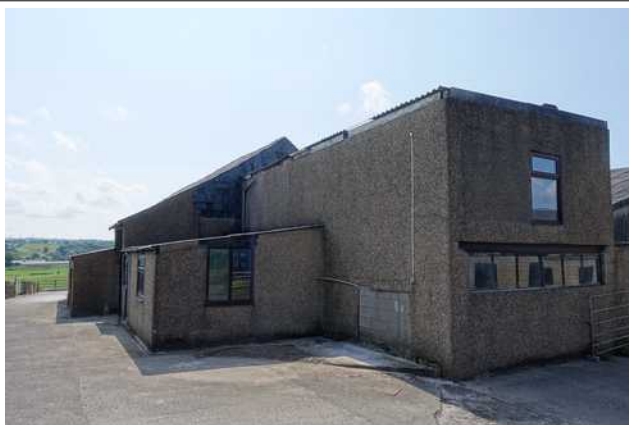
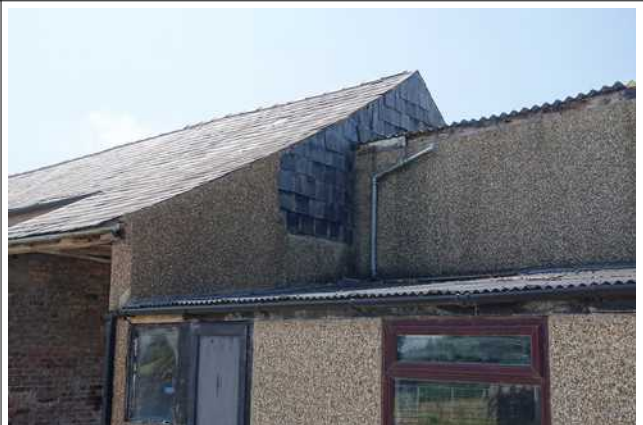
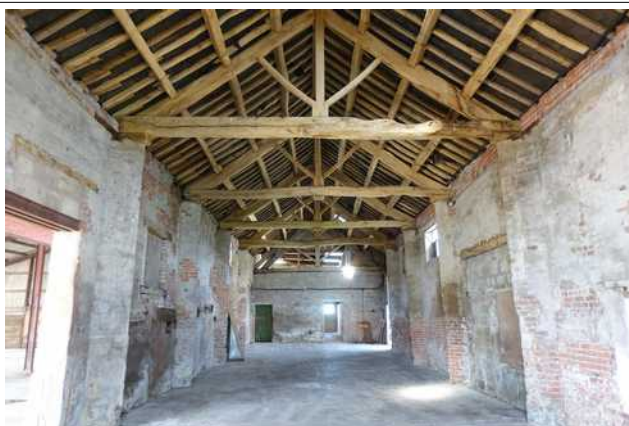
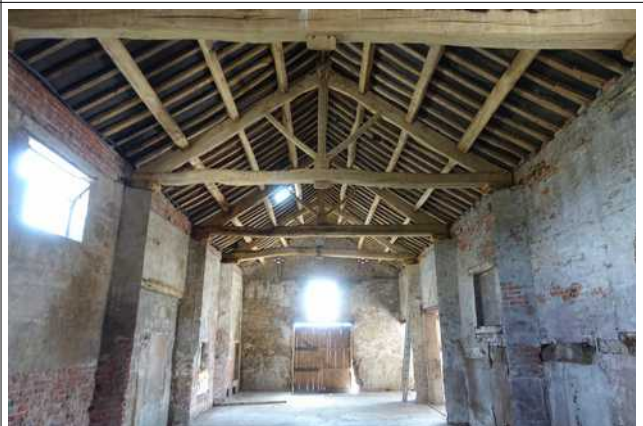
Barn 1 is a brick built two storey barn with single storey extensions to the north and eastern facades. The building has a double pitched slate roof, extensions have single pitched unlined corrugated fibreboard roofs.

External walls are well pointed and partially rendered and pebble dashed with some gaps and crevices present. Gable ends are pointed and sealed. Gaps were recorded on internal walls and all tops within the barn are exposed.

Roof timbers are hand cut and gaps and crevices are present within joints, some cracks were noted within beams. Roof slates are lined with a bituminous roofing felt in good general condition.

The building was assessed as offering moderate roosting potential.

Low risk: Roof stripping will be undertaken by hand and under supervision following installation of compensatory bat boxes.

Roof work should take place following an evening temperature of +5c

Work to affected roof areas will take place with the batworker on call.

Roof slates and fascia boarding should be removed by hand where necessary.

The underneath of slates and boarding should be checked for dormant bats prior to moving.

In the unlikely event bats are found during works. The area should be carefully covered and work stop until the batworker can attend to assess the appropriate way forward.
