Preliminary Bat Roost Assessment Report

Outbuilding at Lower Hud Lee Farm,
Longridge Road,
Hurst Green,
BB7 9QP

12.08.2024

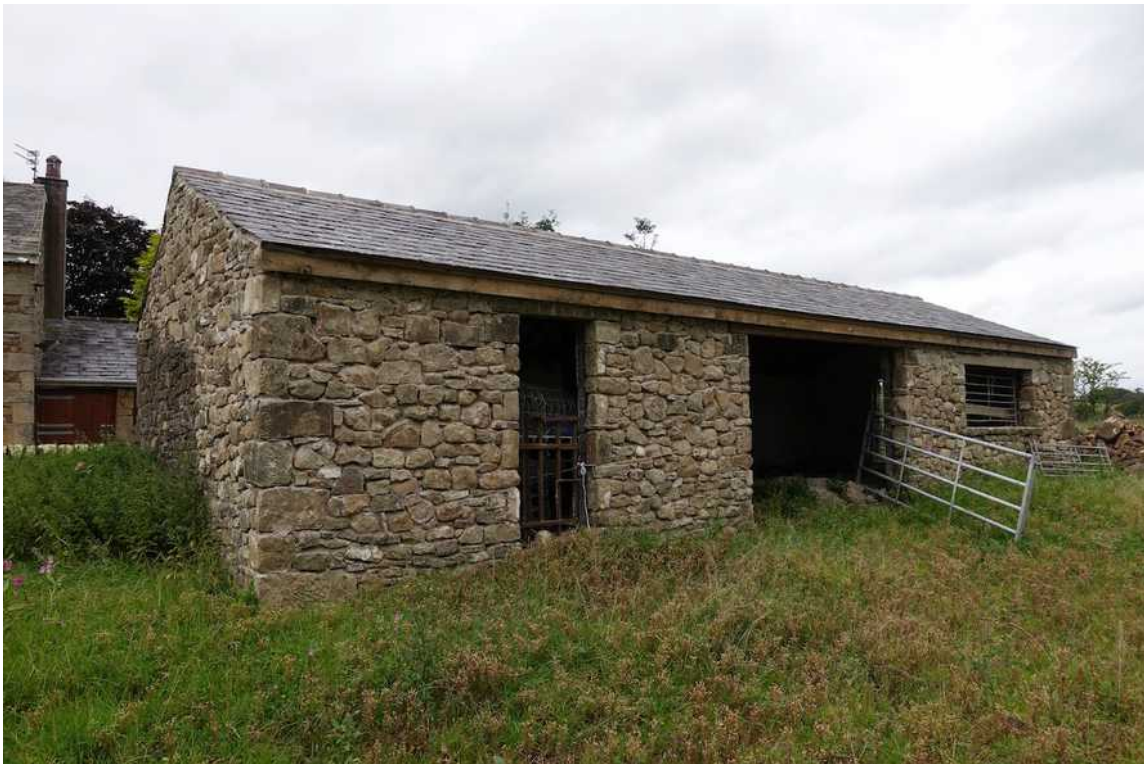
The building was observed to generally have no obvious potential roost features present and was assessed as offering negligible bat roosting potential.

No evidence (in the form of scattered droppings, urine splashing, feeding remains or grease marking) to suggest use by bats was recorded despite suitable undisturbed horizontal surfaces being present.

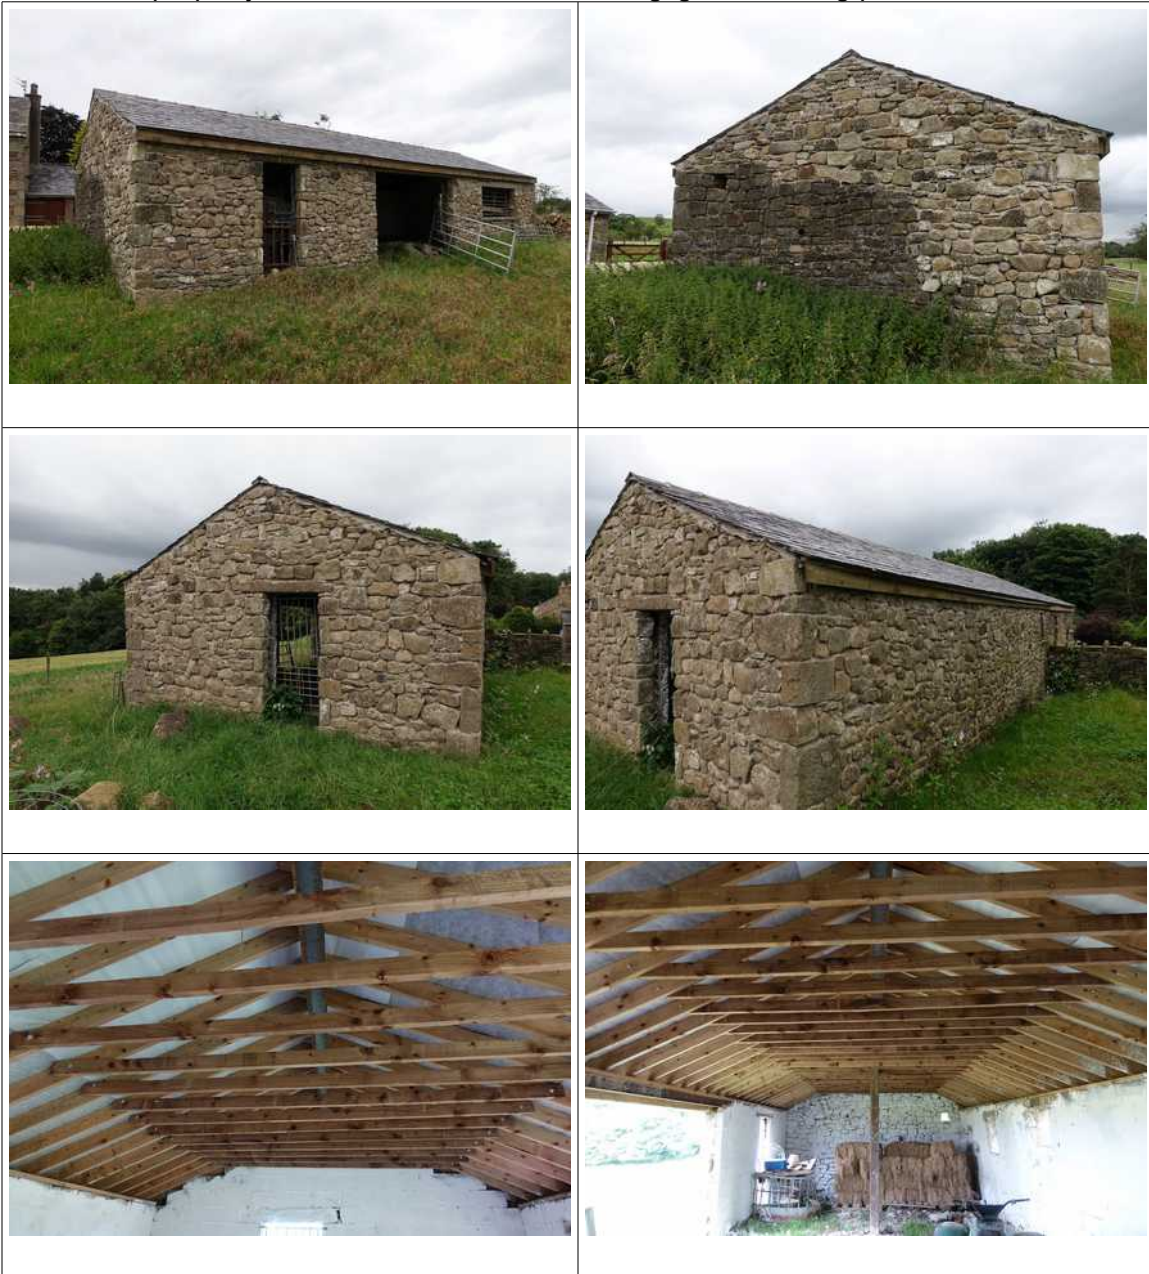
The property consists of a single storey stone built outbuilding with a double pitched slate roof.

External walls are well pointed with no cracks, crevices or cavities present. Eaves and gable ends are generally pointed and well sealed. Fascia boarding has a large behind (+75mm) unsuitable for roosting bats. The roof is in good general condition with close fitting slates. No lifted, slipped or missing slates were observed and ridge tiles are well sealed. A modern breathable membrane is present suggesting recent reroofing.

Overall the property can be considered to offer negligible roosting potential.
