Bat Survey Report and Method Statement European Protected Species (Bats)

1 Ferry Butts,
Garstang Road,
Chipping,
PR3 2QJ

15.01.2024

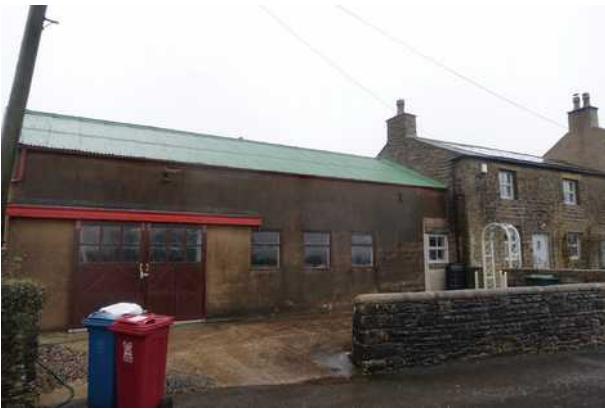
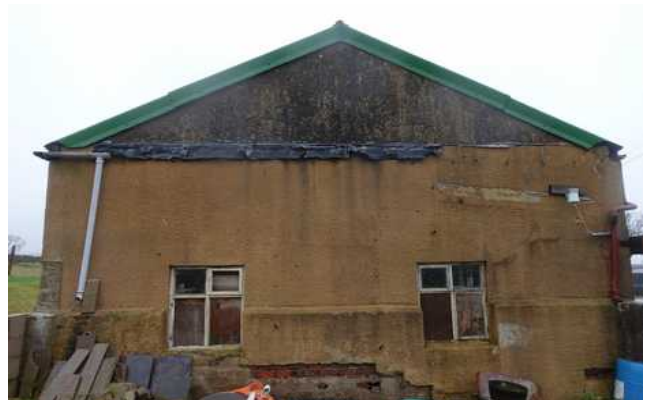
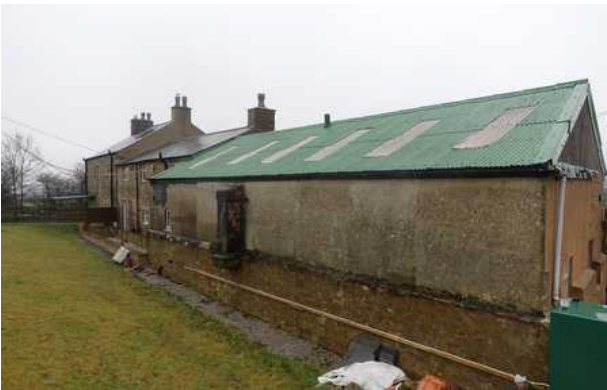
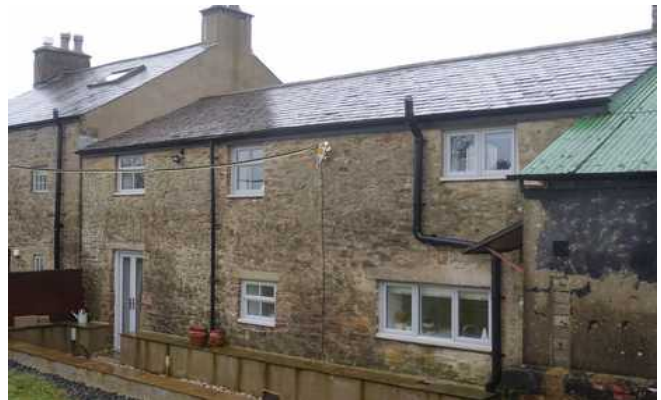
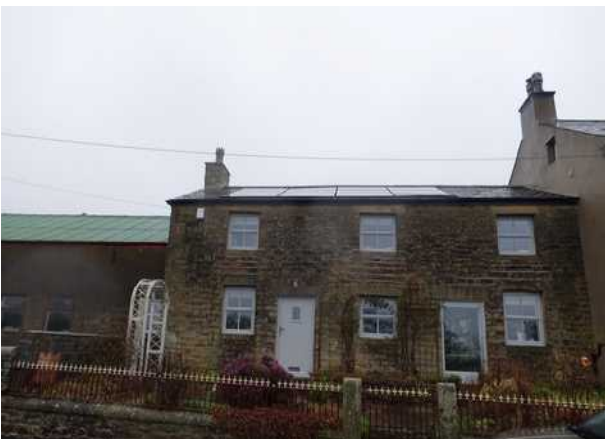
The property consists of a single storey outbuilding with double pitched corrugated roof adjoining an end terrace two storey stone built cottage with double pitched slate roof.

External walls are generally well pointed and rendered, with no obvious cracks, gaps or crevices present Fascia boarding is generally close fitting, however one area of a wide (+50mm) open gap is present on the frontage.

Roof panels are close fitting, roof lights are present on the rear roof aspect. The ridge is sealed. Gaps were noted below panels at the gable.

The building was assessed as offering negligible to low bat roost potential when surrounding habitat was taken into consideration.

Work to remove fascia boarding and roof panels should take place following night temperatures of 5c

Fascia boarding should be removed by hand and under supervision where necessary.

The reverse of fascia boarding and gable end roof panneling should be checked for dormant bats prior to moving.

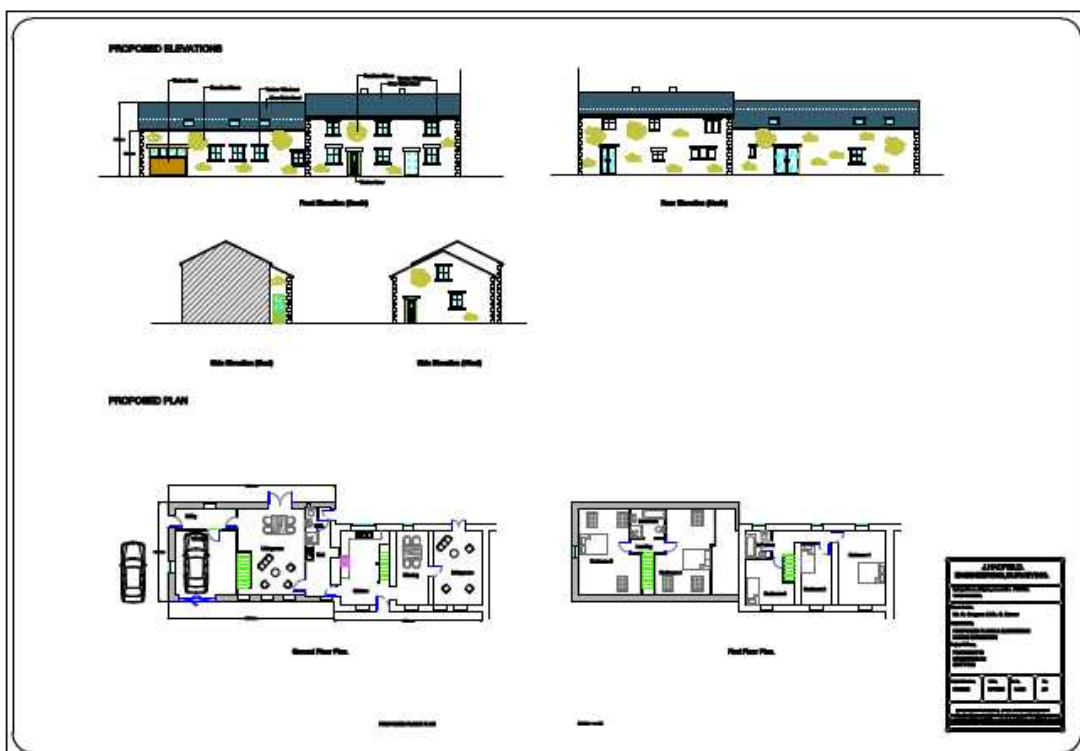
Proposed Development.

The proposed development consists of a residential conversion of the outbuilding.
