**Cunliffe House Cottage,  
Longsight Road,  
Langho,  
Blackburn,  
Lancashire.  
BB6 8AD**

**Preliminary Ecological Appraisal  
in respect of Protected/Notable Species Including  
Bats and Nesting Birds.**

**16<sup>th</sup> December 2024**

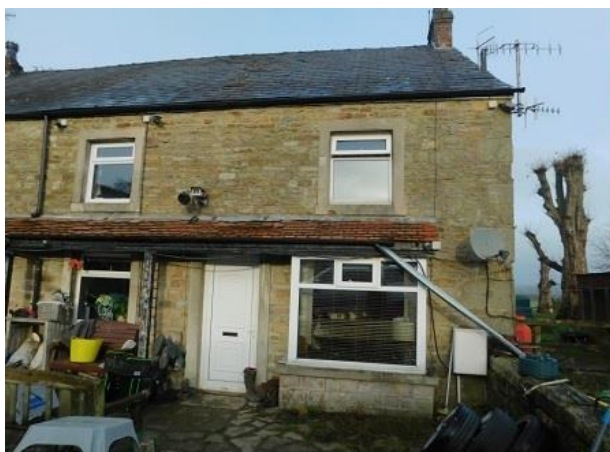
**PHOTO 1**  
**South-eastern Corner**

- All along the southern elevation at ground floor ceiling level, was a pitched dormer roof of slate, mounted over two dormer windows, and also the cottage entrance door, but there was no roof void, nor any insulation. However, at a few locations where the roof attached to the cottage wall, the lead flashing had lifted, and several roof tiles had slipped, but a search around the edges of the tiles, the lifted flashing, and the roof itself using close-focus binoculars, and an endoscope, found neither bat droppings or any other visible evidence of bat roosting, and a search of the all parts of the dormer roof and nearby walls in light produced by an LED ultraviolet flashlight, no indication of bat urine stains was seen, and therefore the gaps around the lifted flashing and the slipped tiles, were all deemed to be of negligible bat roosting suitability, (refer to **figs 3, 4 and 5**, and **photos 1 to 3**).

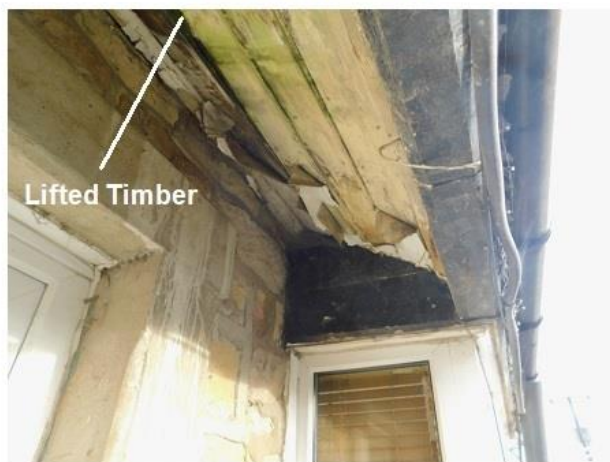
**PHOTO 4**  
**Underside of Southern Porch**

- A small area of timber had lifted beneath the underside of the dormer roof, but a search the resulting gap and the floor beneath it, found neither bat droppings, any invertebrate prey remains, nor any fur grease or urine staining discovered, and therefore the gap was deemed to be of negligible bat roosting suitability, (refer to **figs 3, 4 and 5**, and **photo 4**).

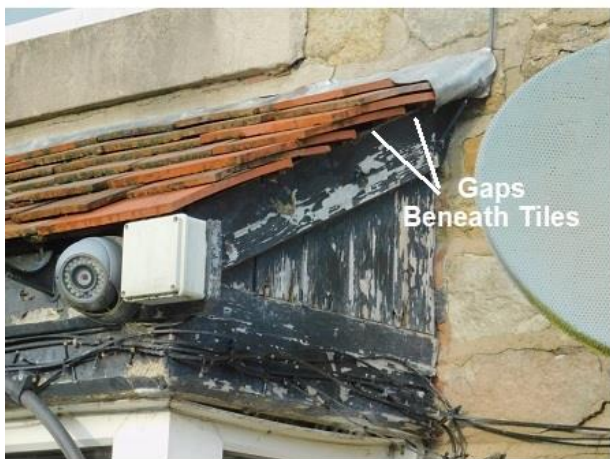
**PHOTO 5**  
**South-eastern Corner of Porch**

- At the eastern end of the dormer roof at the south-eastern corner of the cottage, there were gaps beneath several roof slates but a search of these using an endoscope and UV flashlight, found no bat droppings, or any type of staining, and therefore these gaps were all judged to be of negligible bat roosting suitability, (refer to **figs 3, 4 and 5**, and **photo 5**).

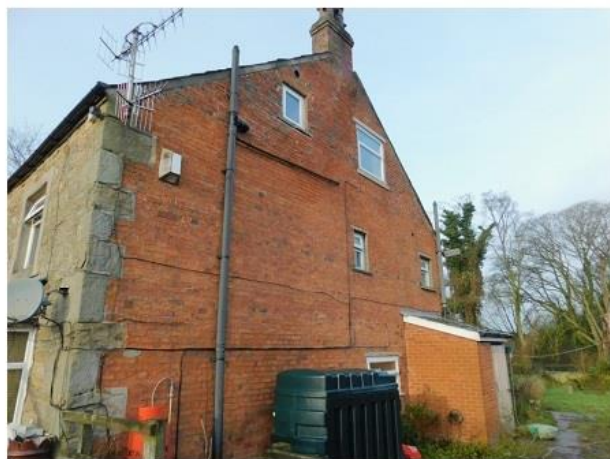
**PHOTO 6**  
**Western Elevation**

It was positioned in a west to east orientation, and other than a toilet, the outhouse was empty, but although it was in good condition, it was cold, damp, uninsulated and unheated, and was therefore concluded not to offer opportunities for either daytime roosting bats, or breeding bats. Also, as frost and inclement bad weather were both very likely to penetrate the interior of the outhouse in the colder months, it did not offer the optimum humidity, and constant low temperatures that are required for hibernating bats, and as neither bat droppings or invertebrate prey remains, nor any other evidence of bat occupation was found during the survey, the outhouse was judged to be of low bat roost suitability, (refer to **figs 3, 4 and 5**, and **photos 6, 8 to 13, 15 and 16** ).

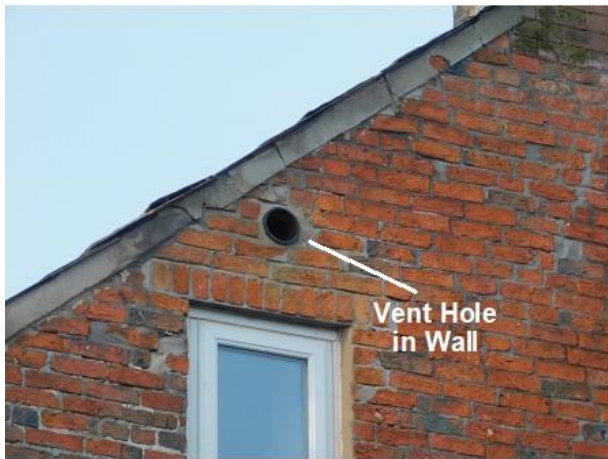
**PHOTO 7**  
**Upper South-eastern Elevation**

- There were two vent holes found in the brickwork, one of these was located at the upper south-eastern corner of the eastern elevation, whilst the other was at the upper south-eastern corner, again in the eastern elevation, and an internal search of these found both to be meshed internally, and as there was neither staining, droppings or any other form of bat roosting evidence found, both of these were thought to offer negligible bat roosting suitability, (refer to **figs 3, 4 and 5**, and **photos 7 to 9**).

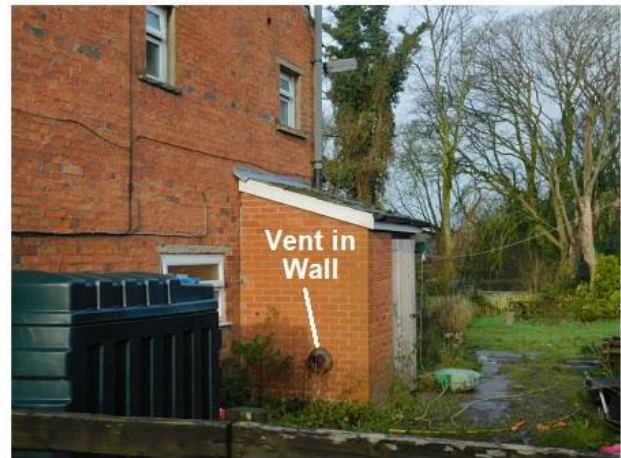
**PHOTO 10**  
**Southern Elevation of Outhouse**

- There was a vent in the southern elevation, but a search of the fan, and its housing, both internally and externally, found the vent to be sealed internally, and therefore there was negligible bat roosting potential within the building, (refer to **figs 3, 4 and 5**, and **photo 10**).

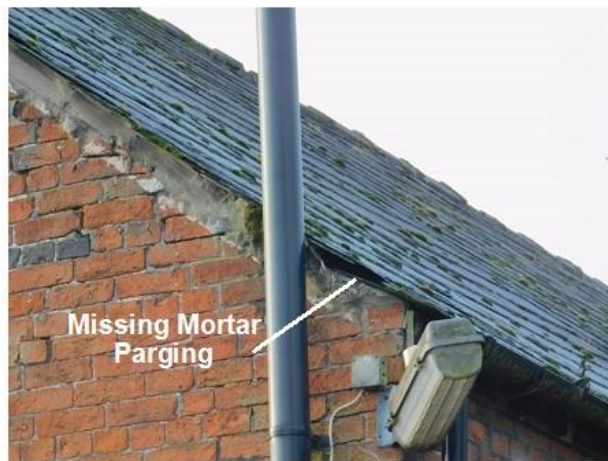
**PHOTO 14**  
**North-eastern Edge of Roof**

- At the upper, north-eastern corner of the eastern elevation, some of the mortar parging at the edge of the roof had become loose and fallen away, and the resulting holes were searched using close-focus binoculars, but neither bat droppings, any insect invertebrate remains or grease fur stains found, Nor was any bat urine staining signs found when the whole area was surveyed in the light produced by an ultraviolet flashlight, and therefore neither of these holes was thought to offer any bat roosting suitability, (refer to **figs 3, 4 and 5**, and **photos 14**).

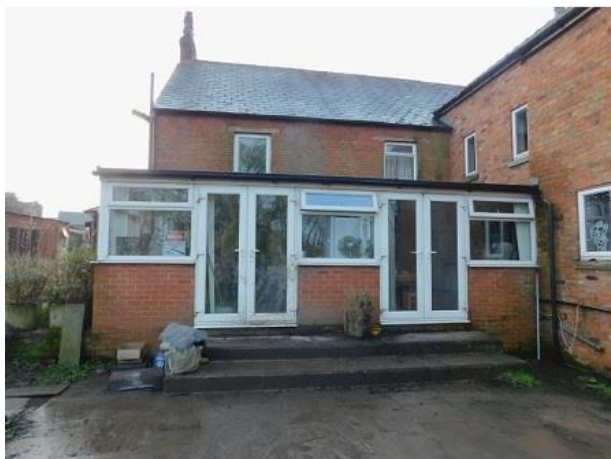
**PHOTO 17**  
**Northern Elevation of Extension**

All parts of the cottage and its extension were structurally sound, being in excellent condition, well sealed and maintained, and all of the windows, doors, gable, and the cladded wall. soffits and roofs, were also well maintained, with little sign of deterioration. A complete search of the all parts the complex found neither bat droppings, any invertebrate prey remains, nor was any fur grease or urine staining observed, and as all parts of the cottage complex were deemed to offer very few opportunities for roosting, the whole complex therefore was judged to be of low bat roost suitability, (refer to **figs 3, 4, and 5**, and **photos 1 to 20**).

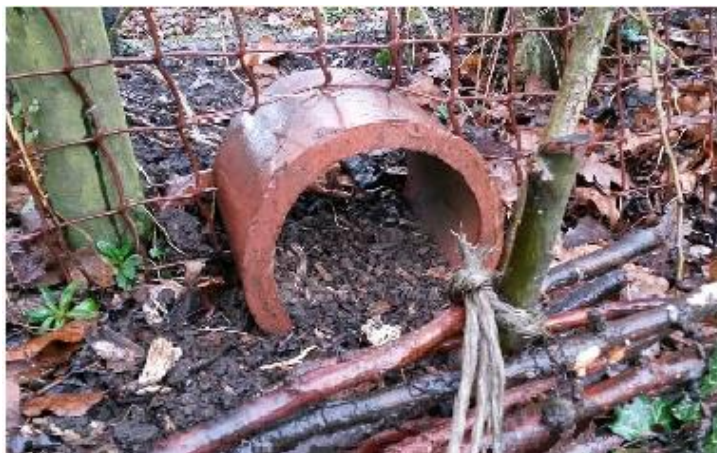
- Similarly, a 13cm diameter drain pipe would suffice through vertical fencing
