Phase I Geoenvironmental Site Assessment
Bolton Fold Farm, Preston Road

Reference: 16-817-R1-1
Date: December 2023

PHASE I GEOENVIRONMENTAL SITE ASSESSMENT

Bolton Fold Farm,
Preston Road,
Preston,
United Kingdom
PR3 3BN

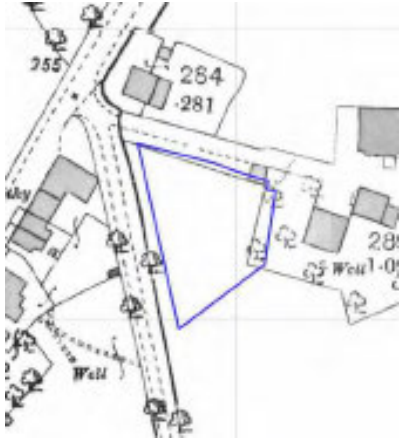
MAP EDITION	HISTORICAL LAND USE	HISTORICAL MAP EXCERPT
<p>1846 to 1892 1:10,560</p>	<p>The site is recorded as undeveloped agricultural land.</p> <p>A series of trees line the field boundary in the north and south west of the site.</p>

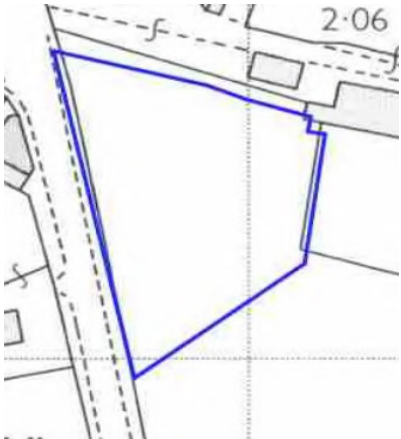
<p>1967 1:2,500</p>	<p>No significant changes recorded.</p>

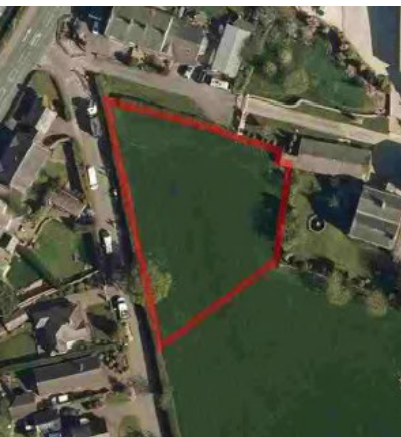
<p>2020 Satellite Imagery</p>	<p>No significant changes recorded and the site remains in this configuration.</p>

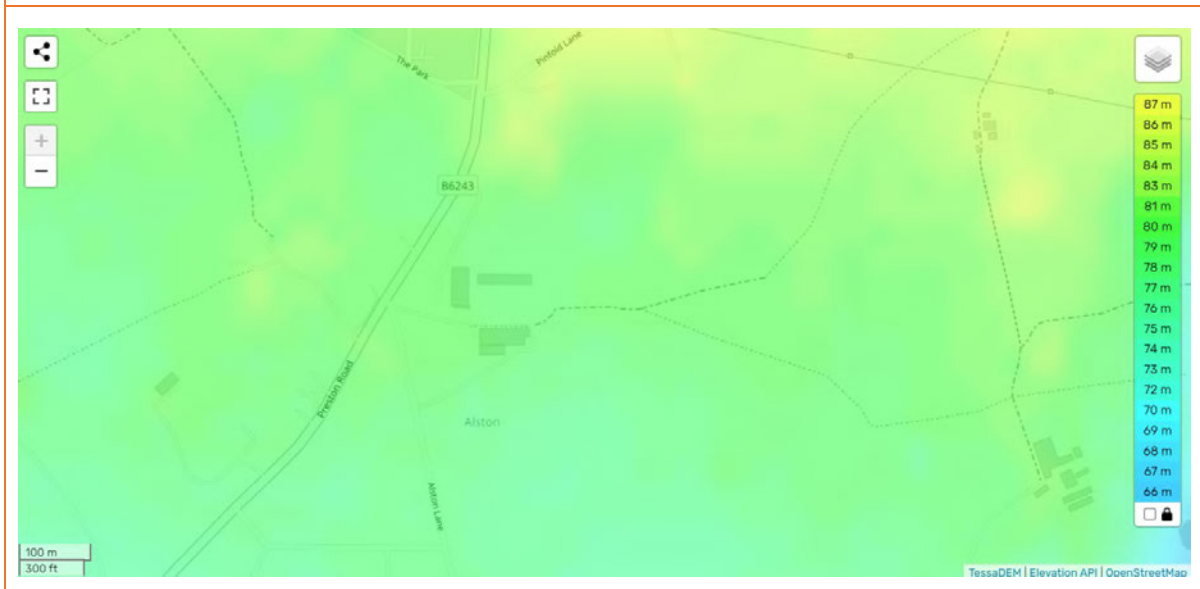
FIGURE 4.3 SURFACE LIDAR DATA (HTTPS://EN-GB.TOPOGRAPHIC-MAP.COM/)

Due to the largely undeveloped nature of site, it is considered the present-day geomorphology is representative of natural conditions.

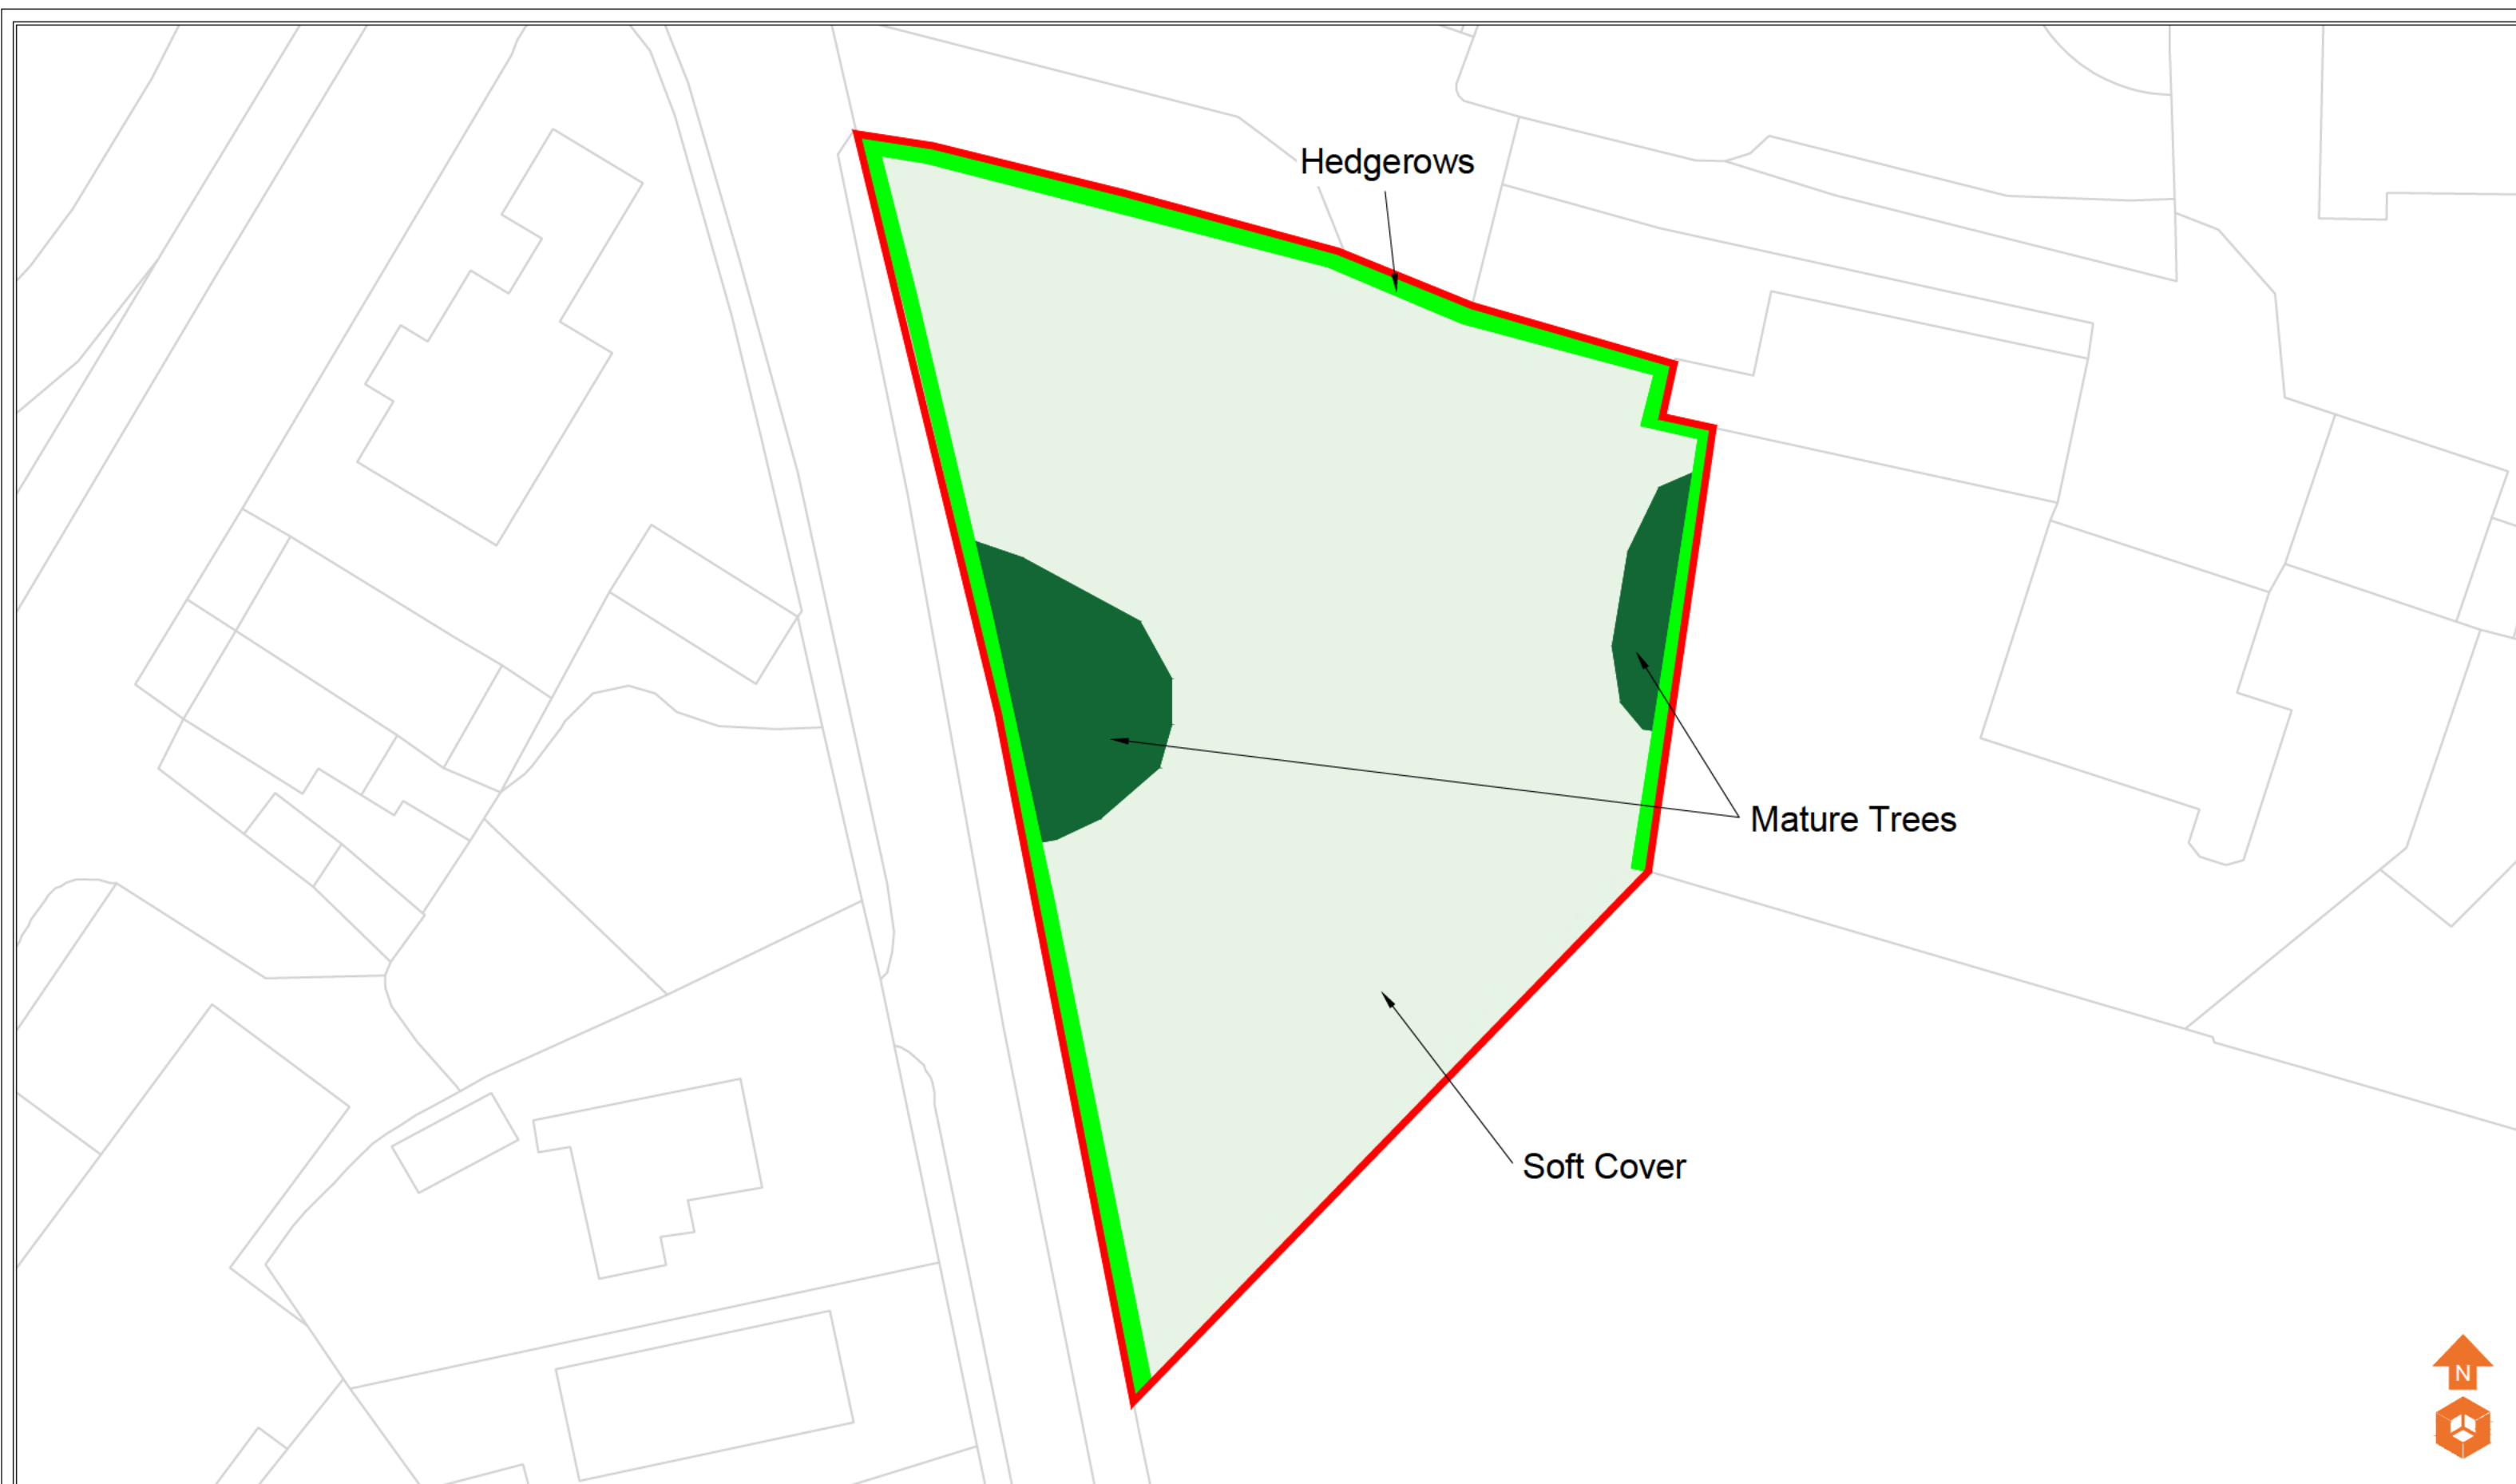
Drawing Title:
**Historical Features
Plan**

Historical Features

Field Boundary (Pre 1846 - Pre 1892)
