# **Preliminary Bat Roost Assessment Report**

**Outbuildings at Pewter House Farm,  
Carr Lane,  
Balderstone,  
BB2 7LN**

**13.11.2024**

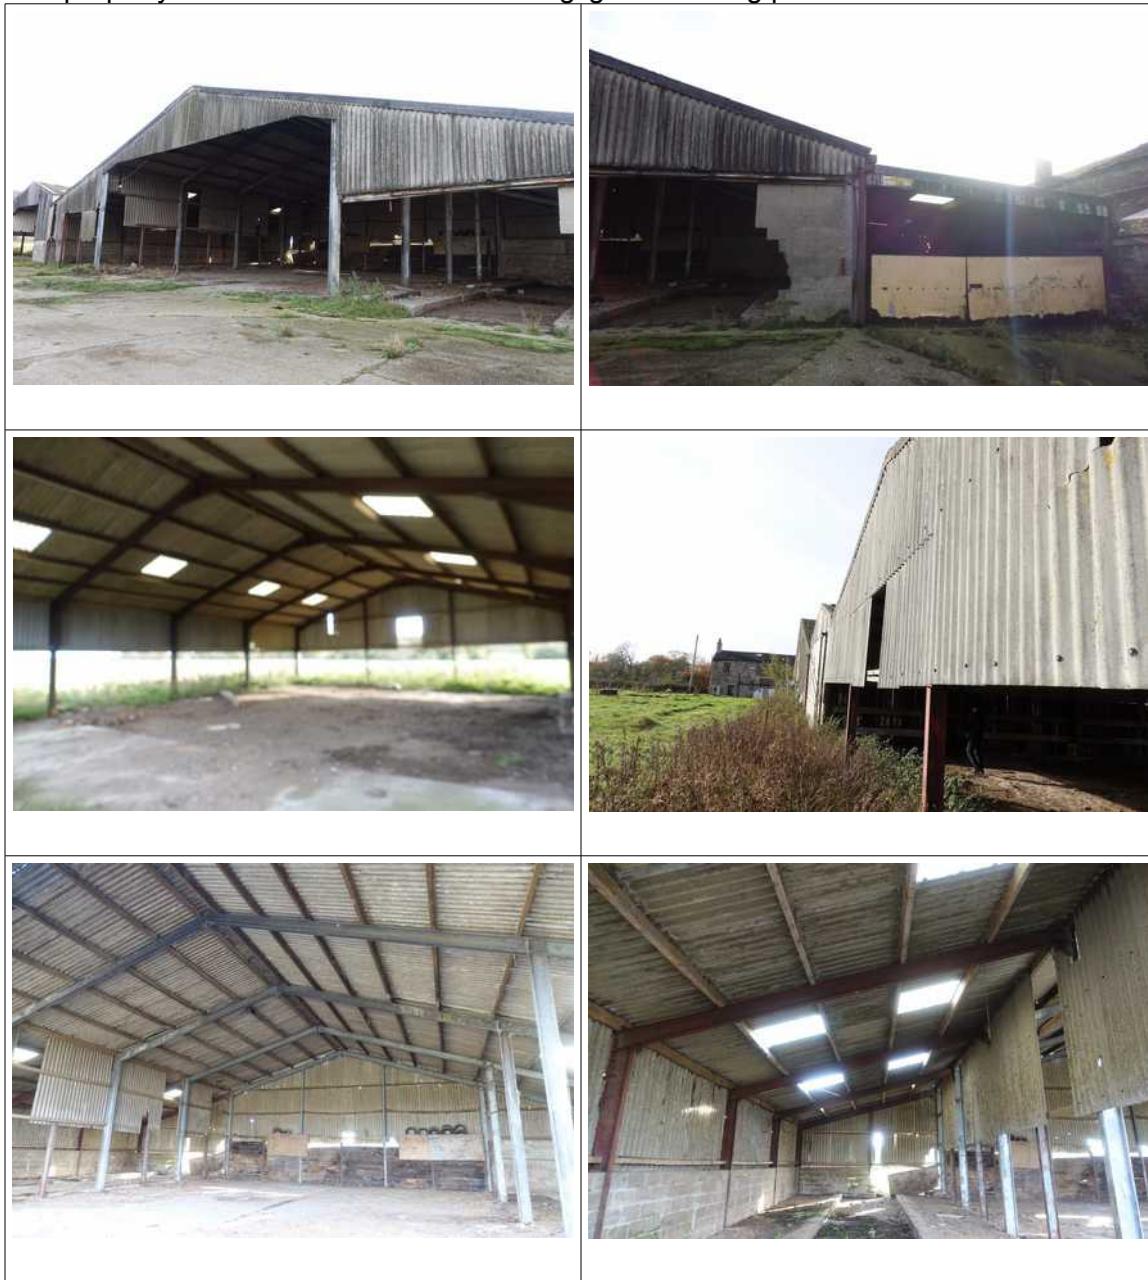
The property consists of a series of single skin steel portal style agricultural outbuildings with corrugated fibreboard roofs..

External block walls where present are generally well pointed with no obvious cracks, gaps or crevices. Corrugated fibreboard walls and roofs are unlined and the ridge is exposed to the interiors. The outbuildings are open with rooflights allowing considerable internal illumination.

The property can be considered to offer negligible roosting potential.
