# Bat Survey Report and Method Statement European Protected Species (Bats)

High Edge Farmhouse,  
Tinklers Lane,  
Slaidburn,  
BB7 4TP

12.02.2024

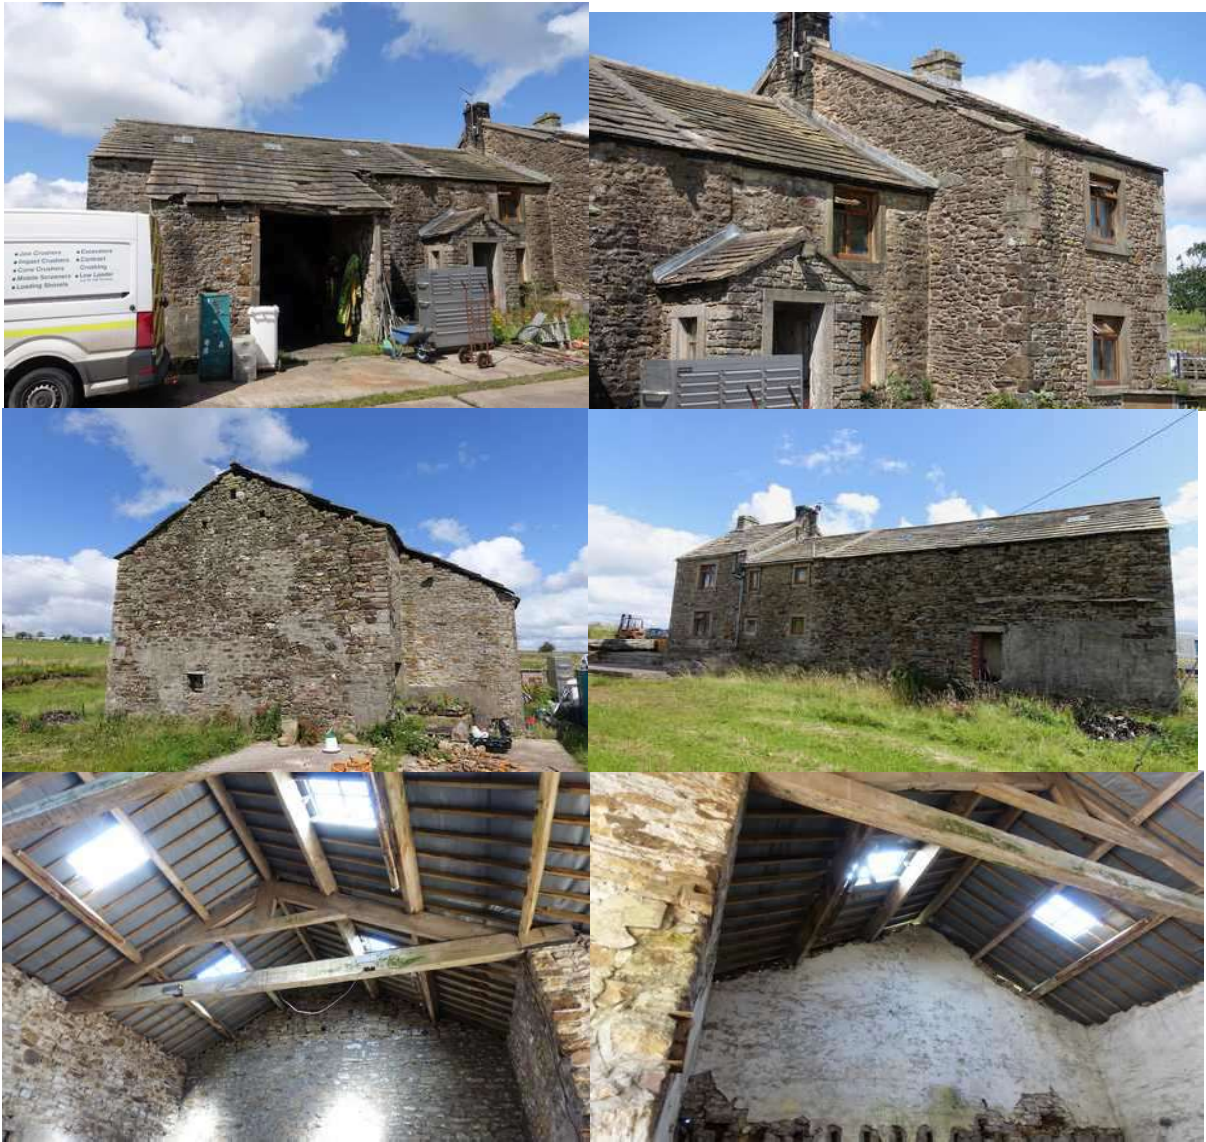
The property consists of a two storey stone built farmhouse and adjoining barn with a double pitched stone slate roof. A two storey porch is present to the frontage of the barn.

Gaps are present in external and internal walls and at wall tops. Lifted, slipped and missing roof slates are present, and gaps below ridge tiles were noted. A modern breathable membrane suggests recent re-roofing.

The building was assessed as offering low bat roosting potential when combined with surrounding habitat.
