# **Preliminary Bat Roost Assessment & Breeding Birds Survey Report**

## **Site: Barn at Cheethall Farm, Clitheroe BB7 3LH**

10<sup>th</sup> December 2024

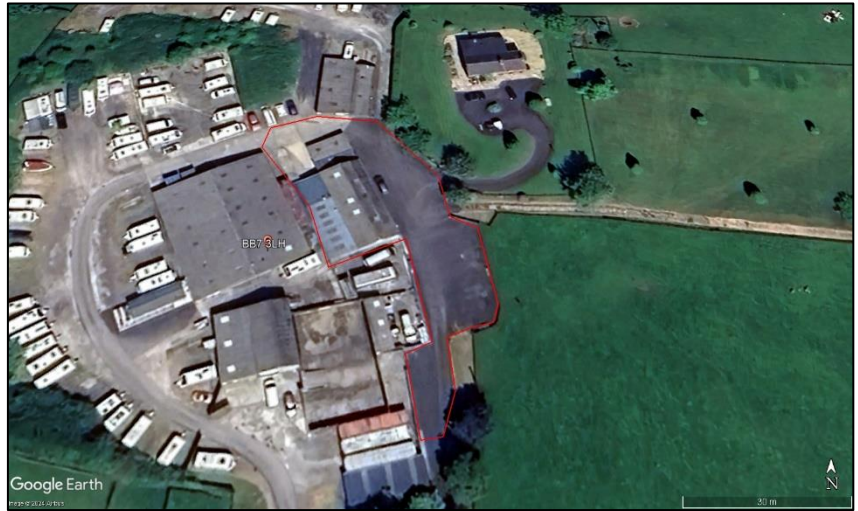
The survey building is a link-detached two-storey agricultural barn with small lean-to extension to the north.

Traditional stone and red brick-built solid walls with a corrugated sheet roof, without lining.

Photo 1: Overview of the site with the survey area outlined in red.

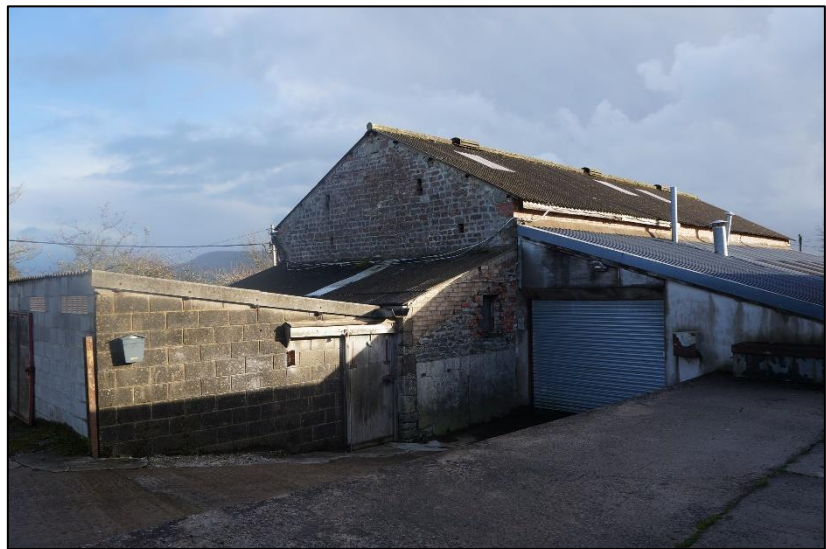
The fascia boards on the single-storey extensions have a gap to the wall, forming a crevice suitable for bats to use for day roosting.

The North gable end has gaps in the brickwork pointing which are also a potential bat roosting feature.

Photo 2: Northwest elevations of the barn, showing the area where the single storey extensions have been added.

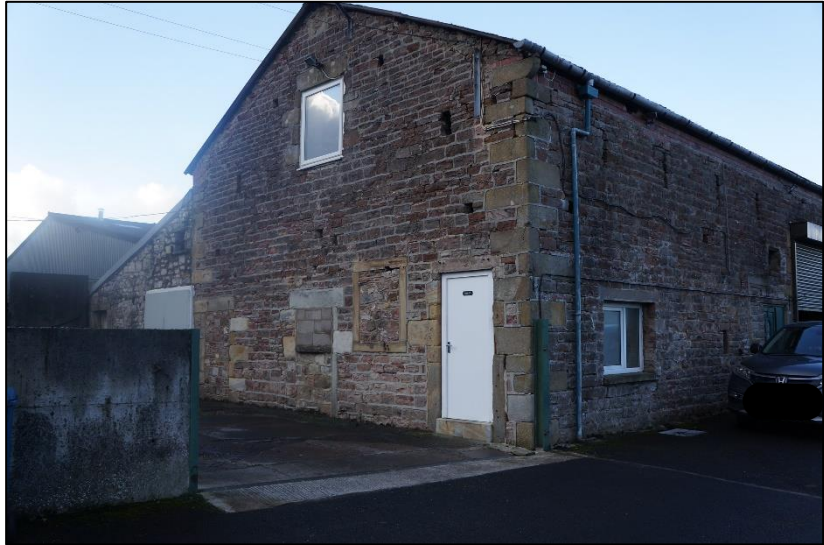
The southern gable end is well pointed, with well-fitting uPVC door and window frames. The eaves have also been pointed sealing this area well.

Photo 3: South & east elevations of the building, the gable end having less gaps and potential roosting features than other elevations.

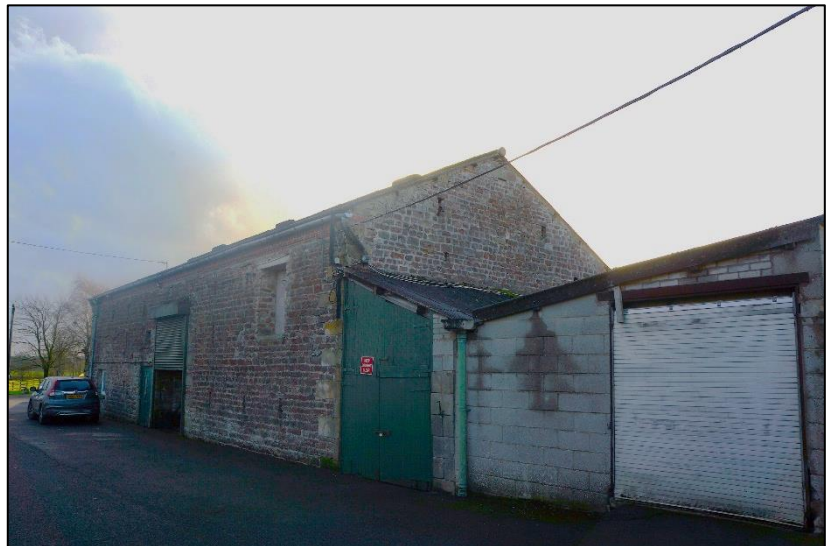
The front (east) elevation of the building had an open roller shutter door, with a timber door and further roller shutter to the single-storey extensions. All doors had gaps that both birds and bats could use to enter the buildings, with a gap behind roofline materials, brickwork and also in the lintel of a bricked-up window.

Photo 4: East elevation of the barn and single story extensions.

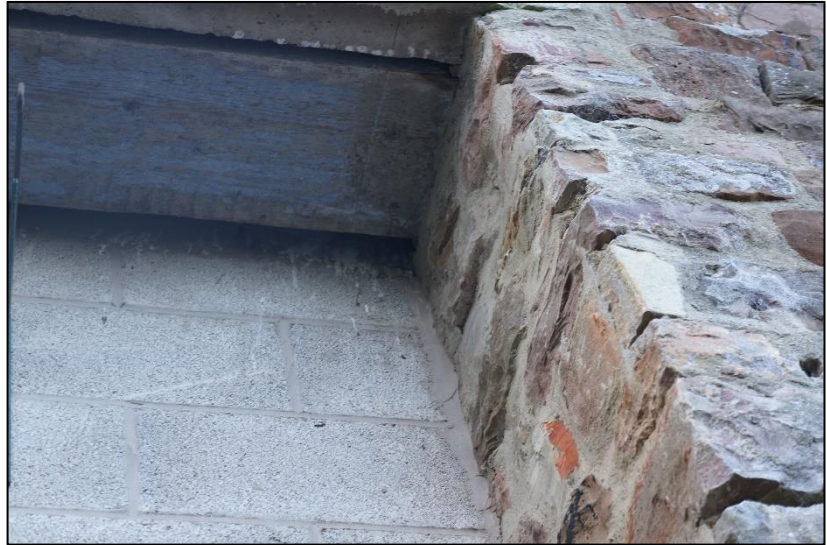
There were bird droppings (likely swallow) on the face of the blocks in the first-floor window, suggesting the wooden beam has been used for nesting above. The smaller gap forms the type of feature known to be used by crevice dwelling bats.

Photo 4: Close up of gaps in lintel and blockwork on the east elevation of the barn showing evidence of birds nesting above the wood lintel, and the smaller gap suitable for bats to roost..

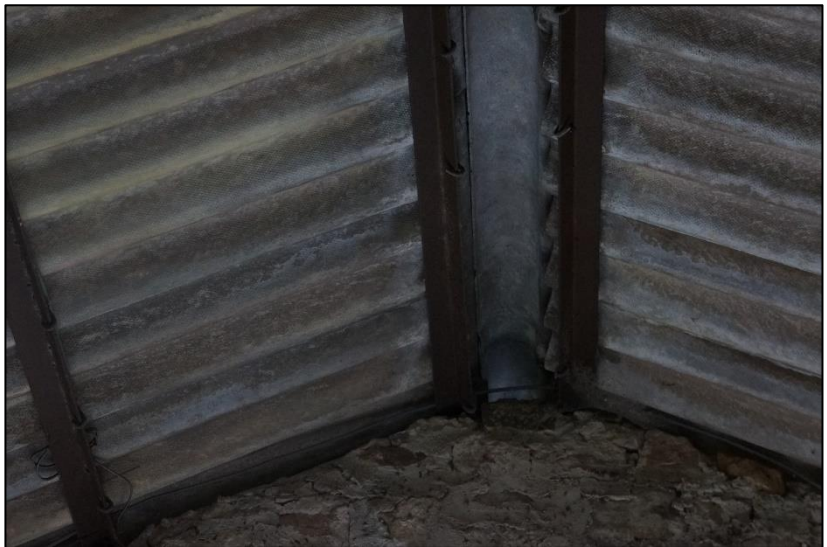
The roof was not lined or underdrawn, with the underside of the roofing sheets visible. There were gaps to the exterior visible at the ridge top on the gable ends, and ventilation slits in the original walls of the building.

Photo 5: Example of the roof materials.

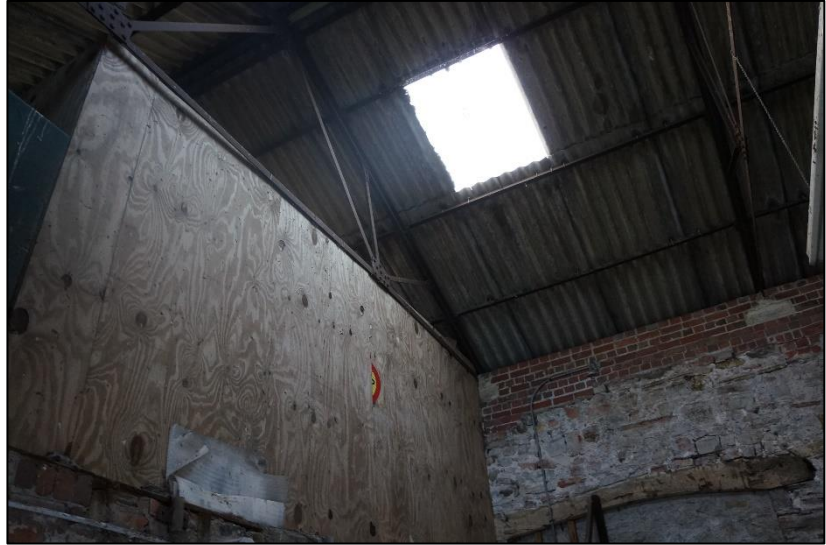
Although there was access to the interior of the building, there were only suitable roosting spaces on the wall tops, the framework of the roof being steel.

The barn was also light and airy with the gaps to the exterior and the roof lights, making it less suitable for void dwelling bats.

Photo 6: Example of the new roof materials.

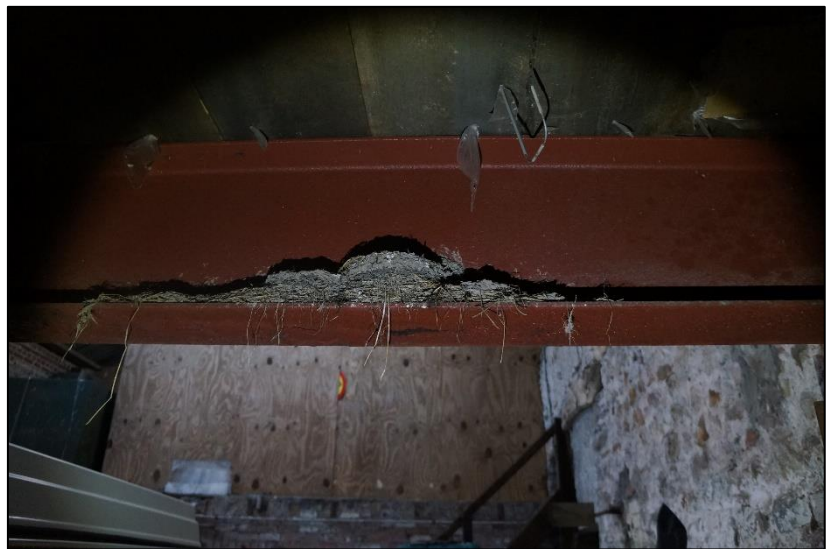
There were 4 visible historic nesting places within the main barn itself, and evidence that the wall tops had been used in places.

Photo 7: Swallow nests on the girder supporting the mezzanine in the main barn.

| <p><b>Recommendations</b></p> | <p>Barn Owl surveys will be required (before any work is carried out) by a suitably experienced &amp; licenced ecologist to quantify how the barn owl(s) are using the barn, to inform a mitigation and enhancement plan.</p> <p>Any building clearance or removal should be undertaken outside the period 1st March to 31st August. If this timeframe cannot be avoided, a close inspection of the building to be removed should be undertaken by a suitably qualified ecologist, immediately prior to clearance. All active nests will need to be retained until the young have fledged. Clearing the Site outside this timeframe avoids delays and further costs.</p> |

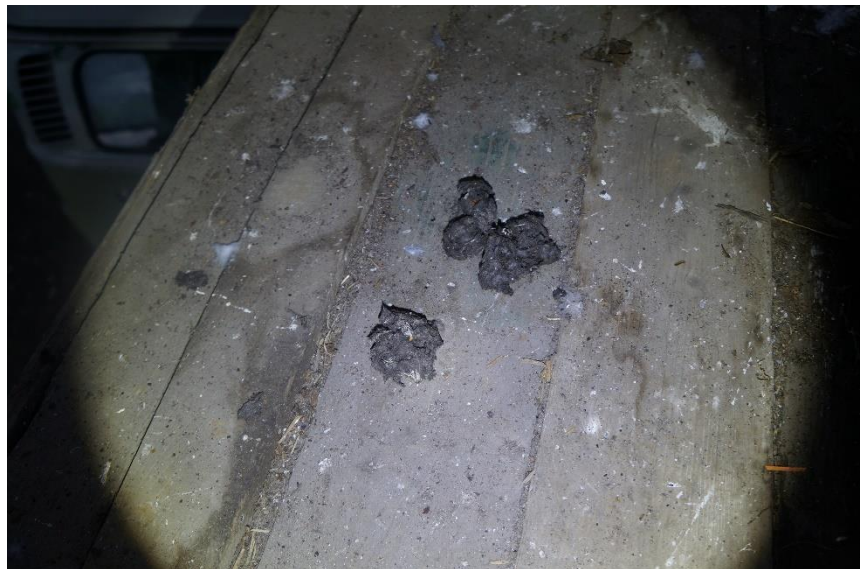
There was evidence of use by a barn owl as a feeding perch, with 20+ pellets (some fresh) on both the ground floor and the upper mezzanine, with urine platter on the walls under one of the ventilation holes in the north gable end, and on the walls close to the pellets.

Photo 8: Barn owl pellets on the upper mezzanine.
