Bat Survey Report and Method Statement European Protected Species (Bats)

**Little Daub Hall,
Parsonage Lane,
Chipping,
PR3 2GJ**

03.12.2024

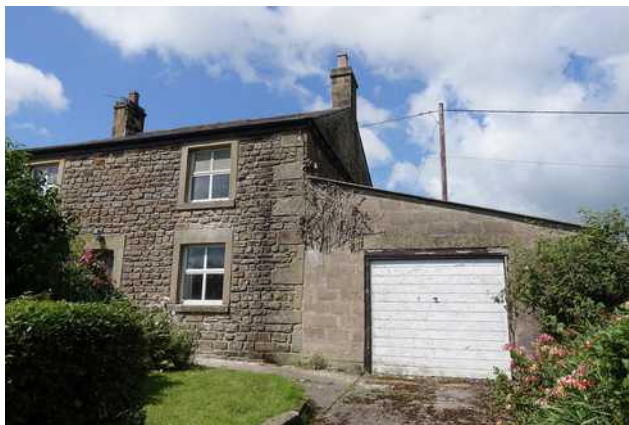
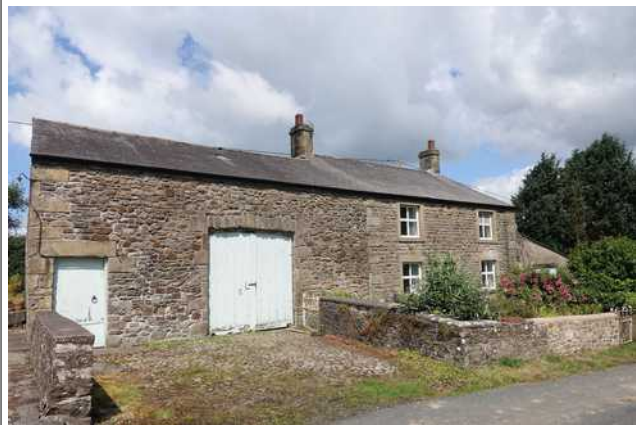
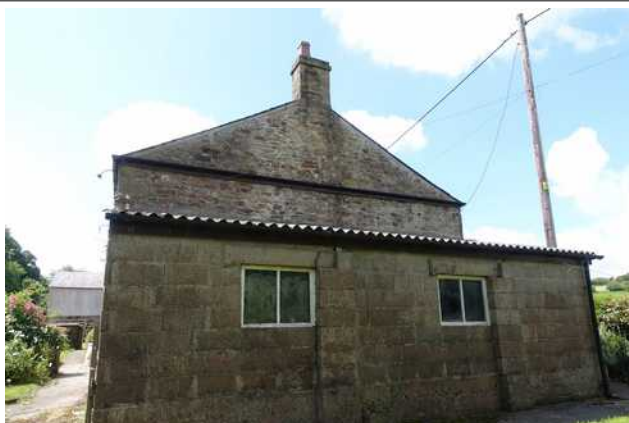
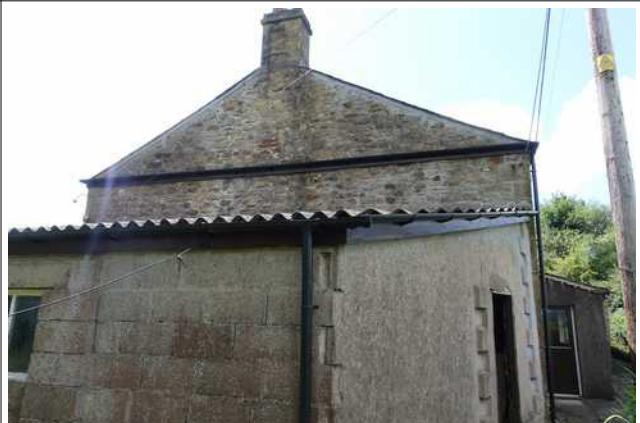
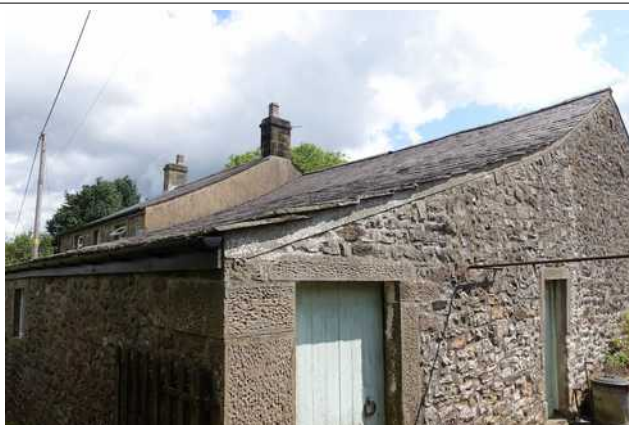
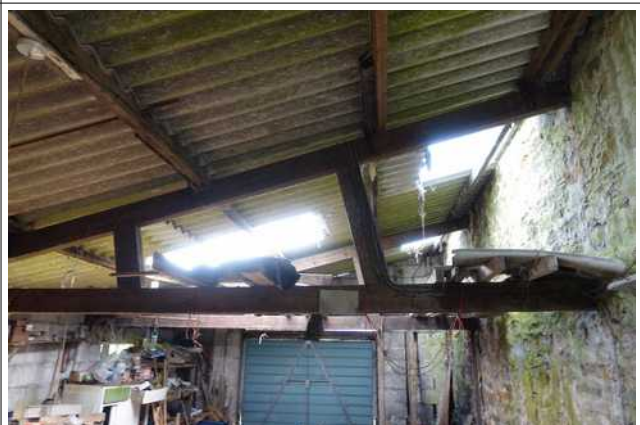
The property consists of two storey stone built house with adjoining barn with double pitched slate roof. The building has a single storey single pitched garage present on the northern gable.

Exterior walls are generally pointed with no cracks, gaps or crevices present. The gable end is pointed and sealed. Gaps were noted behind fascia boarding on the house and garage. Roof slates are generally close fitting with no lifted, missing or slipped slates present. The garage roof is single skin and unlined to the interior.

The building was assessed as offering low bat roost potential.

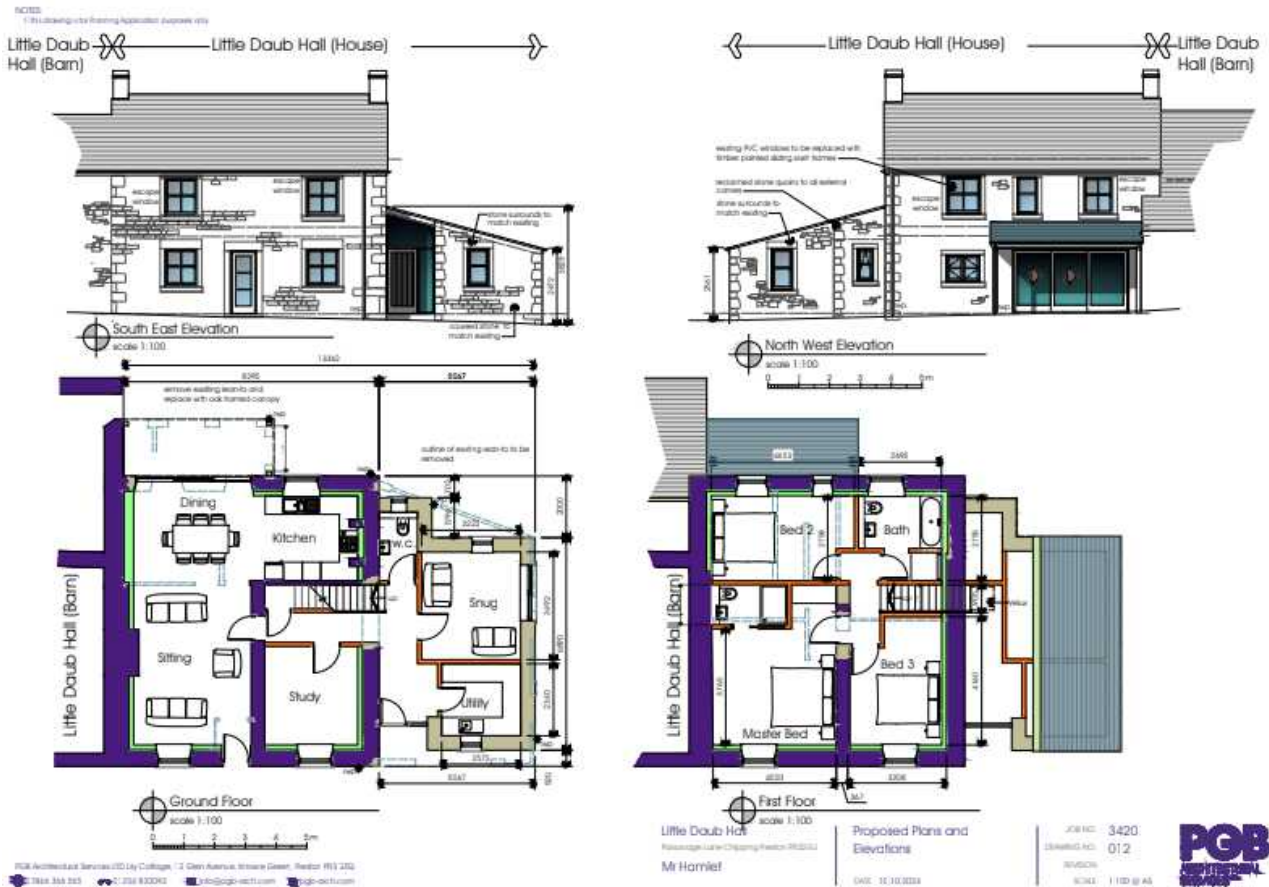
Proposed Works.

Proposed works consist of a residential development including conversion of the existing garage.
