Zhejiang LINYAN

TEST Report

Solar Keymark – Solar collector – LY-HPC10 and LY-HPC30

171031198GZU-001

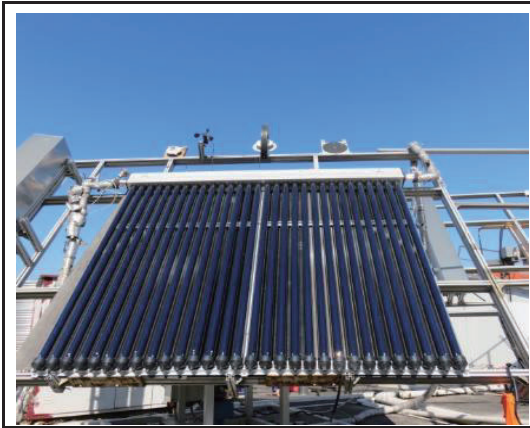
Performance Test

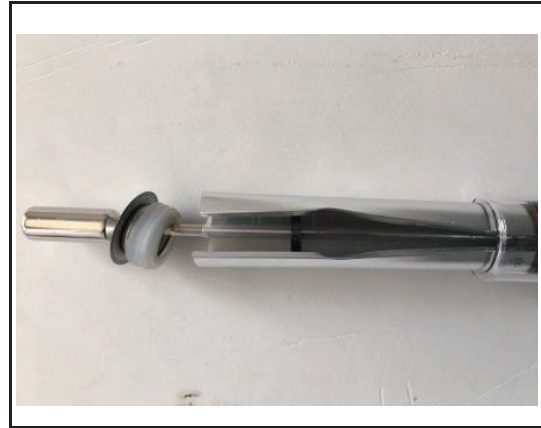
Heat Pipe

External diameter of pipe:	8	mm
External diameter of condenser:	24	mm

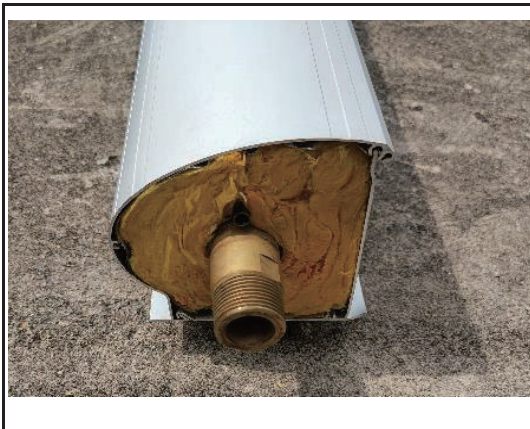
Hander

Material:	Heat pipe and fin	
Fin Length:	1740	mm
Fin thickness:	0.25	mm
Solar absorptance α :	92%(MS)	
Hemispherical emittance ϵ :	7%(MS)	
Surface treatment:	SS-AlNx/Cu	
Bond between riser and fin/plate (e.g. mechanical, solder, weld-ultrasonic, laser):	mechanical	
Number of risers:	10;30	
Riser diameter or dimensions:	8	mm
Distance between risers:	75	mm
Dimensions (Length, Width):	1720mm*10*47mm; 1720mm*30*47mm	
Header diameter or dimensions:	38	mm
Header material:	Copper	
Flow pattern:	Parallel

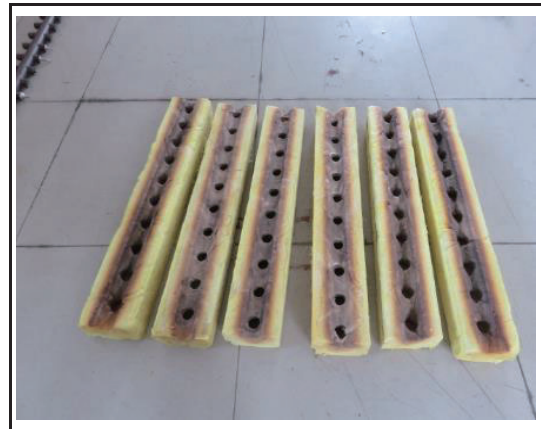
Insulation

Insulation material and thickness (Back):	Glass wool 50	mm
Insulation material and thickness (Side):	Glass wool 60	mm
Collector Enclosure- Seal Compound	Silicon rubber	
Collector Enclosure- Predominant Hardware	Aluminum alloy

Conclusion: Except for the insulation has a little color changed, No major failure appears after test acc. to EN12975-1:2006 + A1:2010, clause 5.3.1.and ISO 9806:2013 Clause 18.
