1 Cockleach Cottage, Chipping Road,
Longridge,

PRELIMINARY BAT ROOST ASSESSMENT

AUGUST 22, 2024

project ecology

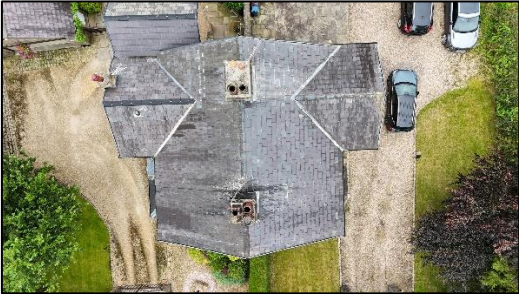
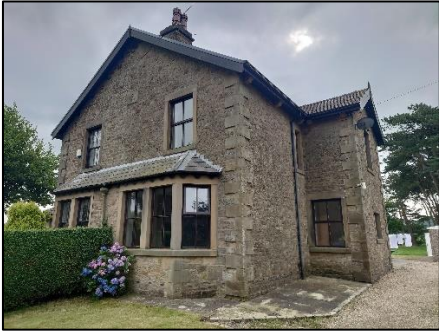
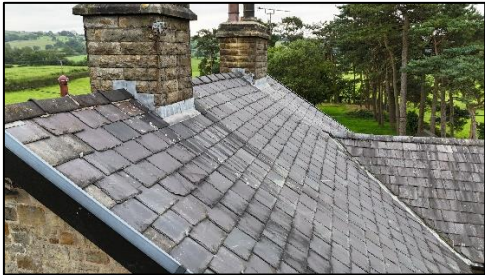
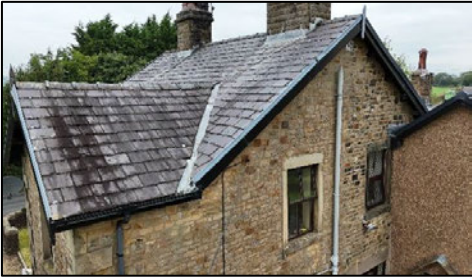
Table 1. Survey Results			
Building Reference	Description	Photographs	Bat Roost Potential Suitability
Dwelling	<p>A stone-built, two-storey, semi-detached dwelling with a pitched and hipped roof. Masonry and associated mortar in good condition with no cracks, flaking, missing or damaged sections.</p> <p>The slate roof tiles are in good condition and sitting flush to one another, with no slipped or damaged tiles.</p> <p>The ridge tiles are also in good condition, free from damage. Small sections of mortar are missing. However, do not provide any entry points or potential roost features bats may exploit.</p> <p>The masonry, mortar and lead flashings associated with the chimney stack are all in reasonable condition with no entry points or roosting habitat present.</p> <p>The roof edges are finished with timber fascia boards and soffits in places. These are in reasonable condition, with minor aesthetic degradation present only and are scribed flush with the stone masonry, with no gaps present.</p> <p>The windows and door frames are sealed to the surrounding masonry with sealant.</p>

Negligible

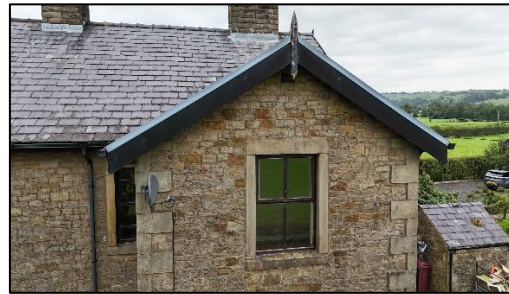
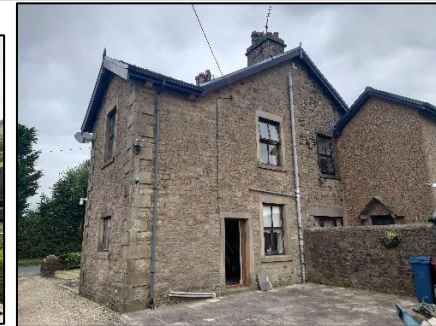
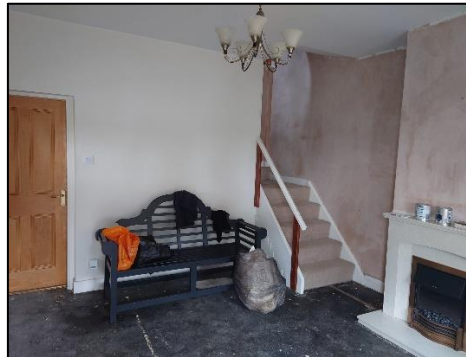
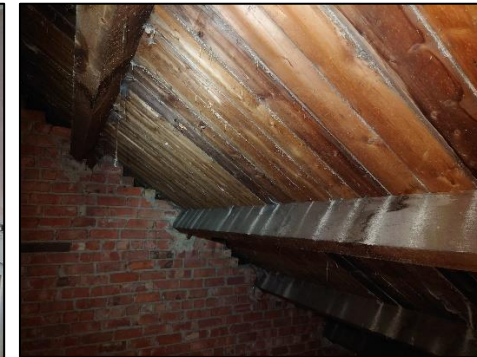
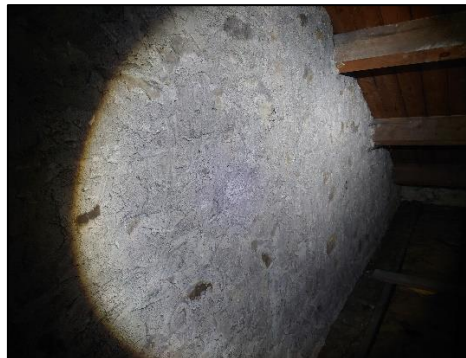
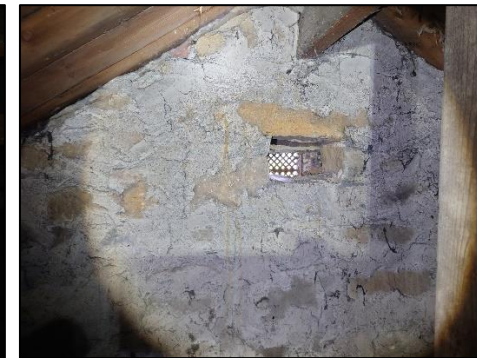
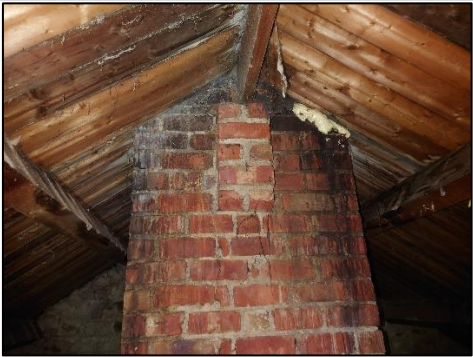
Internally, the first and ground-floor areas are currently undertaking renovation works. However, no roosting features or entry points to onward cavities are present.

The roof void space was easily accessed via a hatch and ladder. The underside of the roof is clad with timber sarking boards throughout. The boards are in good condition, fit flush to one-another with no gaps or missing sections.

The roof timbers are free from cracks and crevices.

The roof void is cobwebbed and dusty, and appears to be sealed, with no daylight or entry points located.

The gable walls are finished with lime render. The render is in good condition, free from cracks and flaking.

A vent is located on the upper section of the southwestern facing gable, where the works are proposed. This is covered with a metal grate, preventing entry by birds or bats.

The brick-built chimney stacks are in good condition, as is the associated mortar. The sarking boards are fit flush around the stacks and in places, sealed with expanding foam.

No access points or evidence of bats was found during the internal or external surveys.

- 6.1.1 As the dwelling is considered to offer negligible bat roost suitability, no further survey work or mitigation is required at this time.
- 6.1.2 This report is valid for 18 months, at which point a suitably qualified ecologist will assess the validity of the report, with an updated assessment likely to be required.

- 6.2.1 It is not always possible to prove absence of roosting bats. Due to the transitional nature of bats, they can roost in suitable features opportunistically and are not always identified during surveys. It is recommended that roof coverings are removed with due caution. Should a bat/bats be identified at any time, work should stop, and a suitably qualified ecologist contacted to attend site and advise how to proceed.

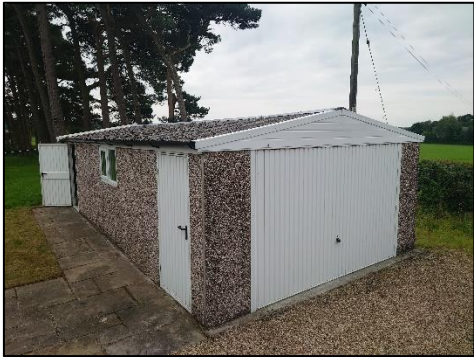
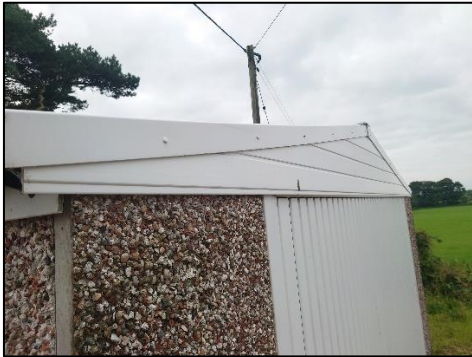
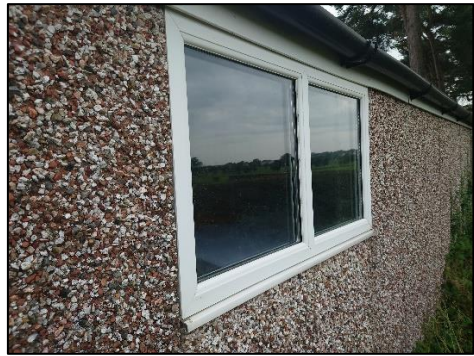
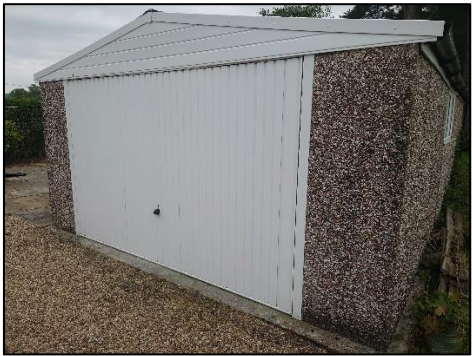
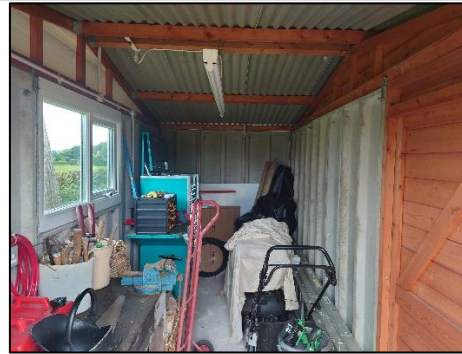
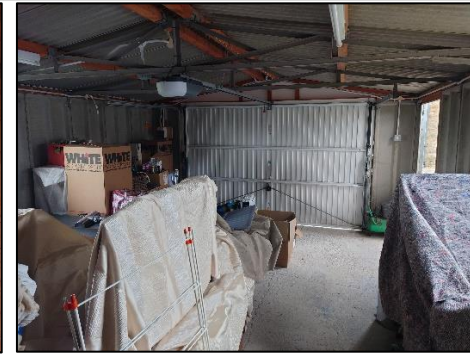
Detached
Garage

A single-storey, concrete, prefabricated garage, with a shallow pitched roof is located on site. This is to be demolished as part of the sites proposals.

The external walls are in good condition, fitted flush to one-another with no gaps or damaged sections.

The uPVC fascia boards and windows are fitted flush to the concrete panels with no entry points or cavities present.

The metal doors and large garage door to the front are also in good condition, and the associated frames are fitted flush to the concrete panels with no access point of roosting habitat present.

The pitched roof is covered with corrugated cement roof sheets. These are all present and free from damage and gaps.

Internally, the garage has two areas used for storage, and can be described together. The

spaces are open to the underside of the roof with no roof void spaces present.

The small roof timbers are in excellent condition, with no gaps or crevices present.

The internal space is cool and well-lit by the windows located on both sides of the garage.

The garage lacks suitable conditions and features associated with roosting bats. No evidence of bats was found during the external or internal survey, and it is considered the garage offers no roosting suitability for bats and is not considered further in this report.
