Bat Survey Report and Method Statement European Protected Species (Bats)

Reasonable Avoidance and Mitigation Measures

Laneside Barn,
Grindleton Road,
Grindleton,
BB7 4QN

31.05.2024

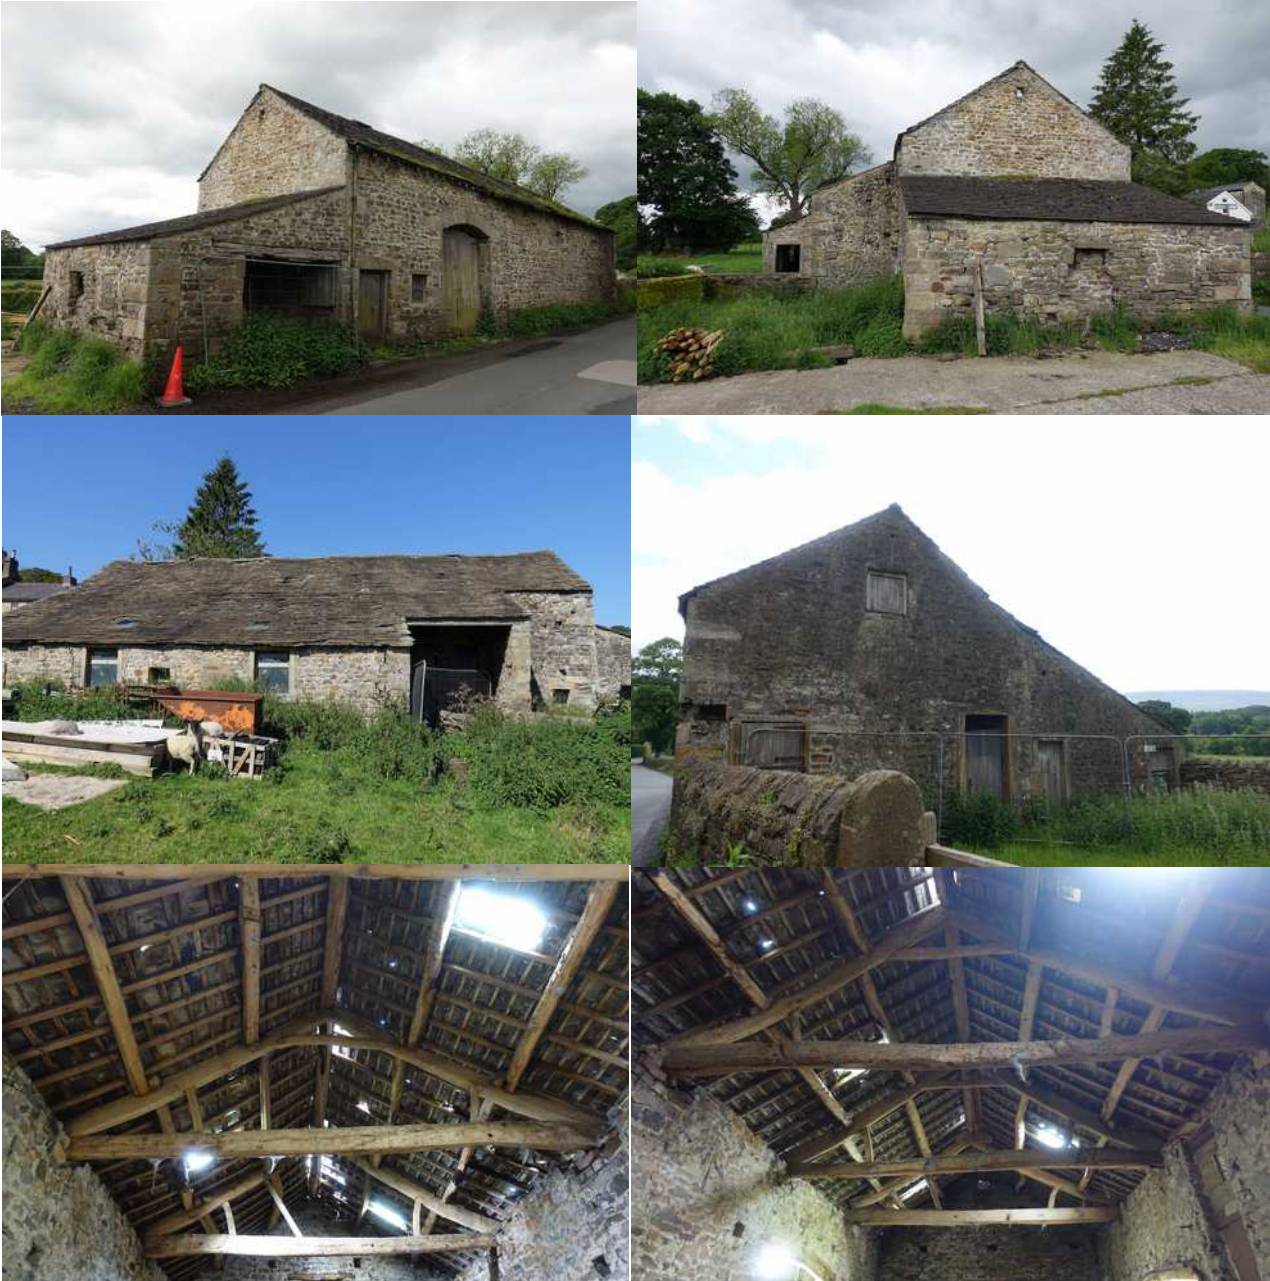
The property consists of a traditional stone built barn with double pitched slate roof.

Areas of missing or lifted slates are present on both sides of the double pitched roof, gaps are present below ridge tiles. Gaps were noted to have increased since previous surveys allowing considerable light and water penetration at the ridge.

Some crevices in external walls are present, however examination by endoscope suggested these were too shallow for use by bats.

No loft space is present, the roof is unlined. Beams and joists are hand cut.
