Barn near Lane Side Farm
Grindleton, Lancashire:
Historic Building Record

Barn near Lane Side Farm Grindleton, Lancashire: Historic Building Record

The barn standing to the south-east of Lane Side Farm, near Grindleton (NGR: SD 75682 45046) is primarily 18th century, but has two 19th century additions. The main part is a six-bay combination barn, with shippon for six cows, threshing bay, a large mew, and separate stable, while the two additions include a shippon for 12 cows and a smaller lean-to structure which appears originally to have been a cart store. The recording was carried out to support an application for prior approval for domestic conversion.

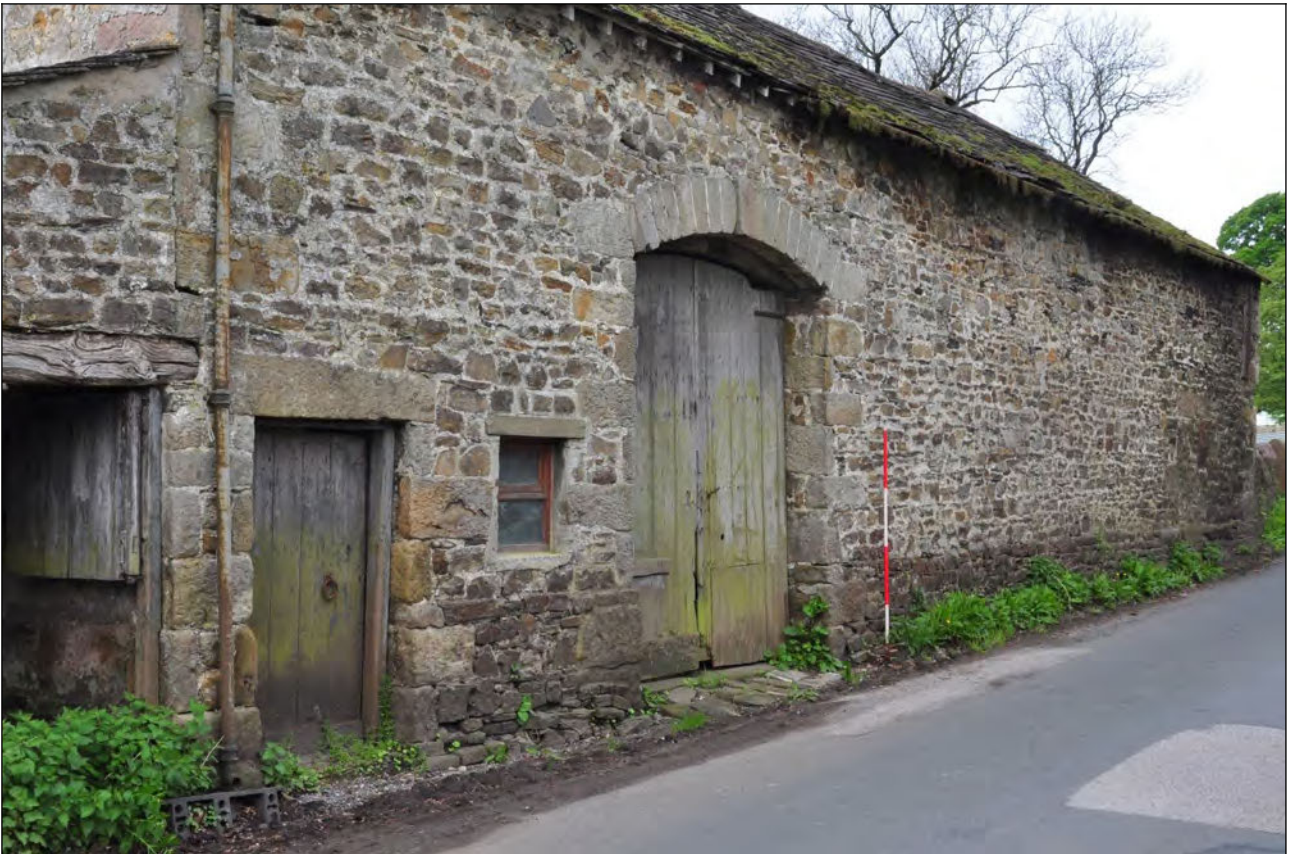
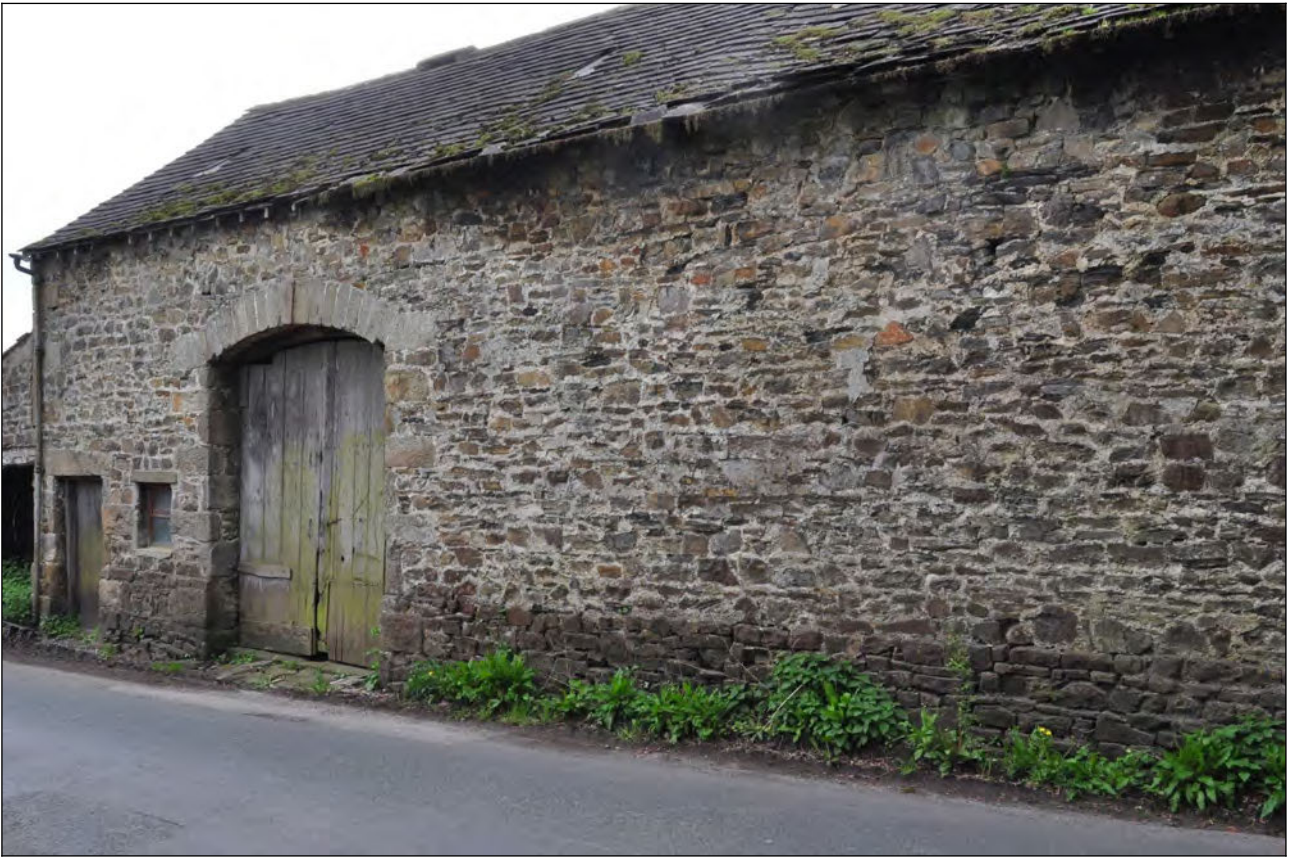
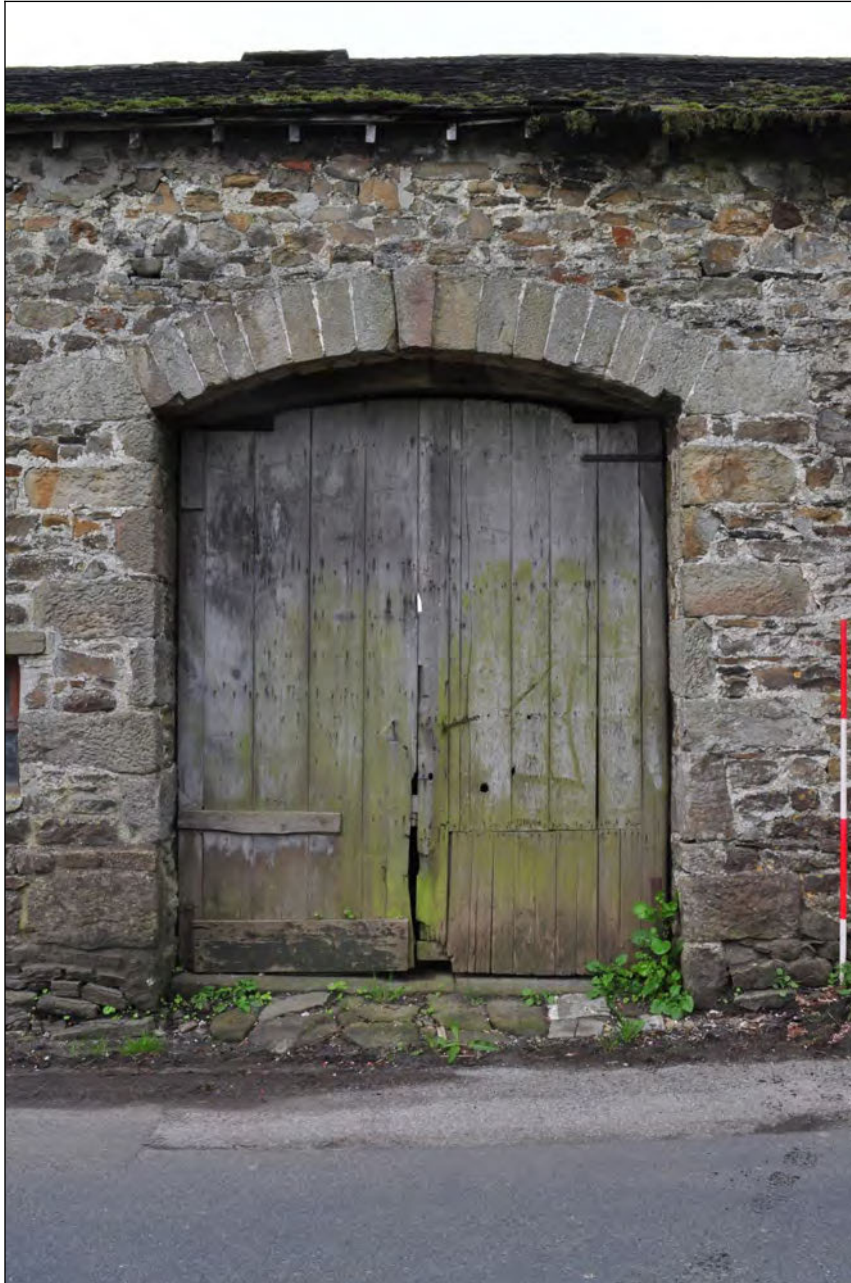
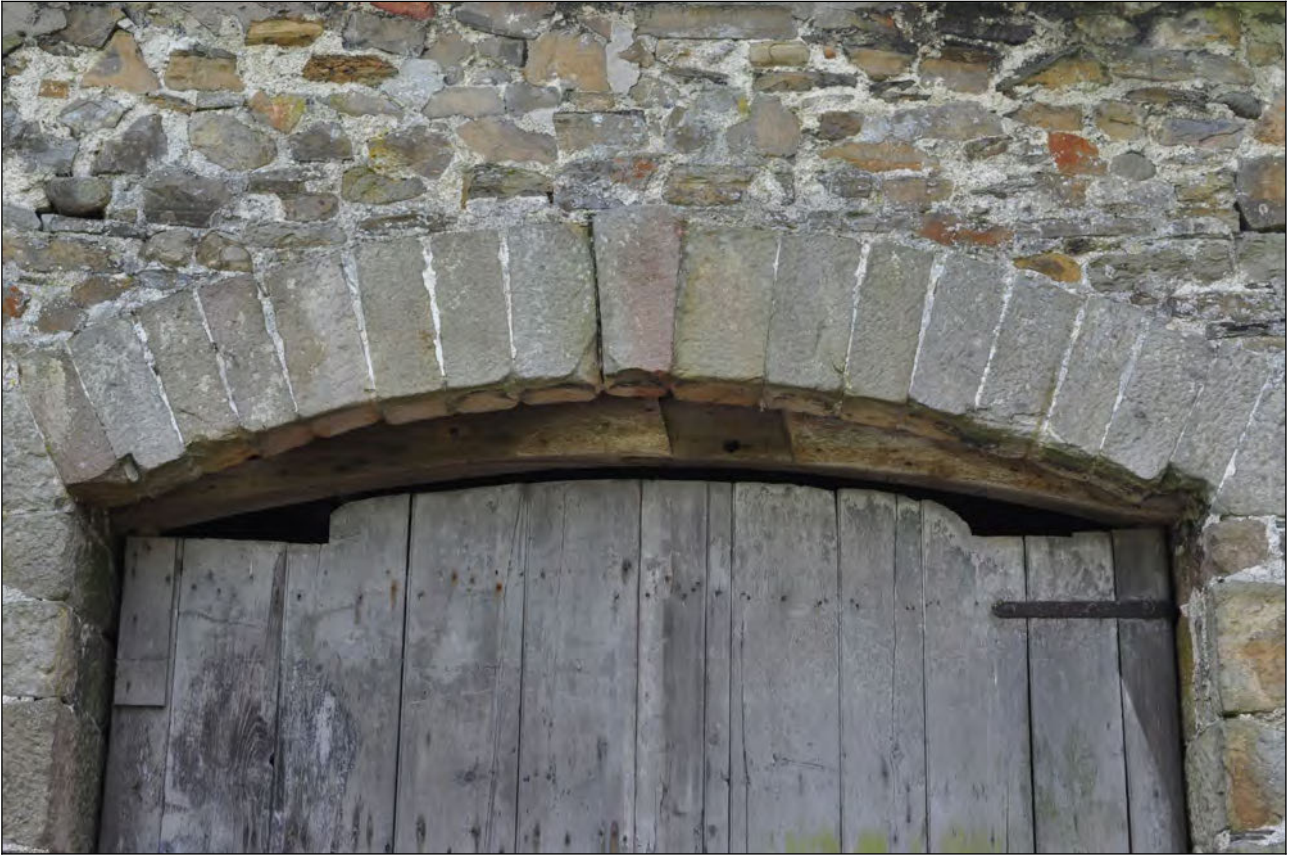
- 7.3 The north front of the main range faces directly onto the road and is very plain, with the cart entrance being the only visual focus; it has a segmental arch with keystone, part of a re-used cruck for an internal lintel, and much repaired, harr-hung doors (**4-7**). There are also two pedestrian doorways: the east one serves a shippon, and has a modern window opening next to it (**8**), while the right-hand one, which gave access to the western end unit, has been blocked up (**9**).

Photo 4: Main building: north elevation

Photo 5: Main building: north elevation

Photo 6: Main building: cart entrance, north elevation

Photo 7: Main building: arch over cart entrance, north elevation

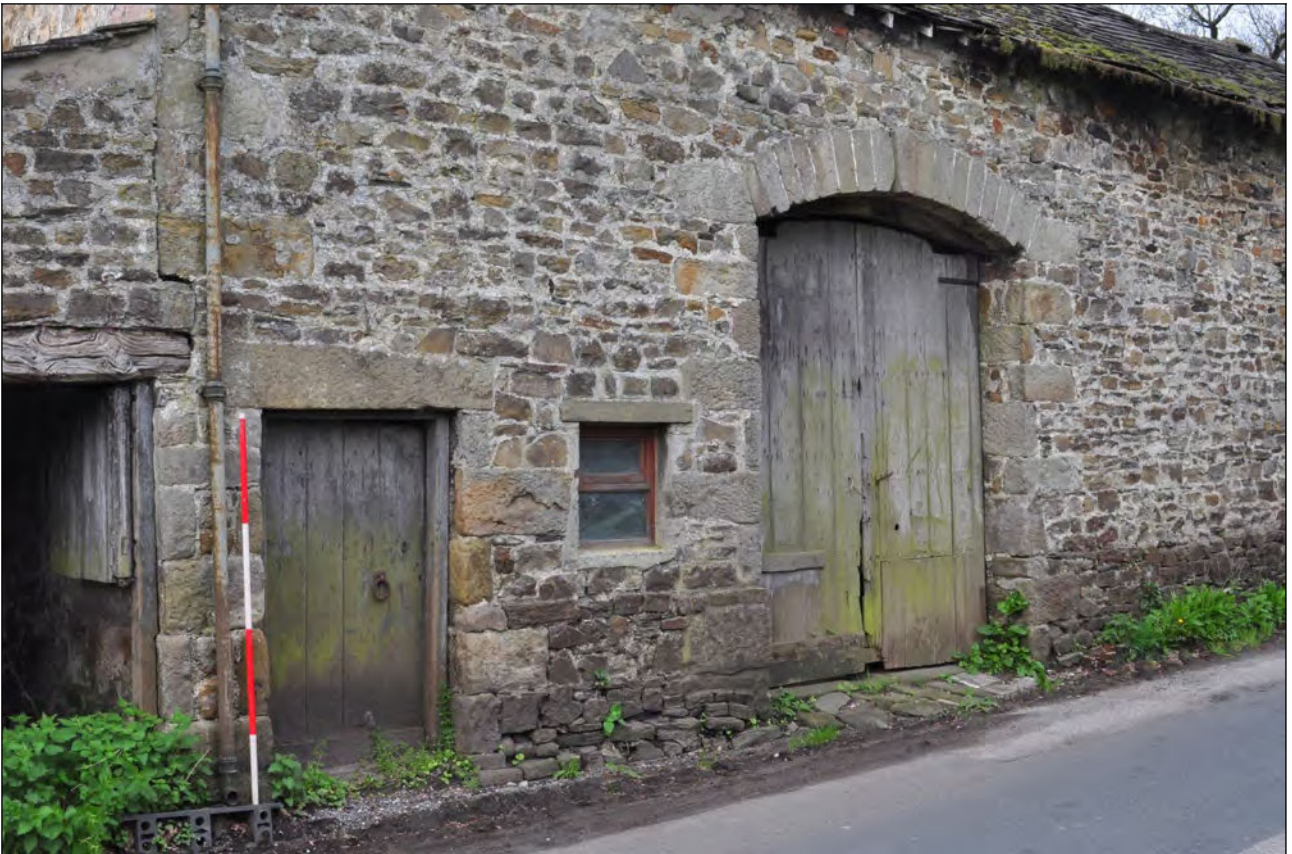
Photo 8: Main building: cart entrance and shippon doorway, north elevation

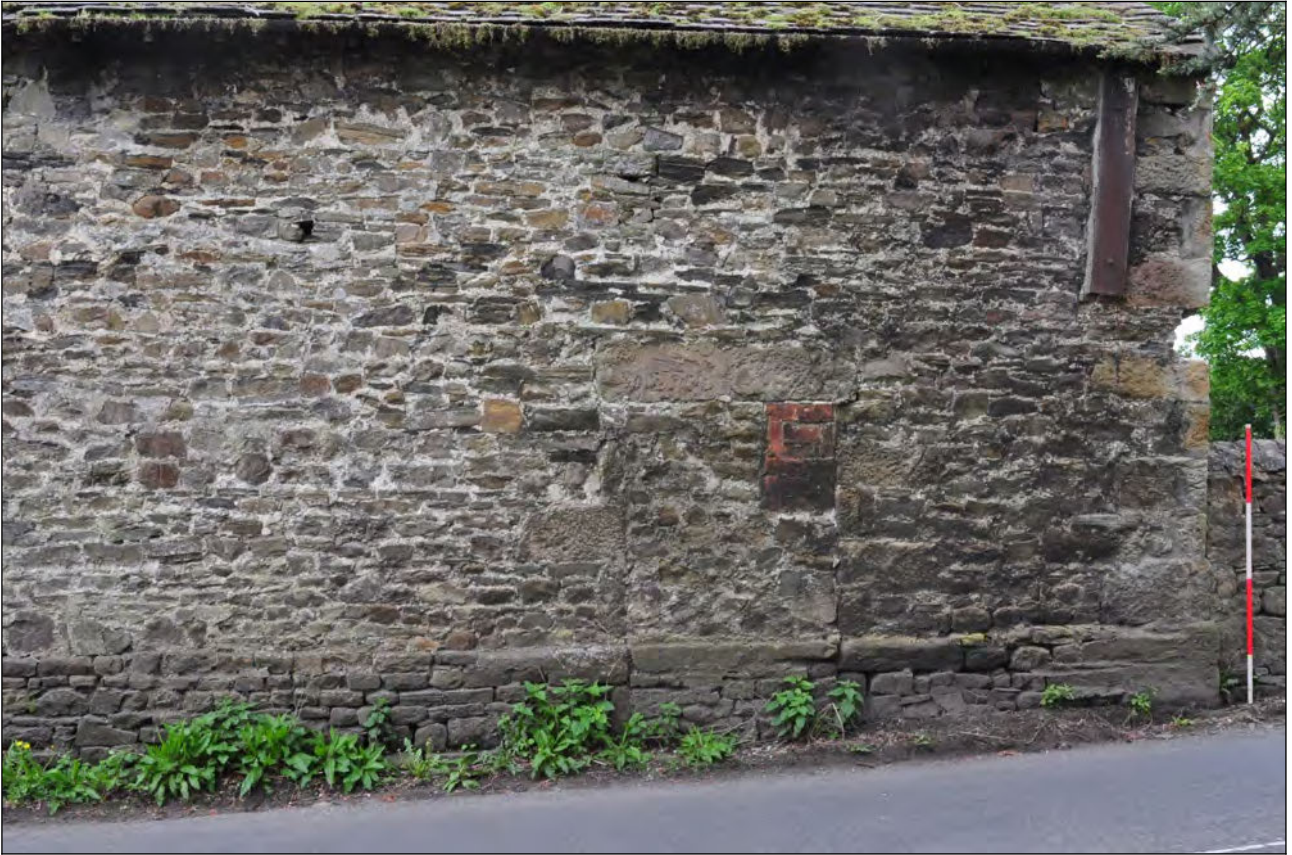
Photo 9: Main building: blocked doorway near west end of north elevation

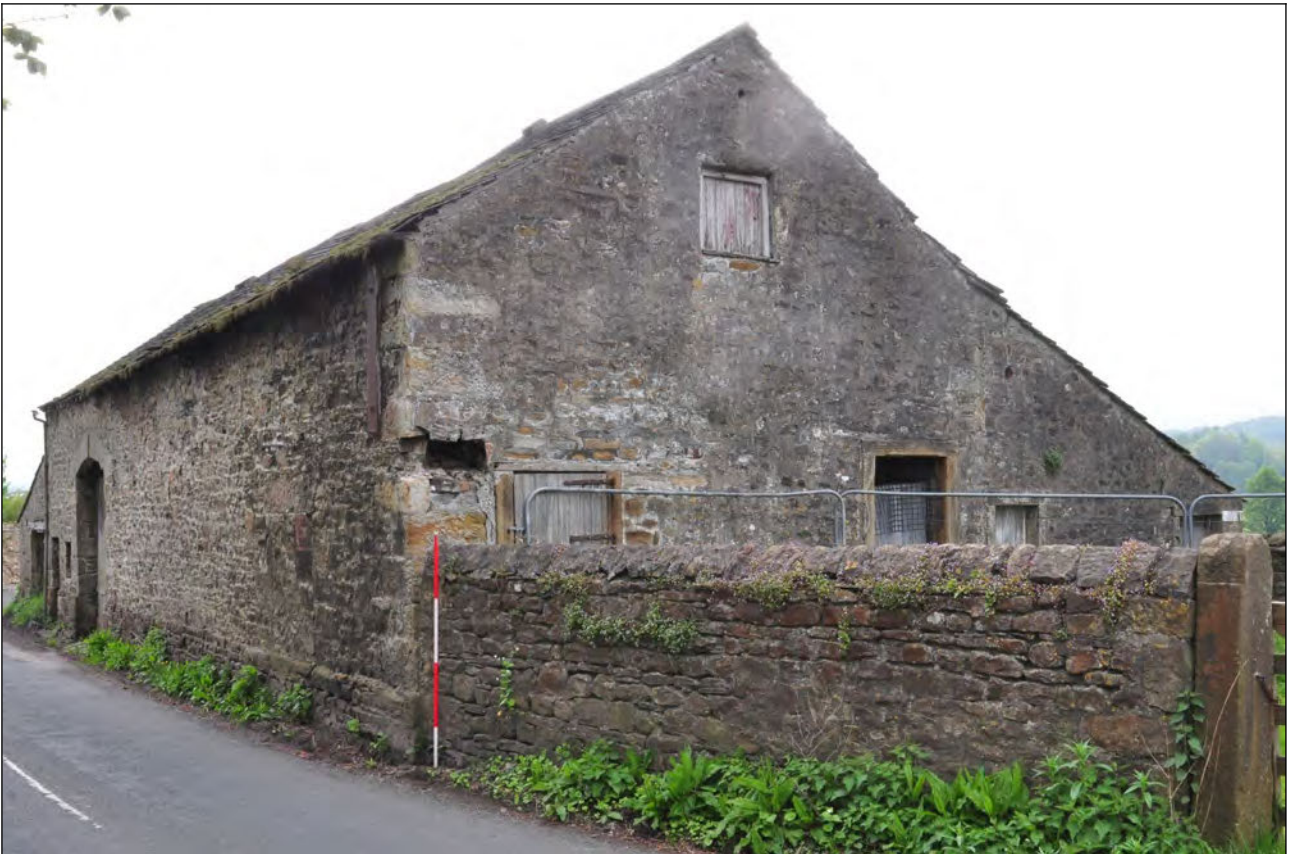
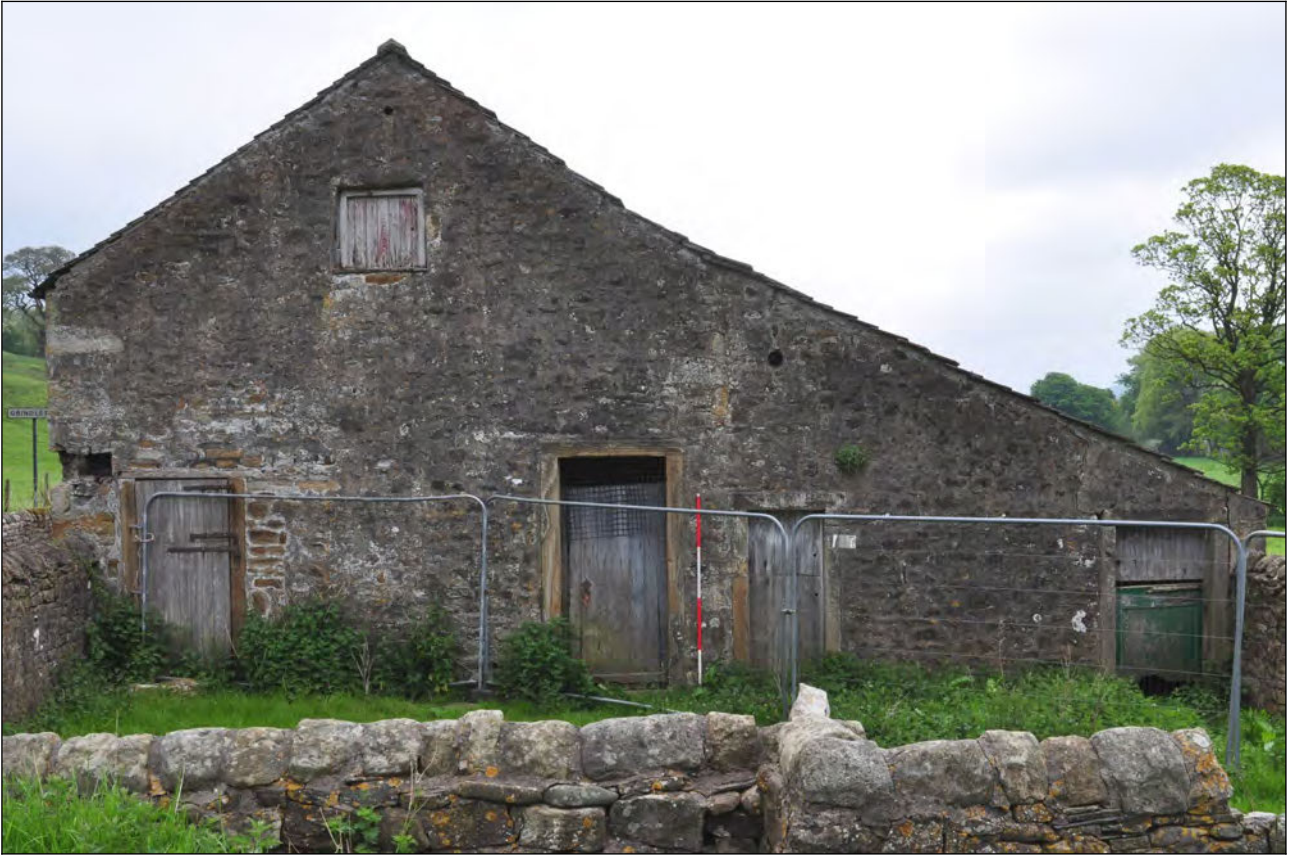
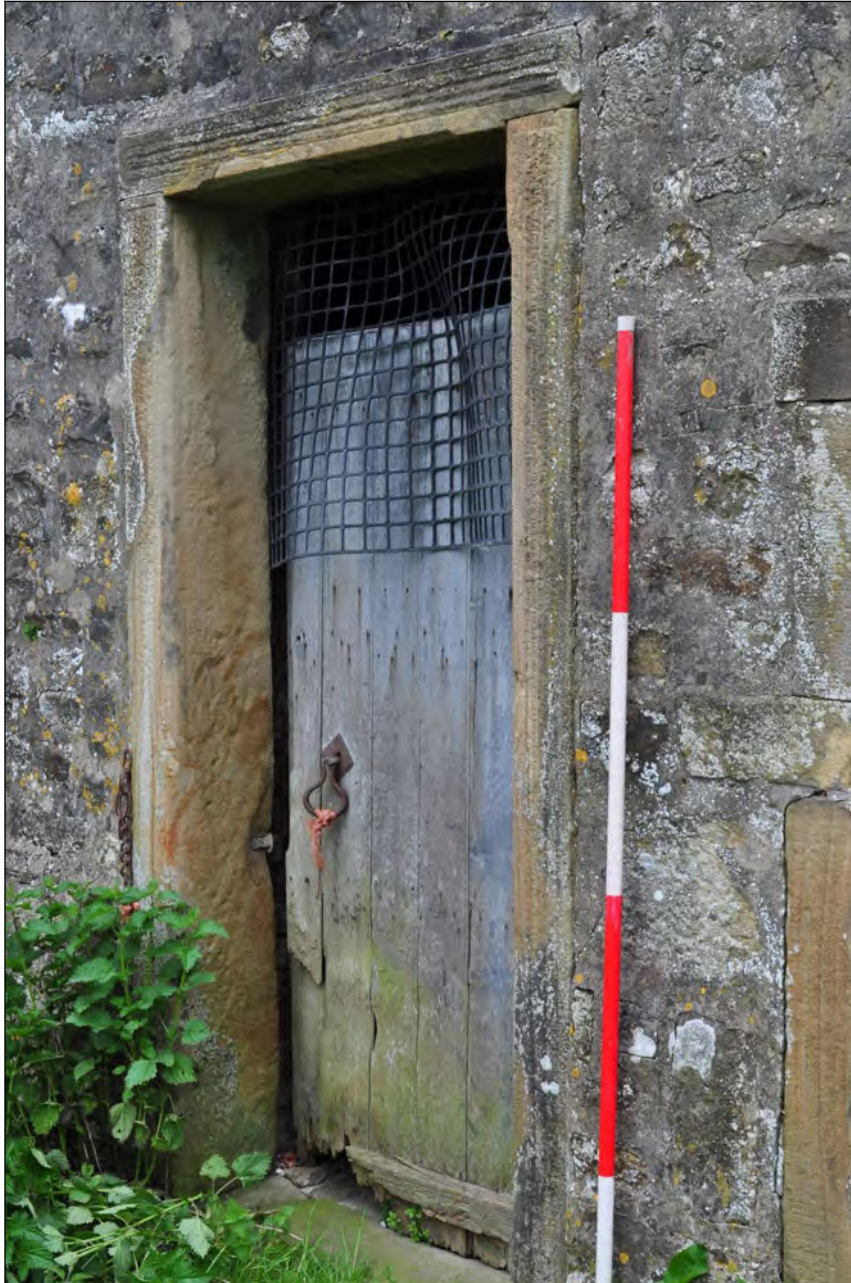
- 7.4 The internal arrangements within the west end of the barn have been altered, and this is evident in the openings in the west gable. There are two doorways: the taller one has monolithic ashlar jambs with distinctive tooling, and now gives access to a stable (10-12). The smaller left-hand doorway appears to have been inserted, probably to compensate for the blocking of the doorway in the north wall, and a high level forking hole may also be secondary. The gable has been extended to the south, to form the side of the later shippon. Adjacent to the west side of the barn is a cobbled fold-yard, with incomplete boundary walls (13).

Photo 10: Main building, looking south-east

Photo 11: Main building and south shippon: west elevation

Photo 12: Main building: stable doorway, west elevation

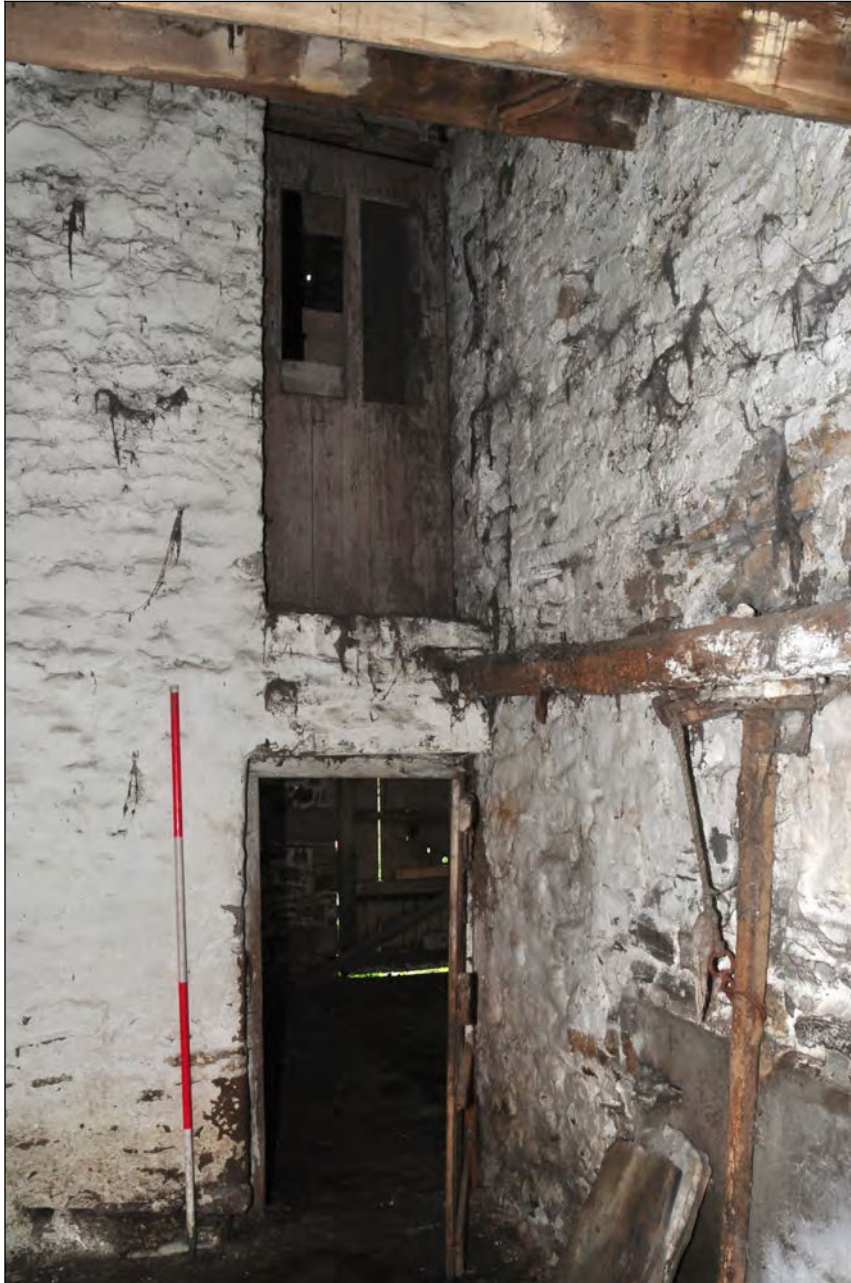
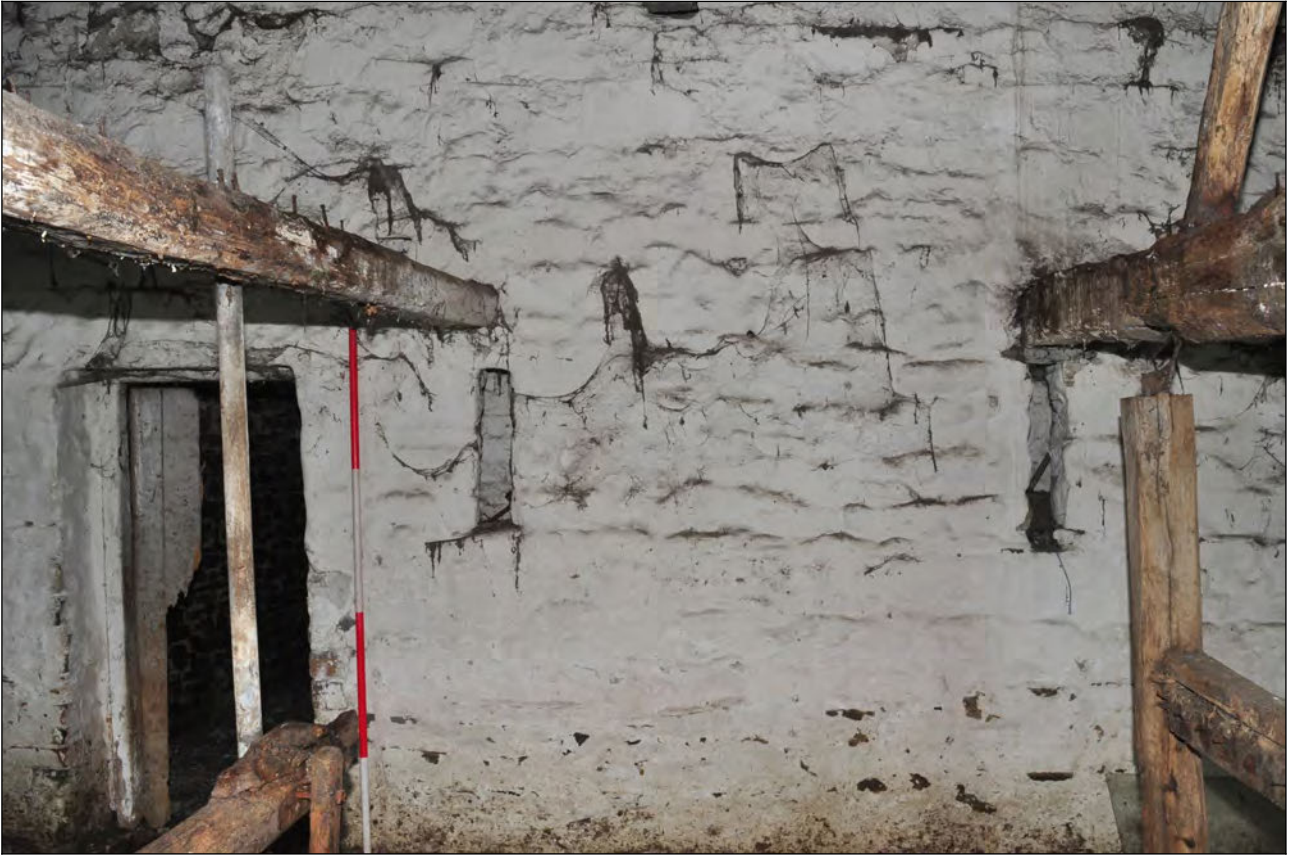
- 7.5 The main building's south side has a cart entrance and doors matching those opposite to the north, although it is now enclosed within an added porch (14-17). To the east of it is a mucking-out hole to the small shippon, but the remainder of the south side faces into the later shippon, and has been limewashed. Three splayed breathers are still evident within the wall, but three doorways have been inserted (including one at hayloft level) (18,19).

Photo 18: Main building: inserted doorways in south side, within later shippon

Photo 19: Main building: breathers in south side, within later shippon

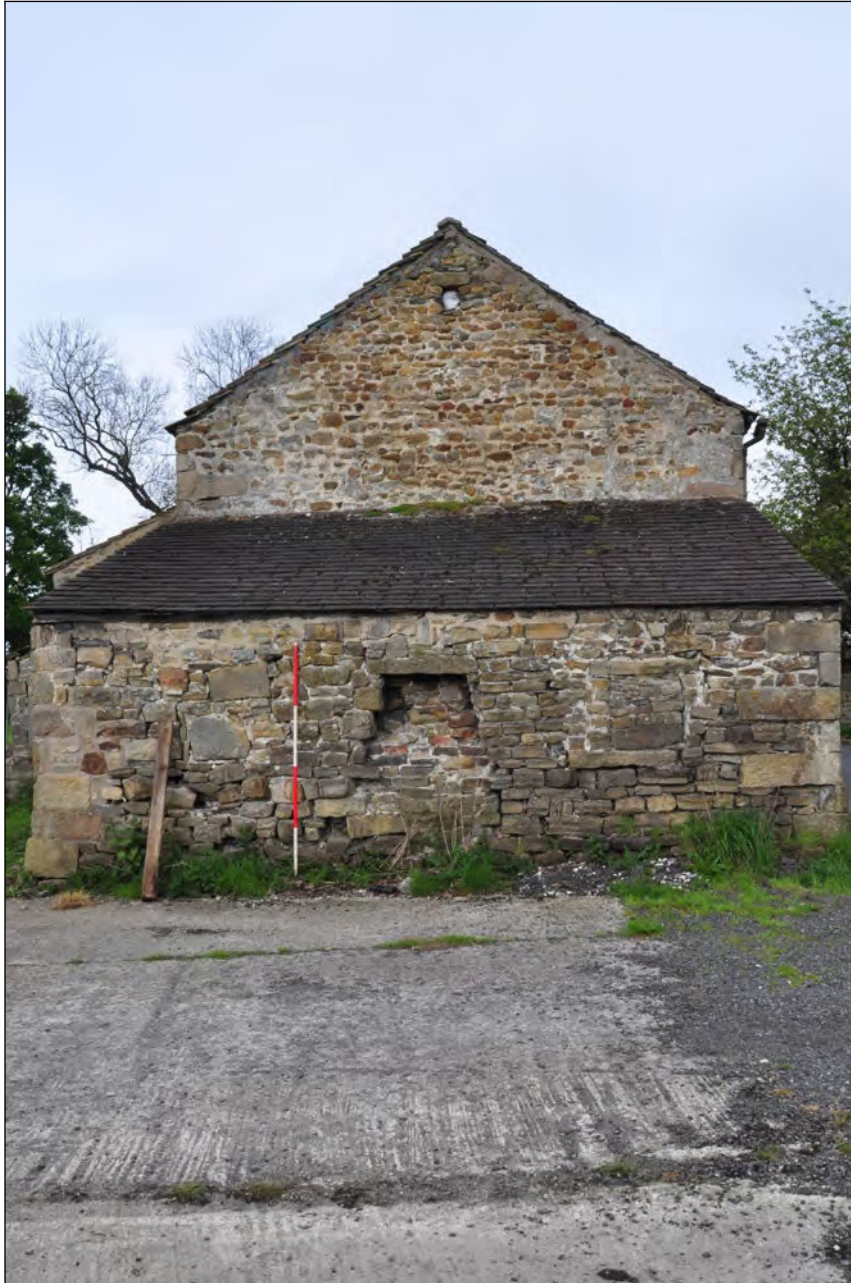
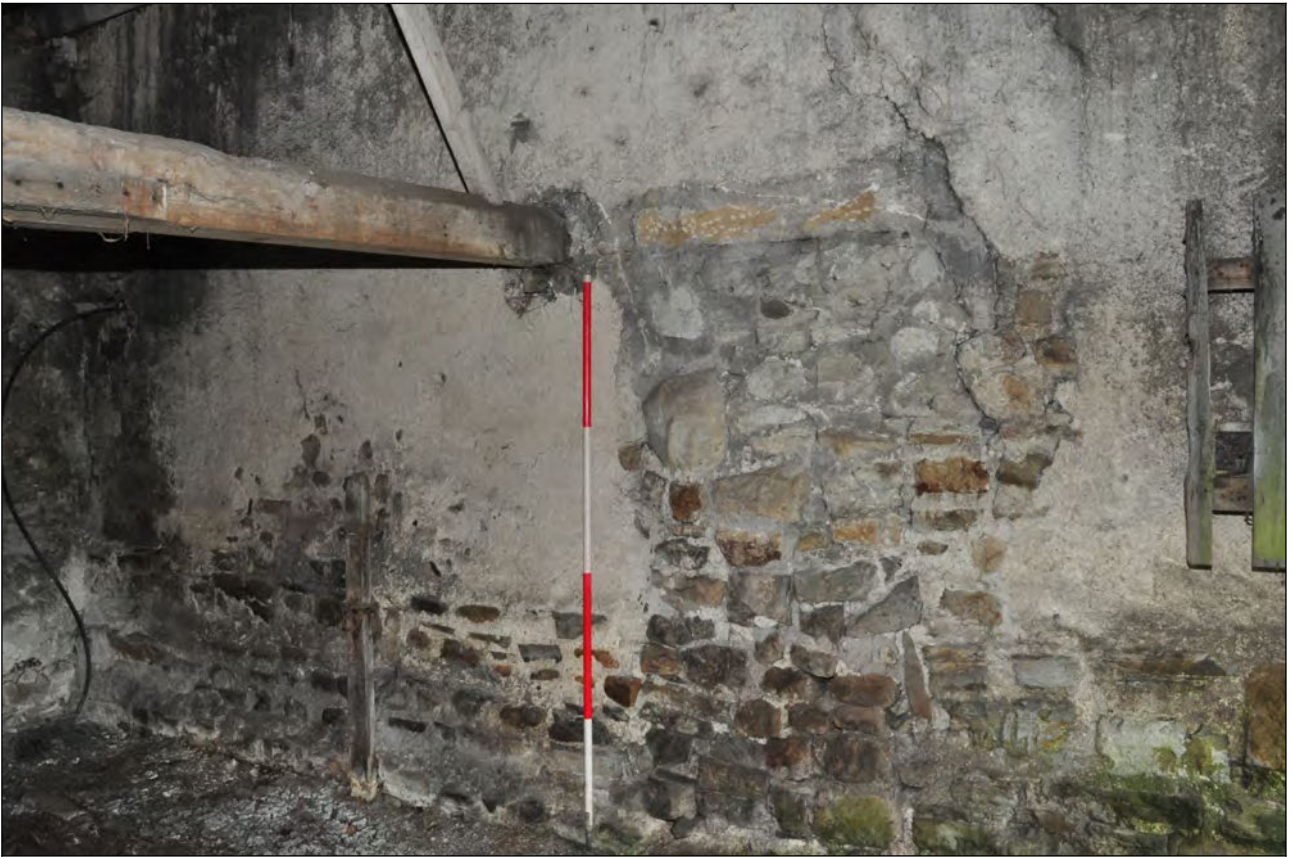
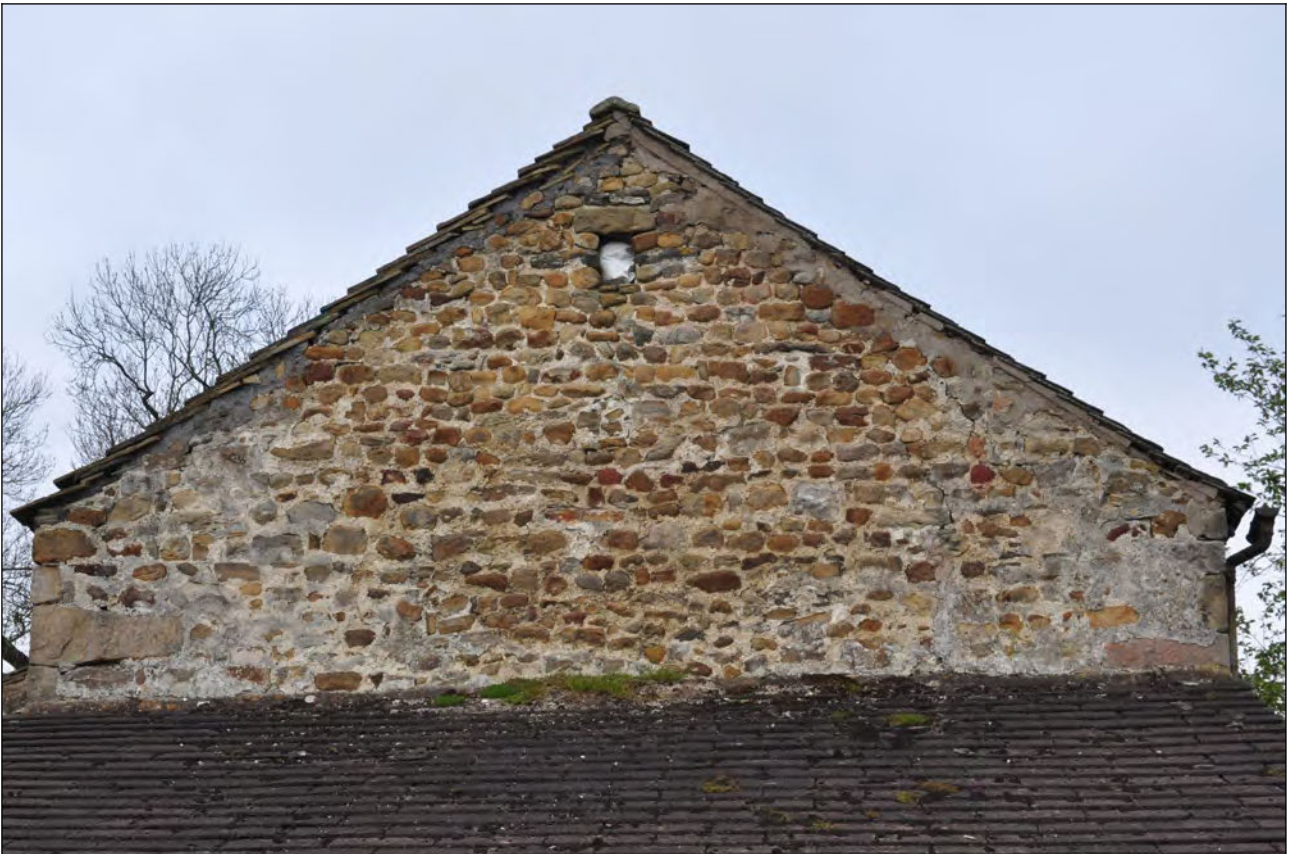
- 7.6 The east gable of the original barn now has a lean-to against it (20), within which a blocked doorway, probably secondary, can be discerned (21). There is a plain owl-hole close to the ridge (22).

Photo 20: Main building: east gable

Photo 21: Main building: blocked doorway in east gable, within later lean-to

Photo 22: Main building: east gable

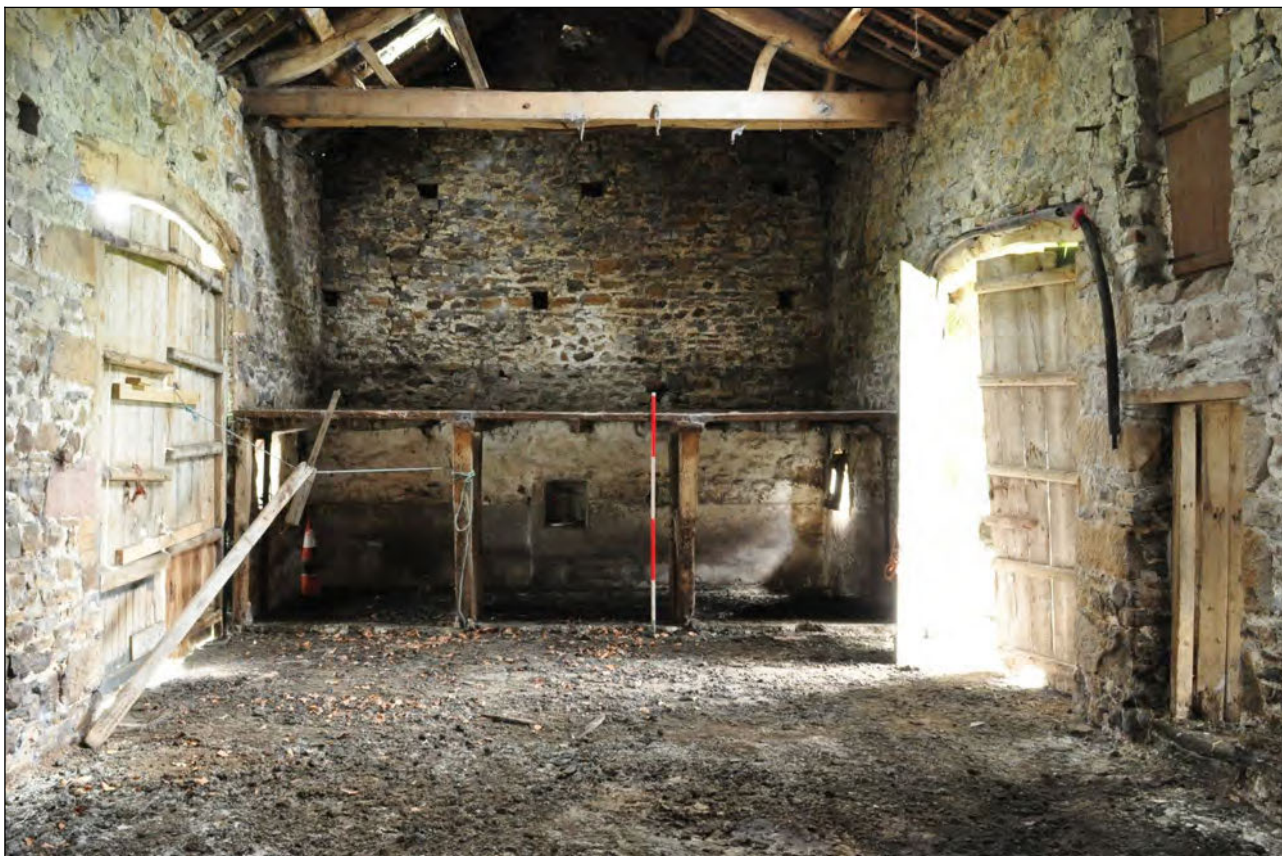
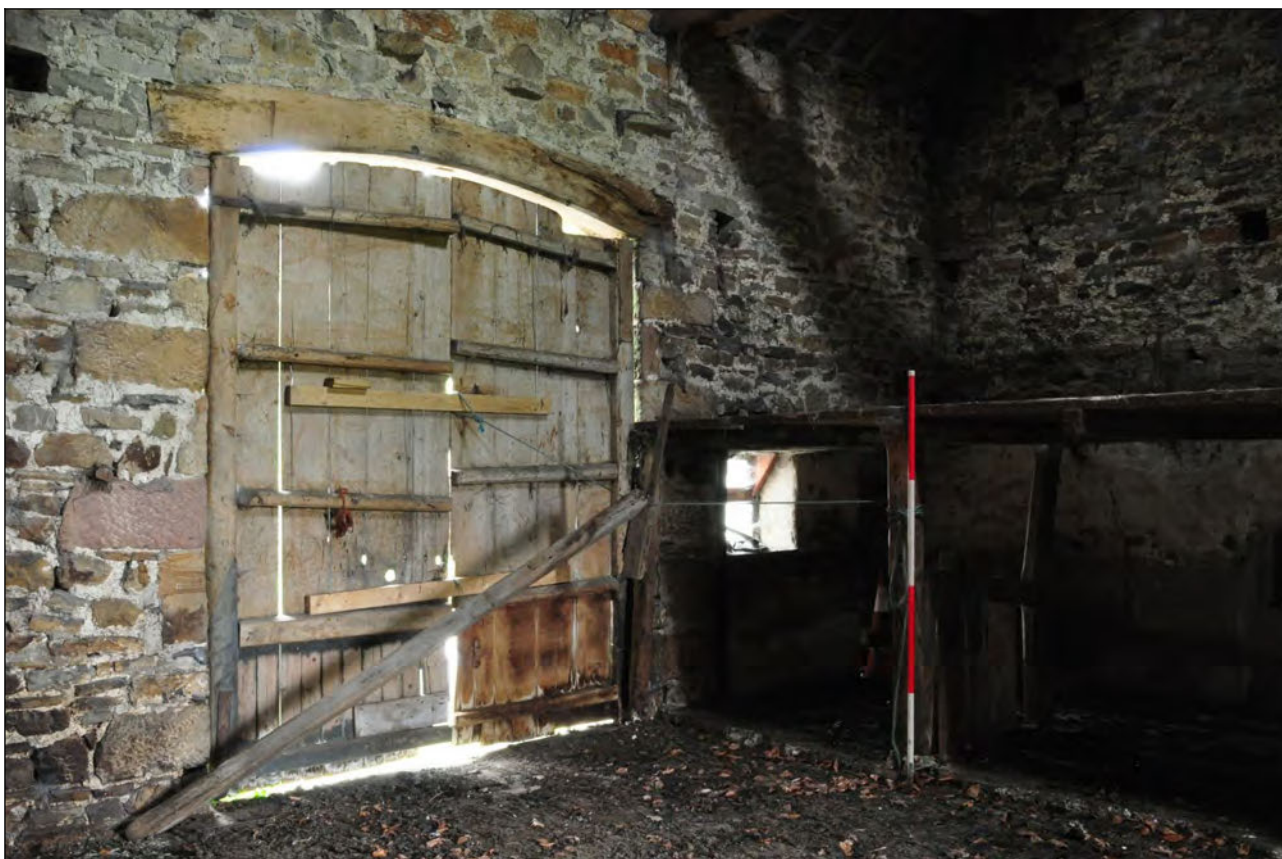
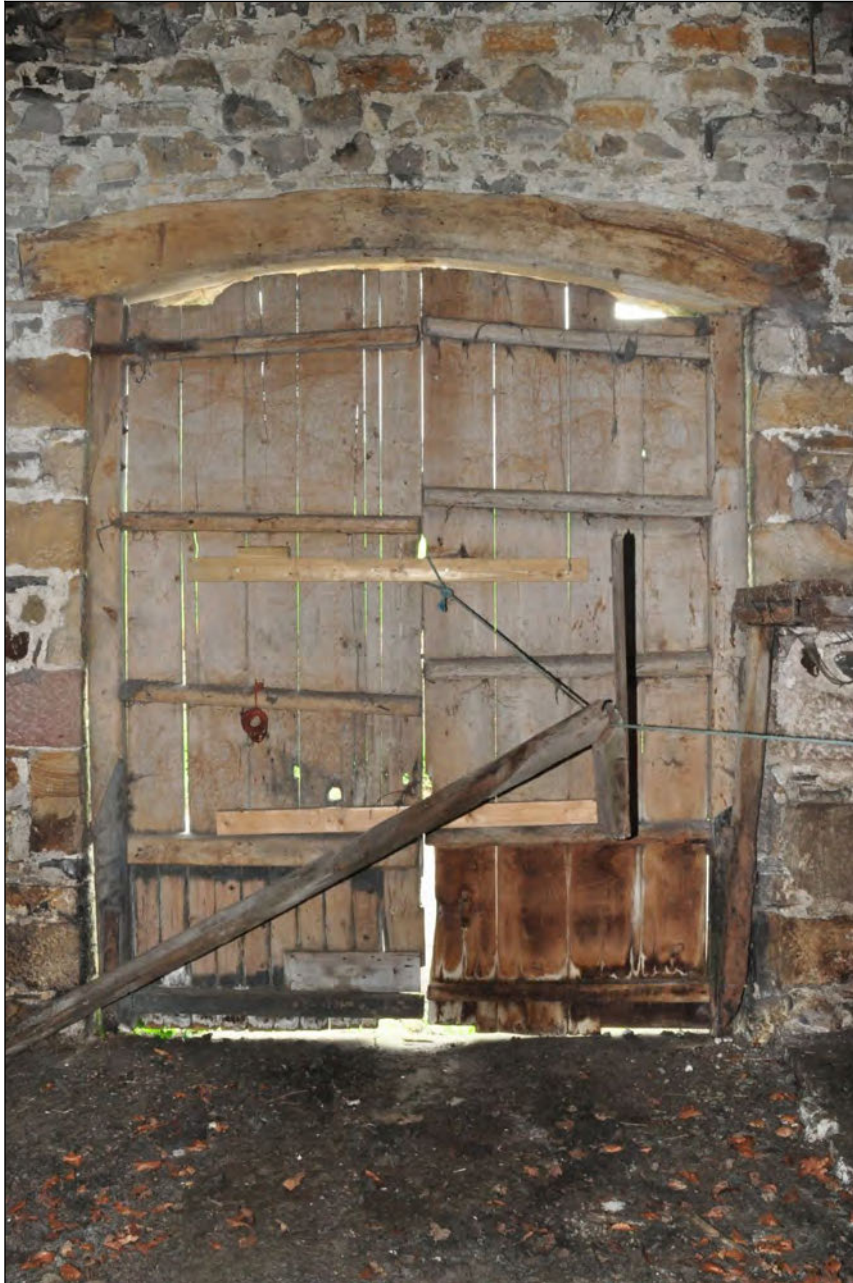
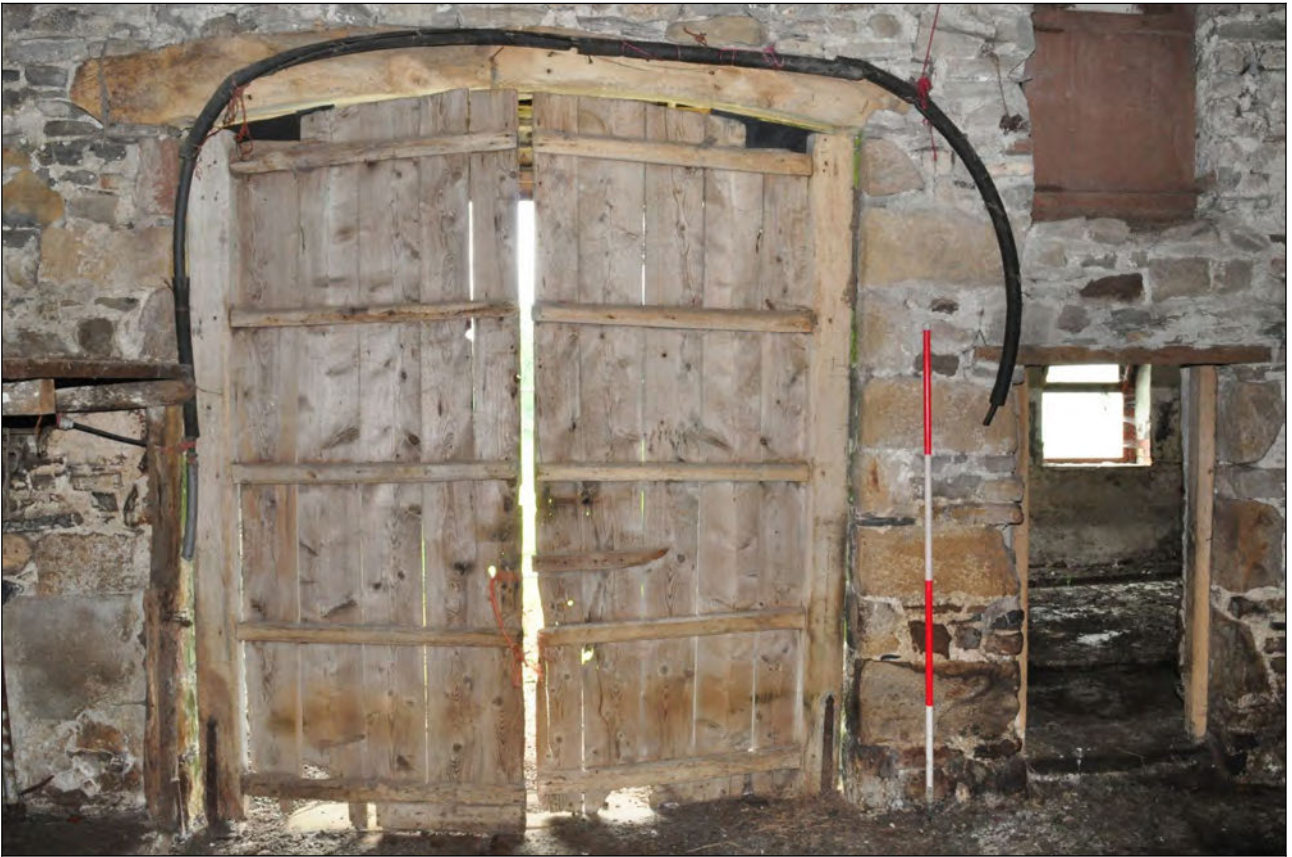
- 7.7 Within the barn, the flagged threshing bay between the cart entrances (23-26) separates a typical shippon for six cows in the east end from the three open bays to the west. The shippon is timber-framed and much degraded, but its two oak boskins survive and continue to support the hayloft, although this has been renewed with softwood (27-29). A lamp hole in the east gable and mucking-out hole to the south are also characteristic features (30,31). The shippon has a concrete floor and rendered walls, indicating it continued in use well into the 20th century.

Photo 23: Main building: interior, looking east towards shippon

Photo 24: Main building: interior view of north cart entrance, looking north-east

Photo 25: Main building: interior view of north cart entrance

Photo 26: Main building: interior view of south cart entrance and inserted doorway to later shippon
