Barn near Lane Side Farm
Grindleton, Lancashire:
Historic Building Record

Barn near Lane Side Farm Grindleton, Lancashire: Historic Building Record

The barn standing to the south-east of Lane Side Farm, near Grindleton (NGR: SD 75682 45046) is primarily 18th century, but has two 19th century additions. The main part is a six-bay combination barn, with shippon for six cows, threshing bay, a large mew, and separate stable, while the two additions include a shippon for 12 cows and a smaller lean-to structure which appears originally to have been a cart store. The recording was carried out to support an application for prior approval for domestic conversion.

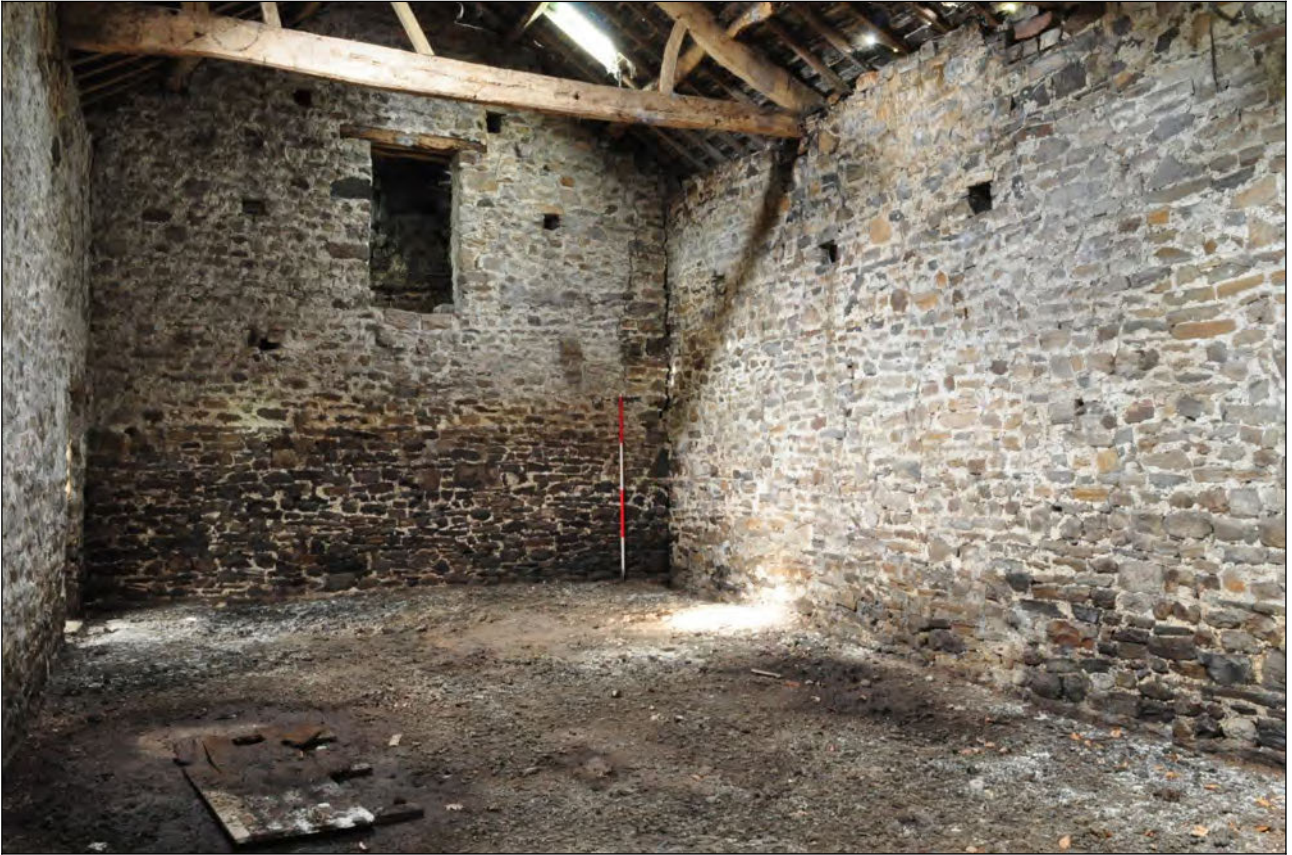
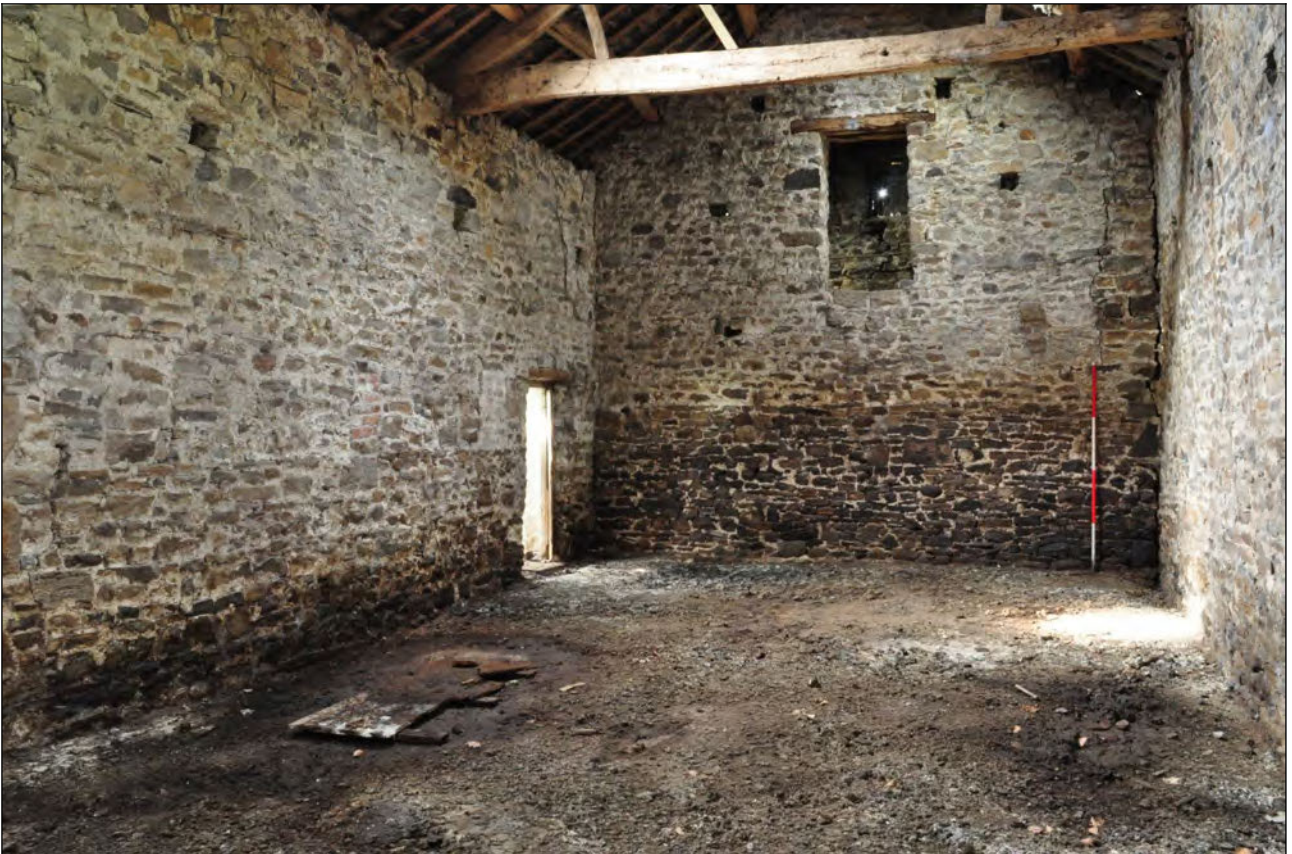
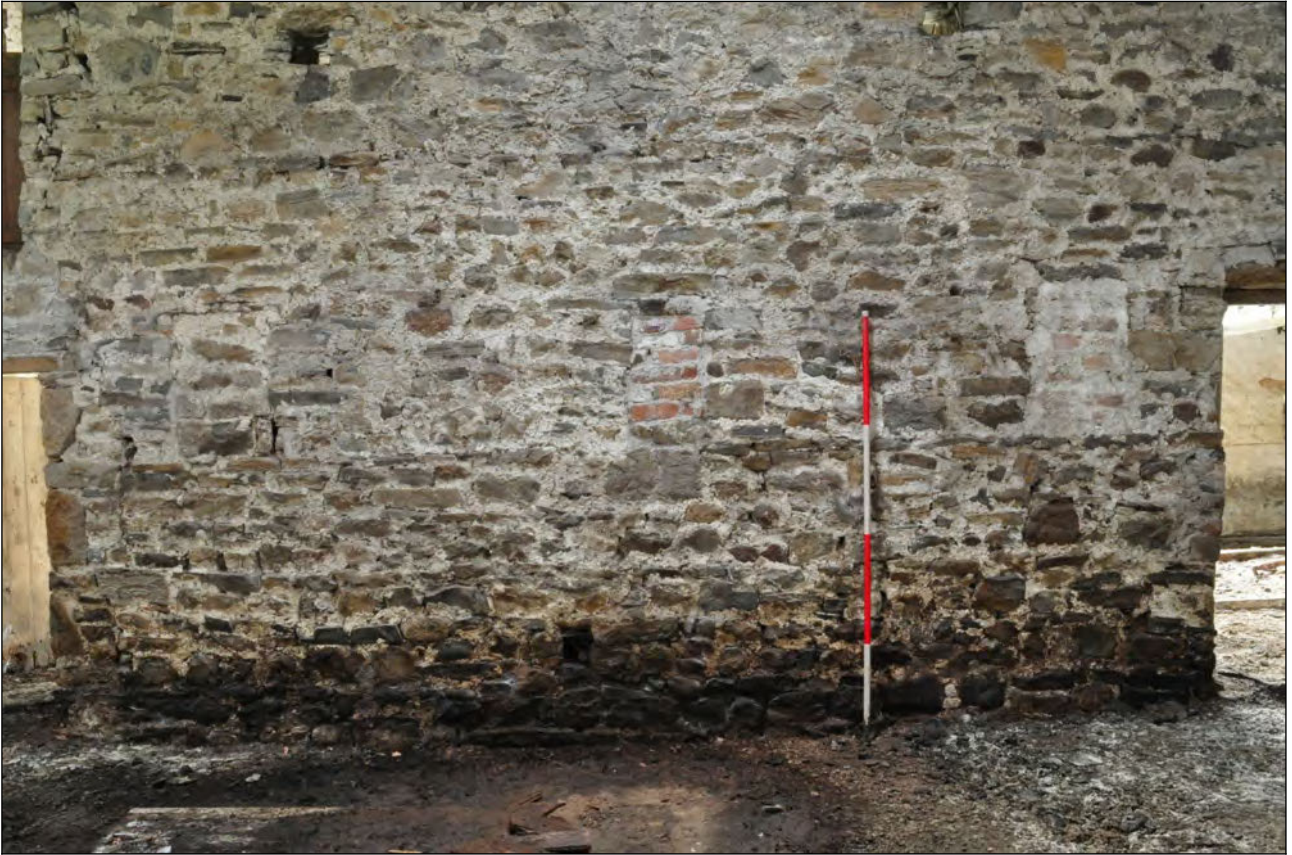
- 7.8 The three bays to the east of the threshing bay are open to the roof and would have formed the mew, probably intended for crop storage originally (32,33), when the three breathers in the south wall would have provided ventilation (34); they are not matched in the north side. There is a high level doorway in the west end giving access to the hayloft in the stable there.

Photo 32: Main building: interior, looking north-west

Photo 33: Main building: interior, looking south-west

Photo 34: Main building: interior, blocked breathers in south side

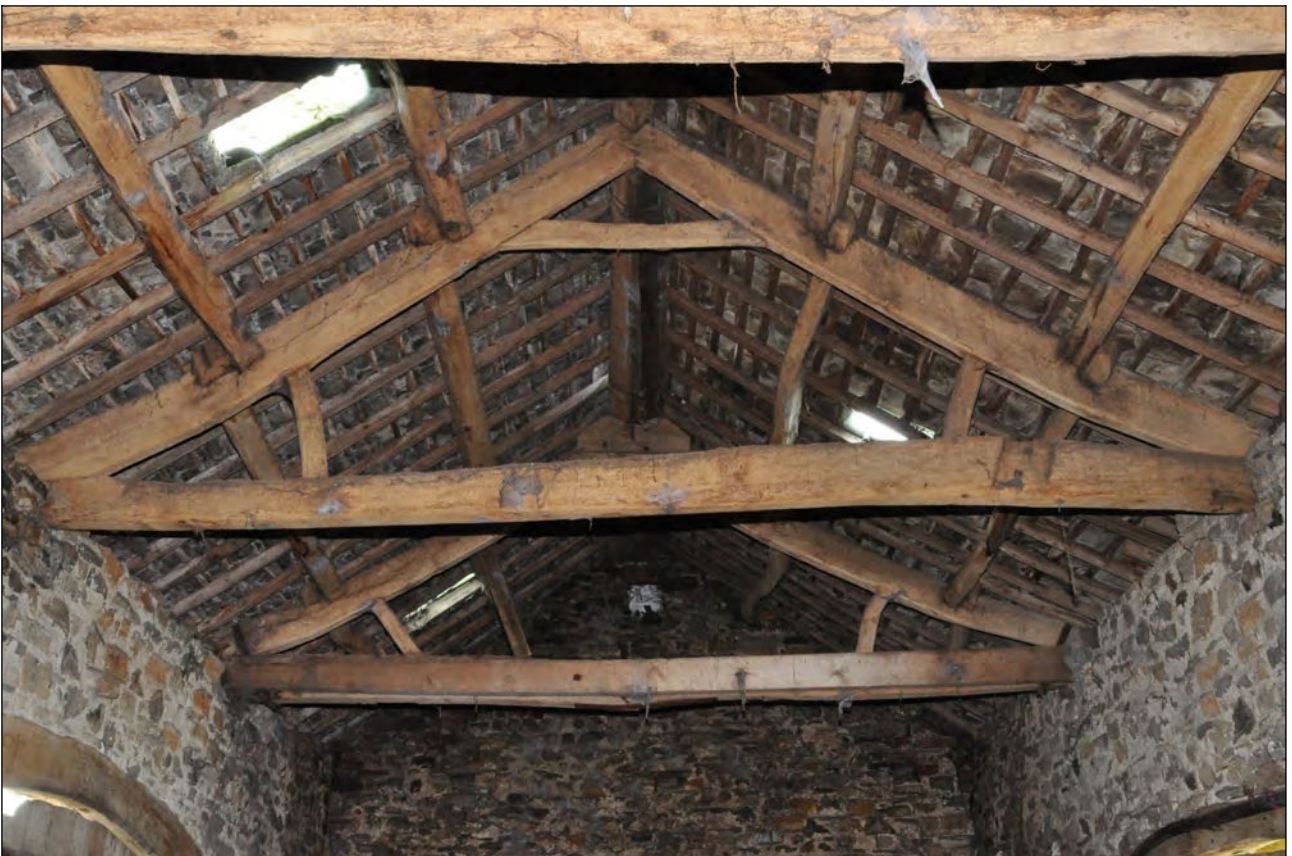
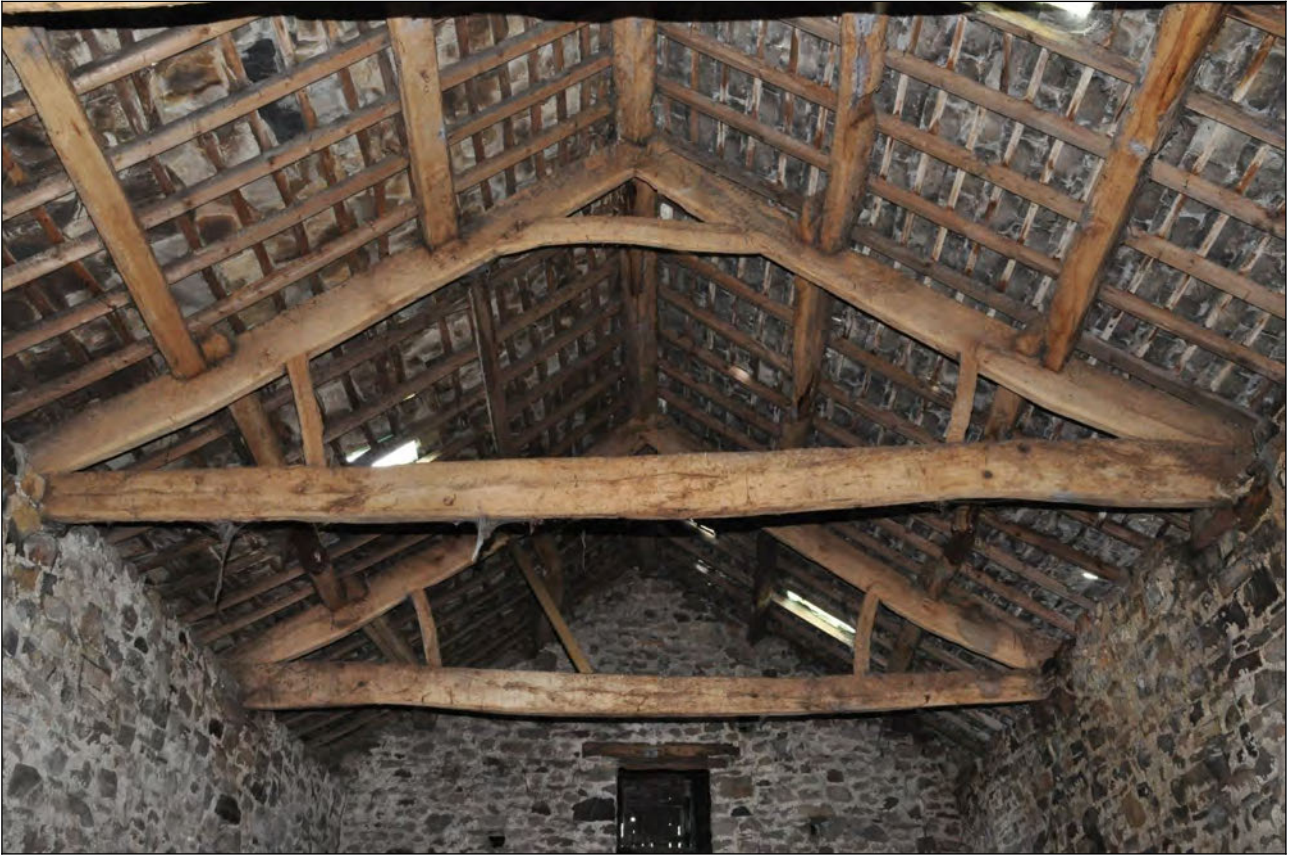
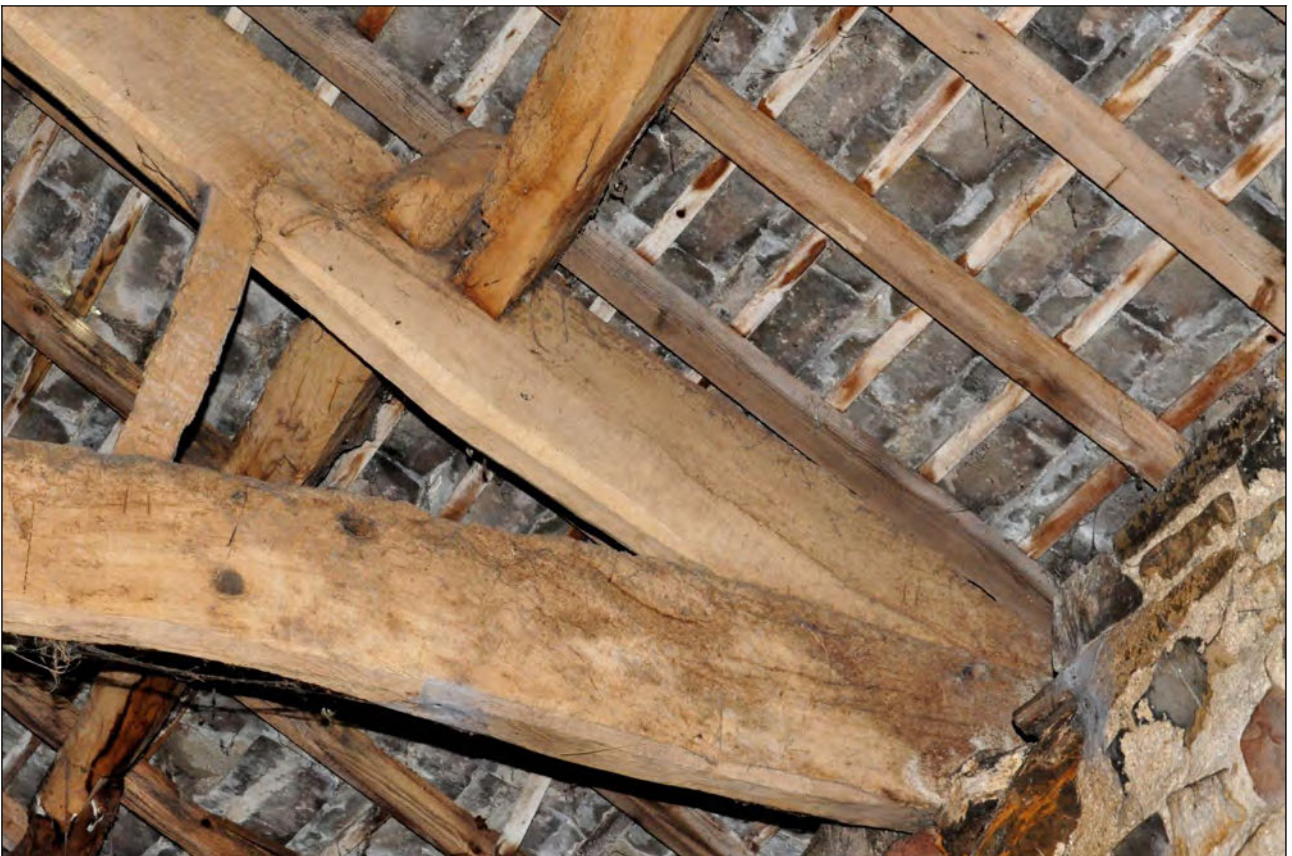
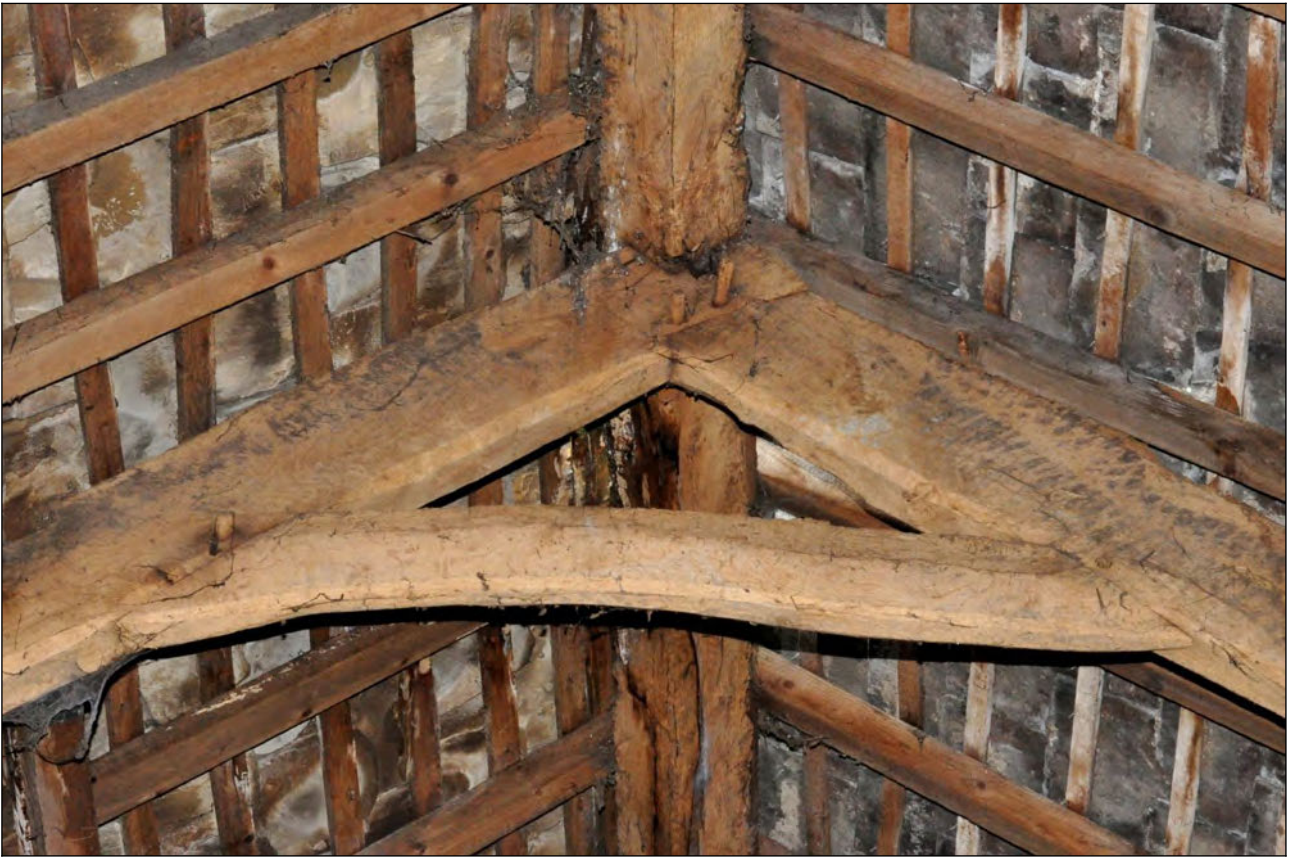
- 7.9 All the roof trusses in this original part are of pegged oak and of principal rafter type, with curved collars and raking struts for the most part, though there have been some losses and repairs; they are a reliable indicator of an 18th century date (35-38). The majority of the purlins are also oak, and those few which are softwood have been introduced as repairs.

Photo 35: Main building: eastern roof trusses, looking east

Photo 36: Main building: western roof trusses, looking west

Photo 37: Main building: detail of north end of roof truss, looking west

Photo 38: Main building: detail of collar and apex of roof truss, looking west

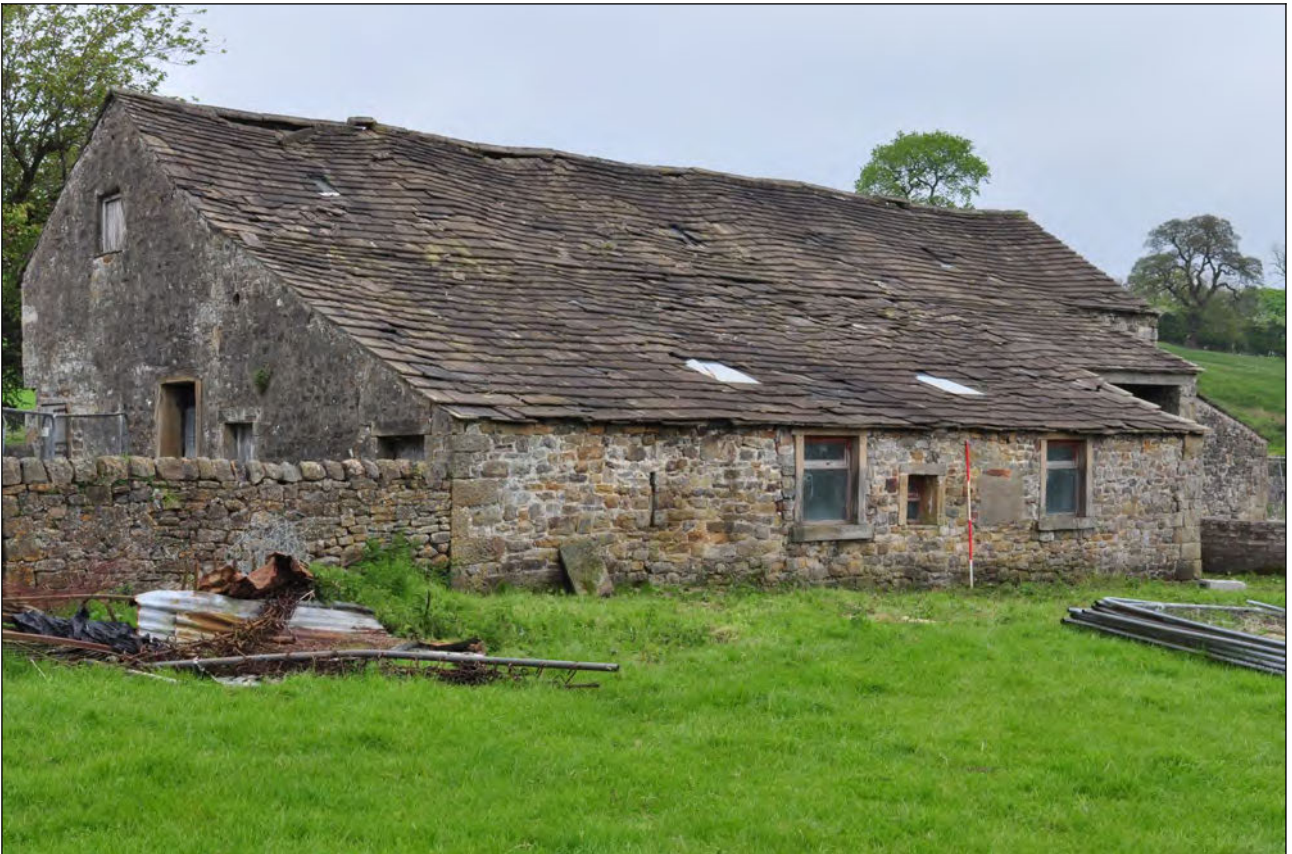
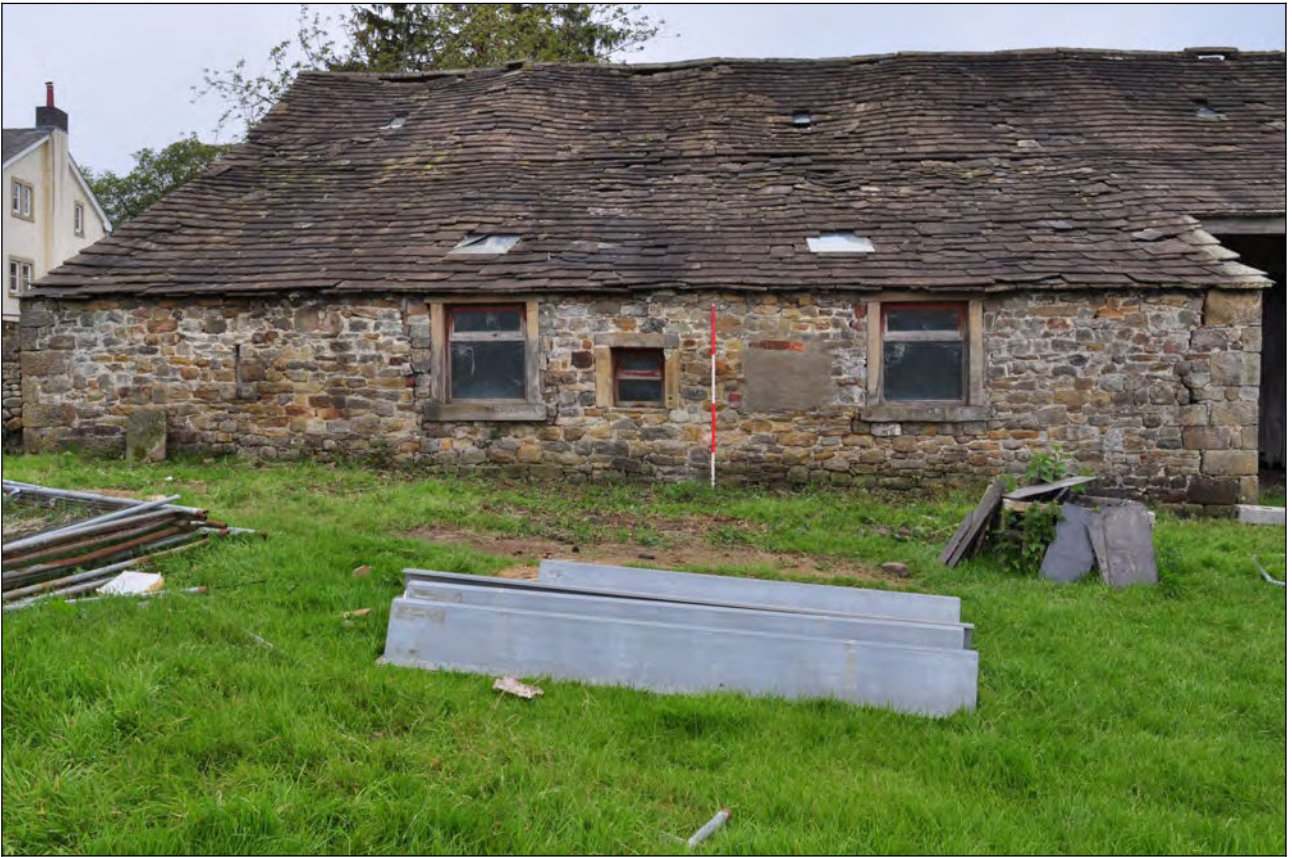
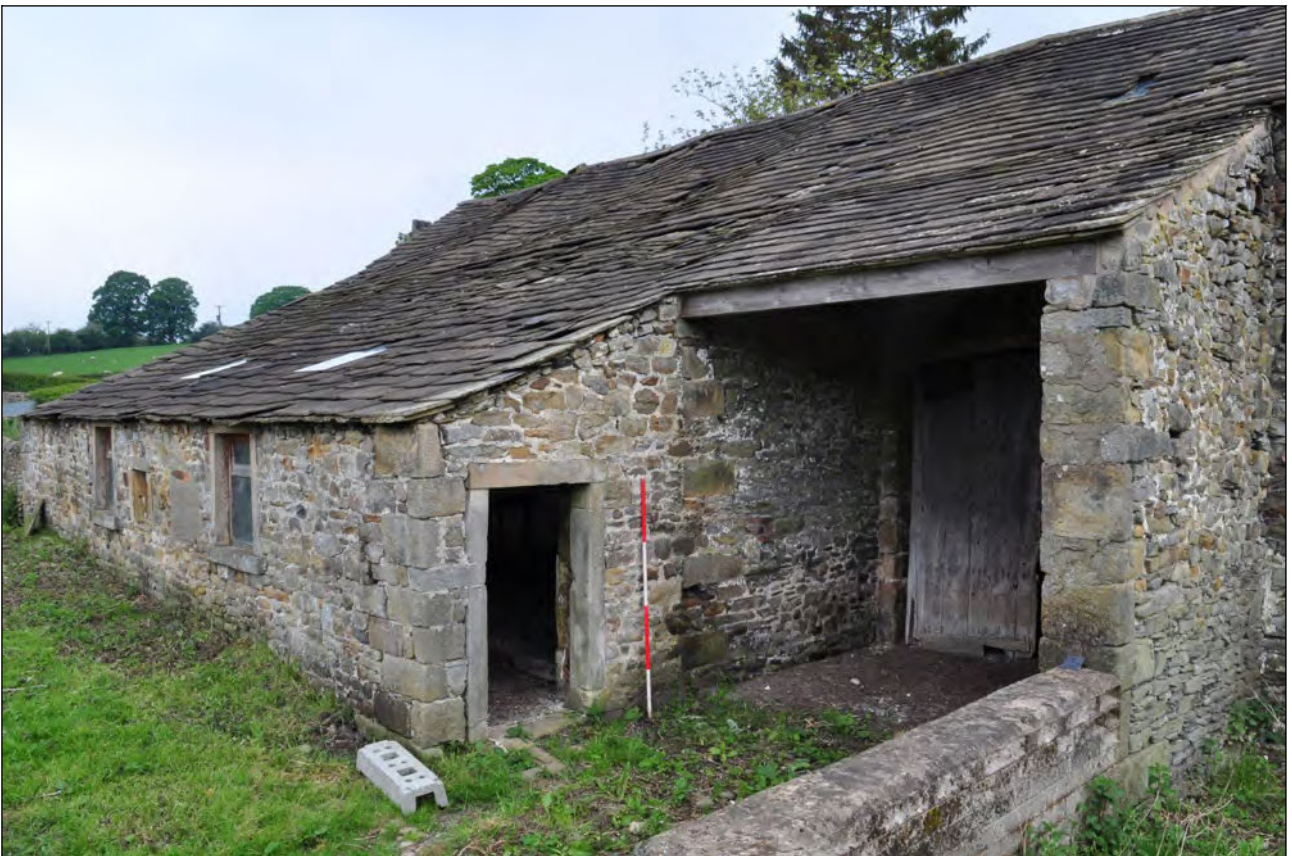
- 7.11 The large lean-to built next to the south porch appears to date from the period between 1847 and 1884, to judge from the Ordnance Survey's historic maps above, and would have increased the number of cows housed at the site in the winter from six to 18 (45-47). In construction it is similar to the principal range and is very plain.

Photo 45: South shippon, looking north-east

Photo 46: South shippon, looking north

Photo 47: South shippon, looking north-west

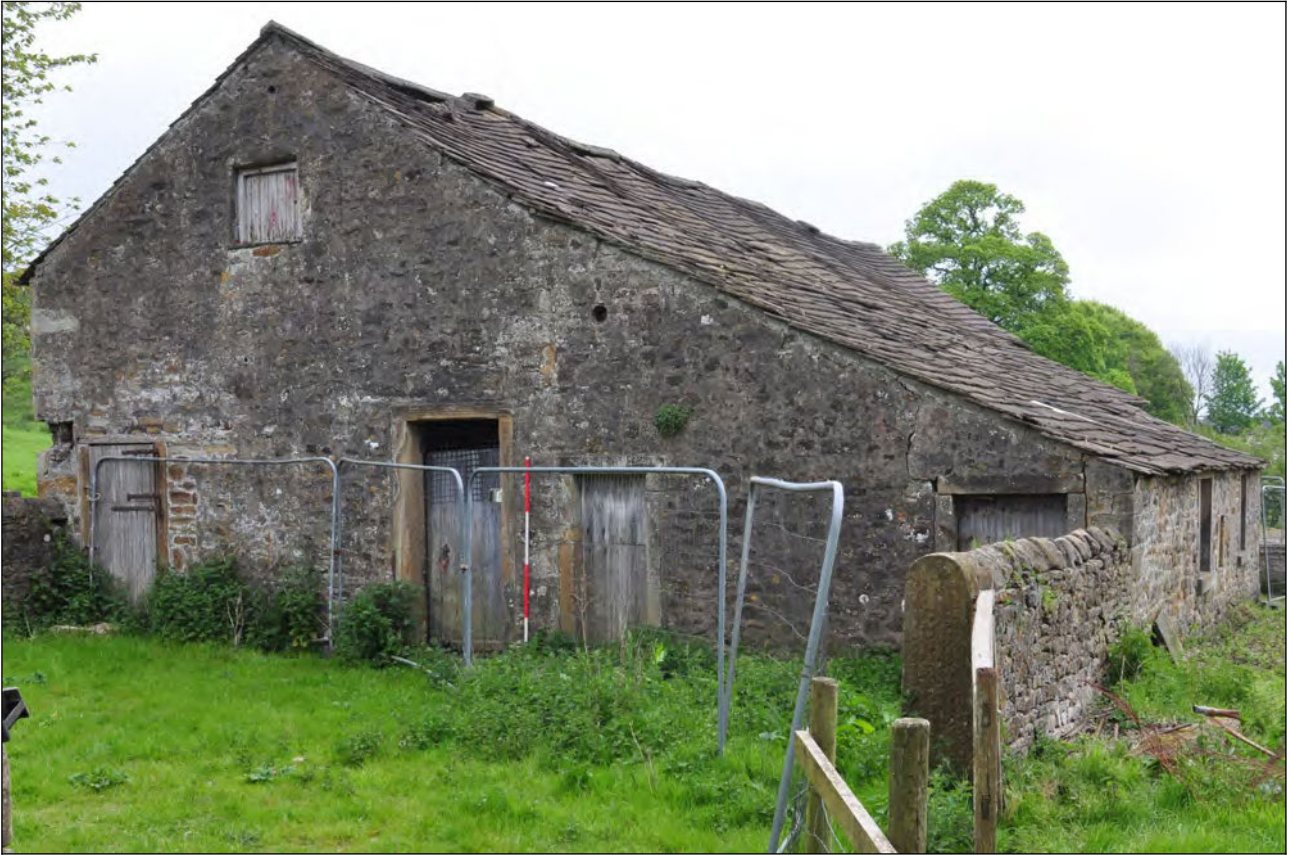
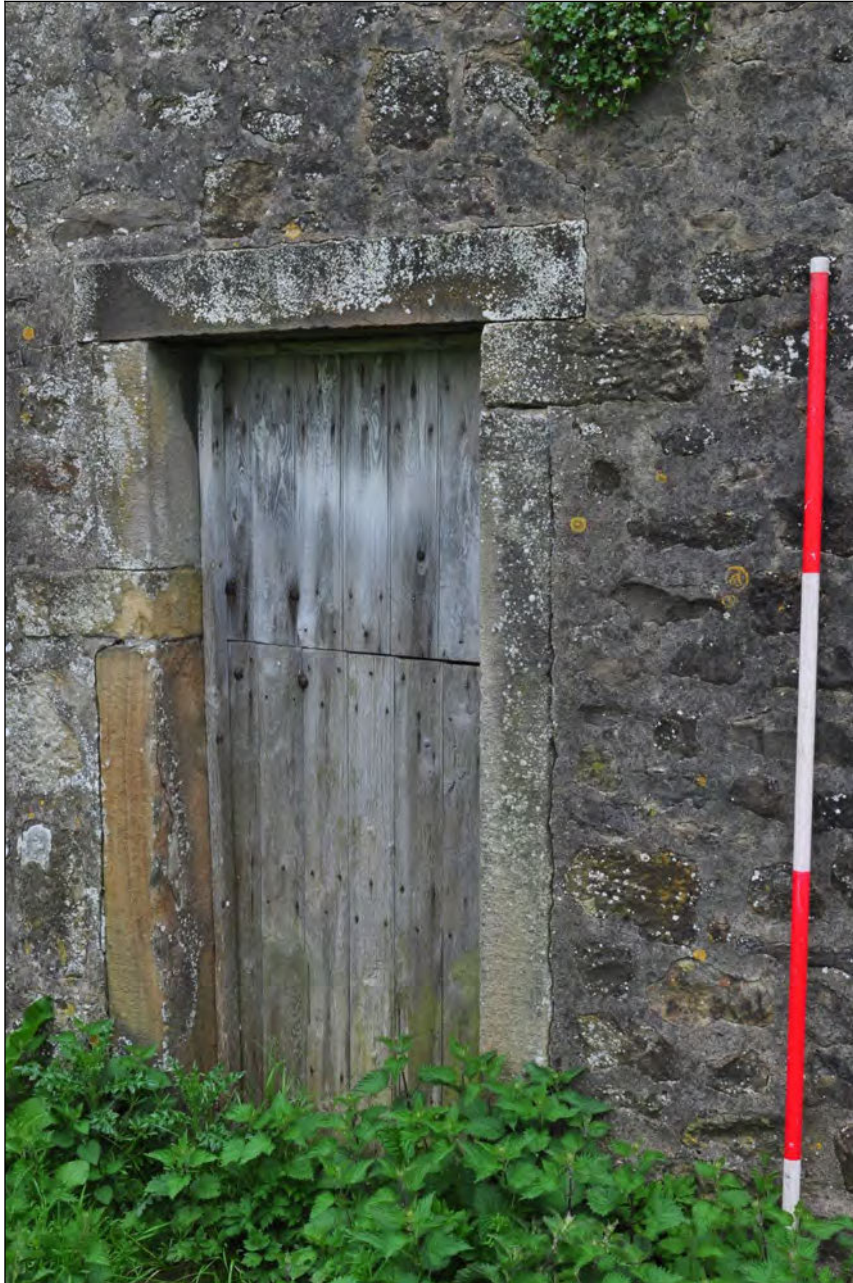
- 7.12 The shippon's west side faces the fold-yard and has two entrances, one to the feeding passage and one to the back of the stalls, and over the former is a blocked forking hole to the hayloft (48,49). There is also a doorway in the east side and various openings in the south wall, including two relatively large, twentieth century windows, as well as an original mucking-out hole and a splayed breather, of which there were probably more.

Photo 48: South shippon, looking north-east

Photo 49: South shippon: doorway to feeding passage, west end

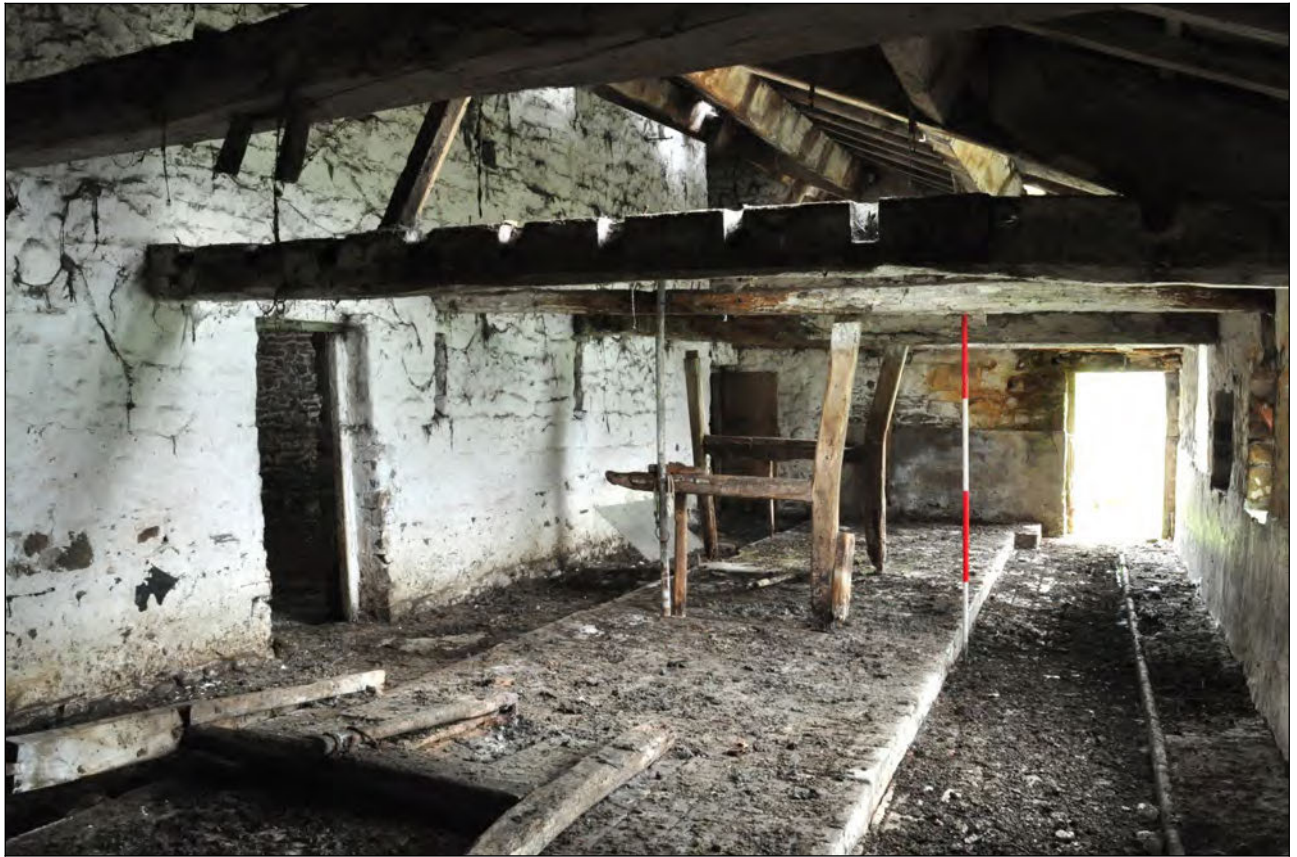
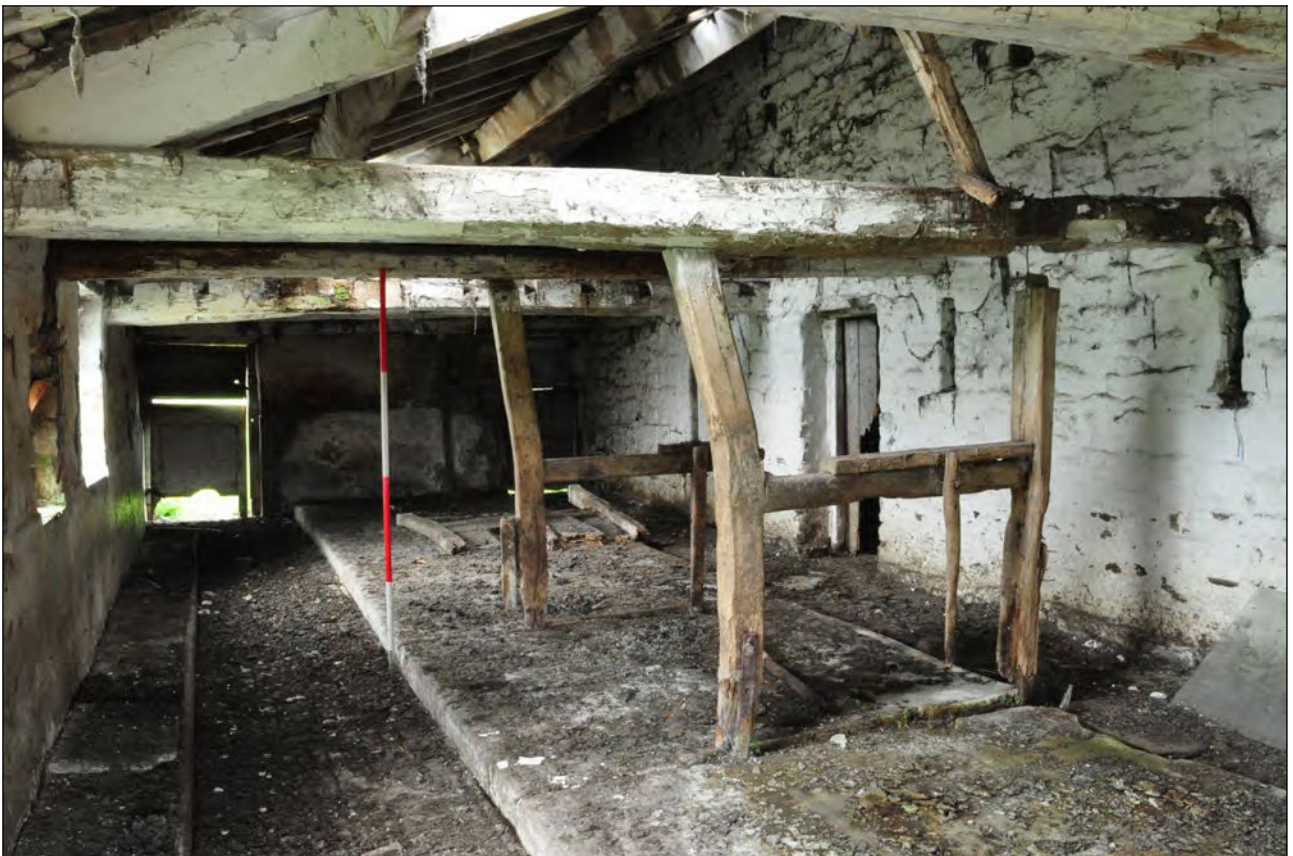
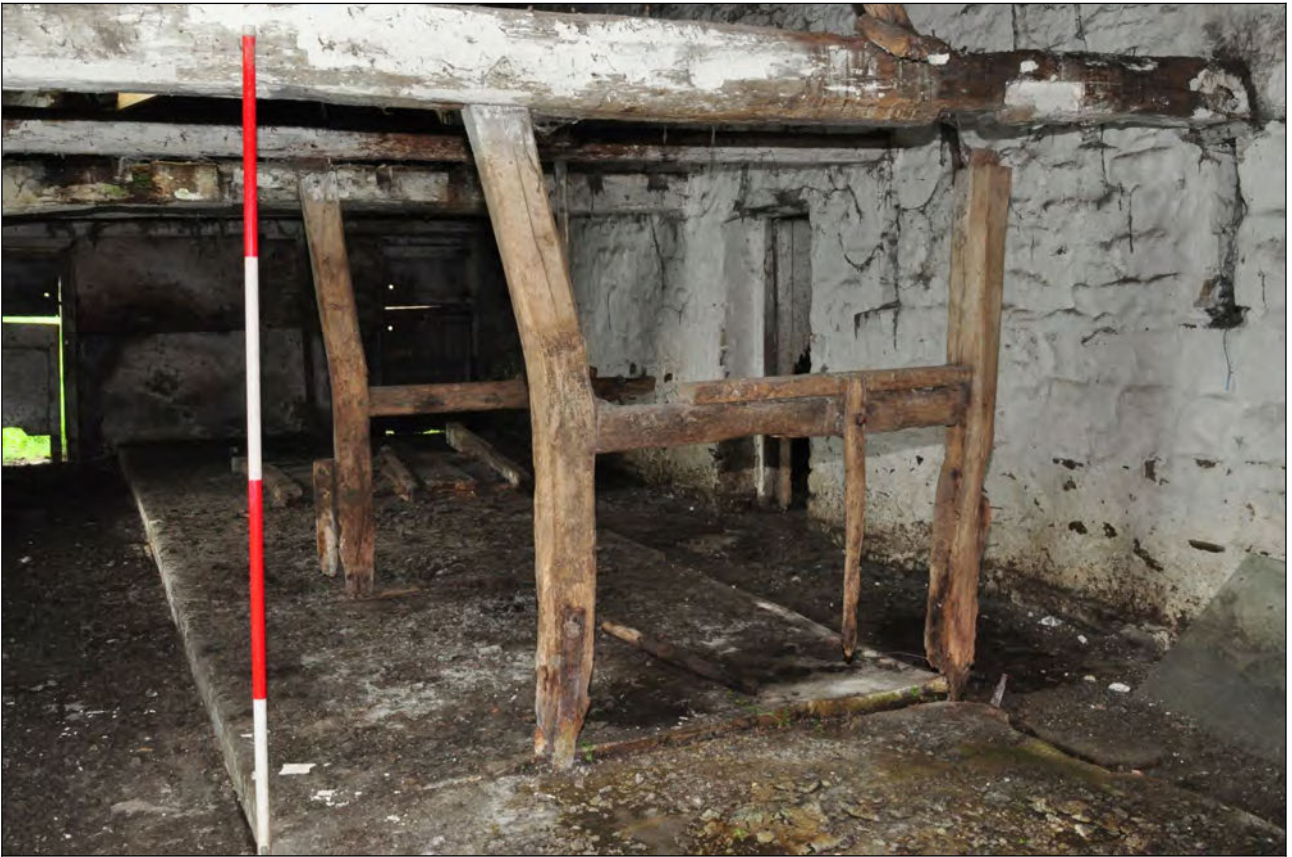
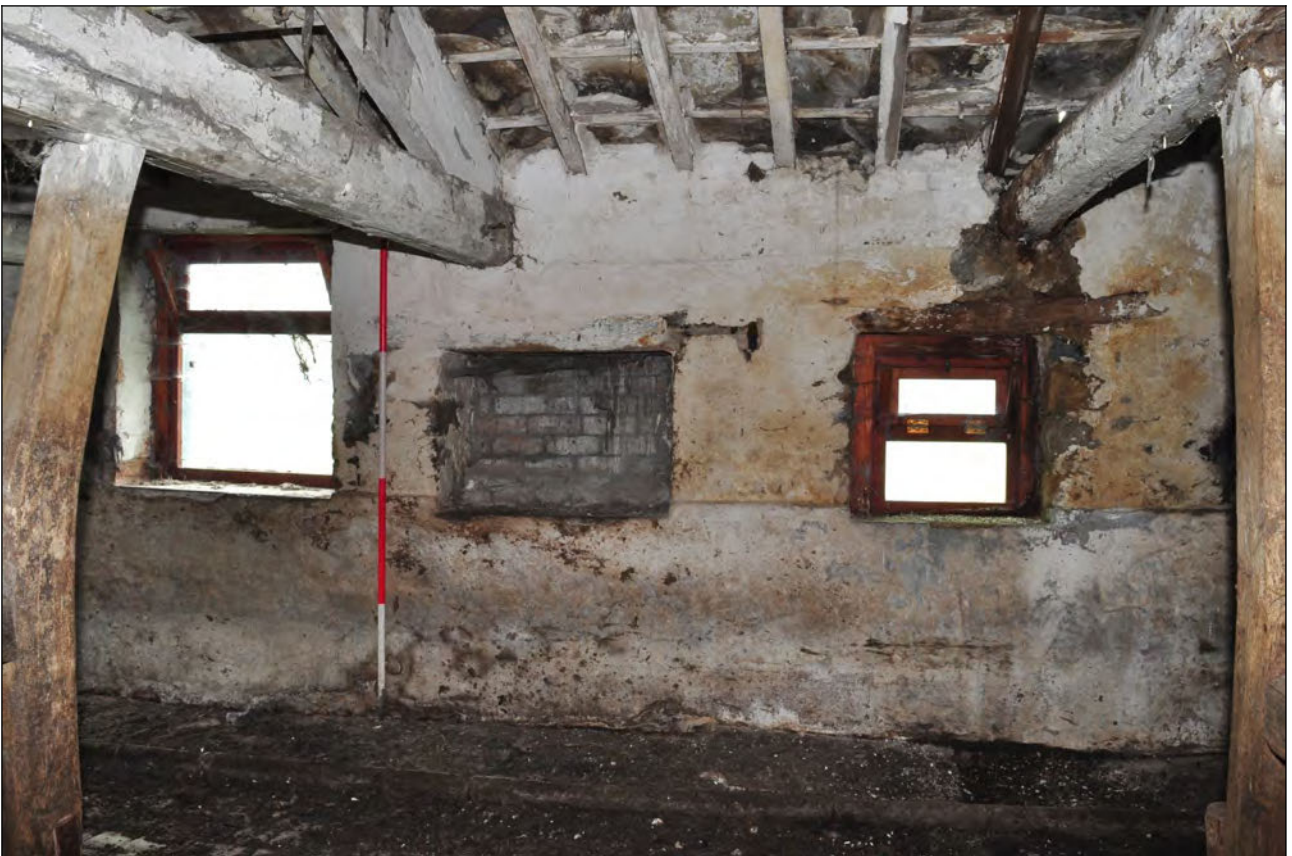
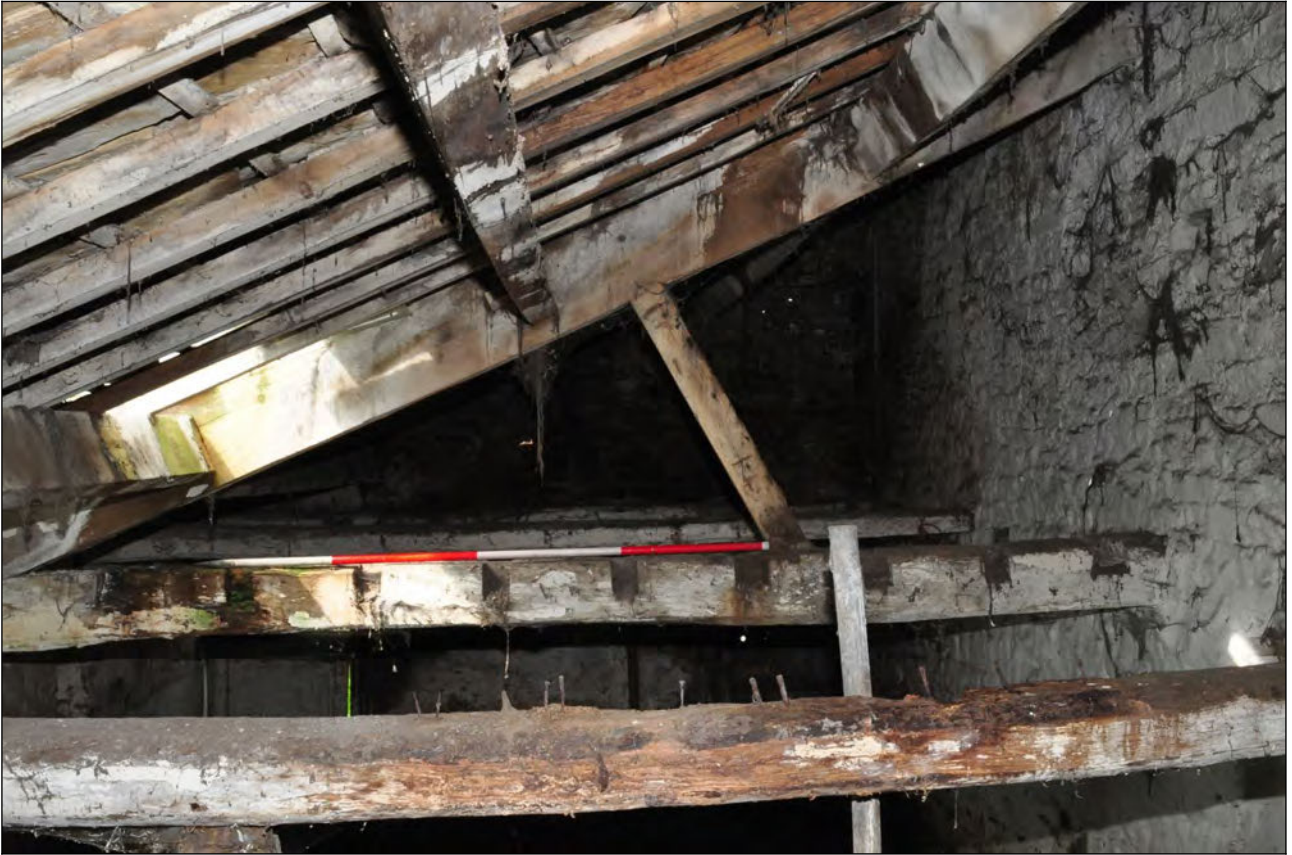
- 7.13 In characteristic fashion the shippon has a single row of stalls, divided by timber boskins with oak posts, but none is fully intact. Those remaining have elbowed heel-posts, so perhaps were re-used from elsewhere, as this form is not in keeping with the likely date of the outshut (50-52). They are fastened below raking trusses, whose tie-beams are also oak, but whose other components, including tusk-tenon purlins, are of imported softwood (53,54). A former hayloft can be inferred from the high level openings in the west and north sides.

Photo 50: South shippon: interior, looking north-east

Photo 51: South shippon: interior, looking north-west

Photo 52: South shippon: interior, remains of boskins, looking north-west

Photo 53: South shippon: interior, openings in south wall

Photo 54: South shippon: interior, showing roof structure, looking west

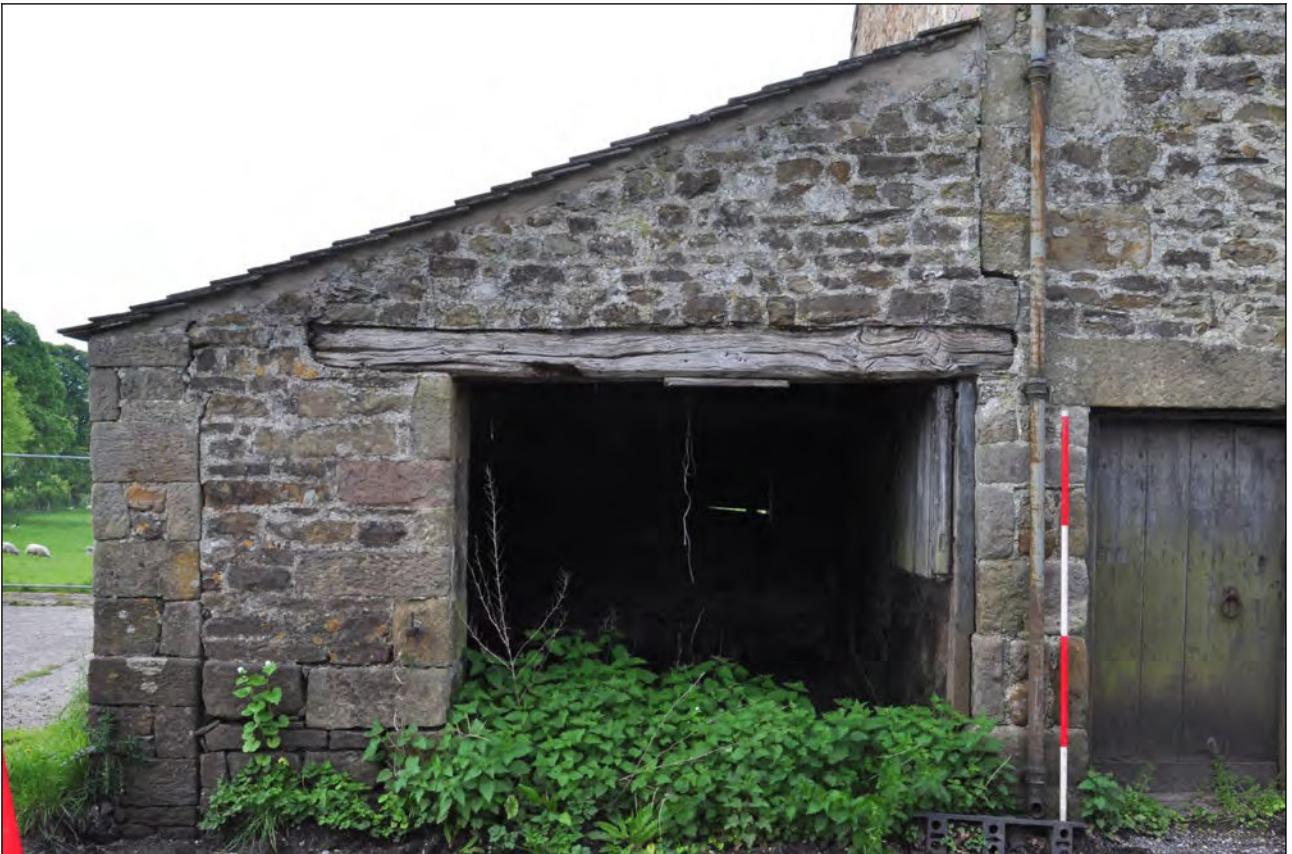
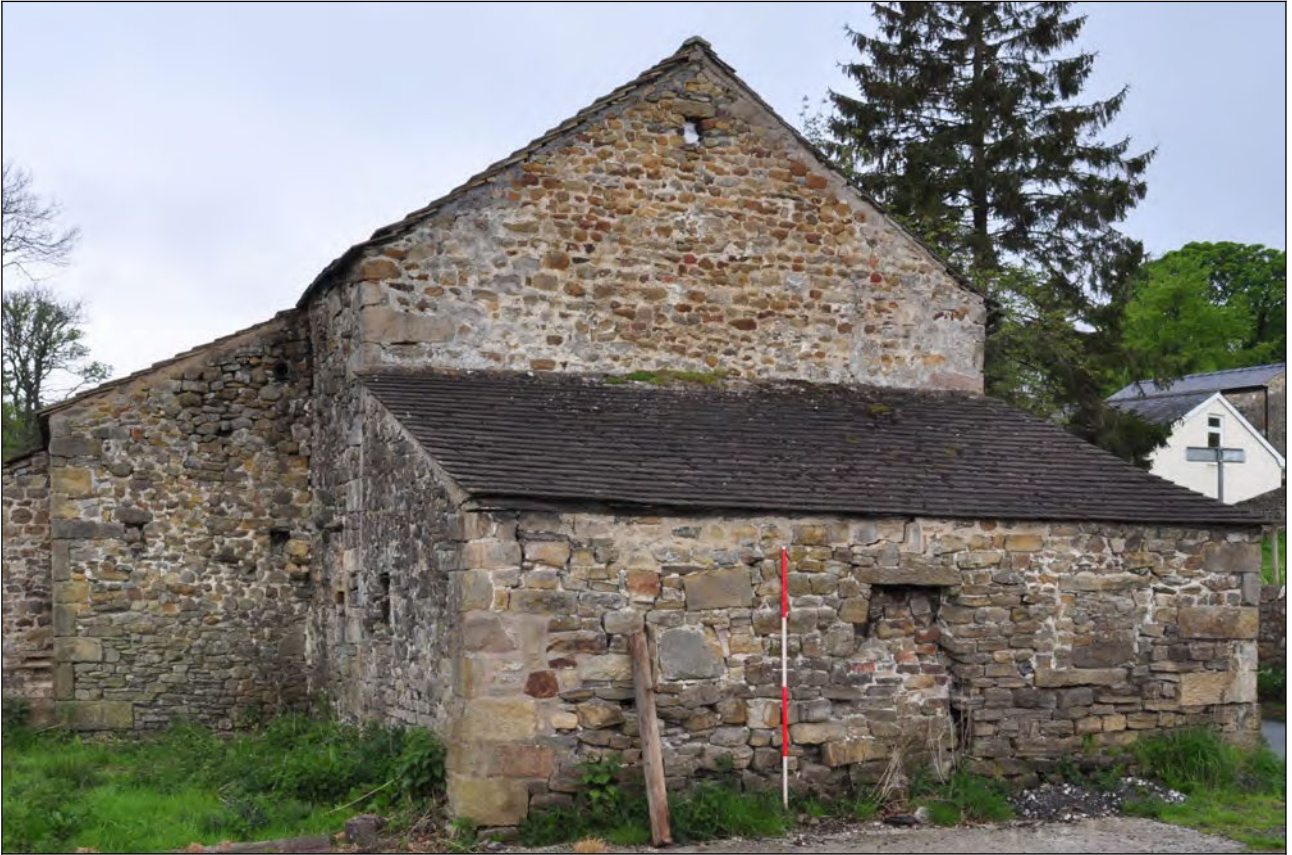
- 7.14 The much smaller lean-to added to the barn's east gable seems to have been a cart store originally, and the opening in its north side formerly occupied its full width (55). Its east wall has been much disturbed, apparently by the insertion of three openings, which have later been blocked (56), while the south side also has a blocked opening as well as an intact one (57). Many of these changes appear to have been associated with the adaptation to house livestock (58-60). The lean-to has a single raking truss of softwood, with tusk-tenon purlins, and

Photo 55: East lean-to: north front

Photo 56: East lean-to, looking north-west
