Barn near Lane Side Farm
Grindleton, Lancashire:
Historic Building Record

Barn near Lane Side Farm Grindleton, Lancashire: Historic Building Record

The barn standing to the south-east of Lane Side Farm, near Grindleton (NGR: SD 75682 45046) is primarily 18th century, but has two 19th century additions. The main part is a six-bay combination barn, with shippon for six cows, threshing bay, a large mew, and separate stable, while the two additions include a shippon for 12 cows and a smaller lean-to structure which appears originally to have been a cart store. The recording was carried out to support an application for prior approval for domestic conversion.

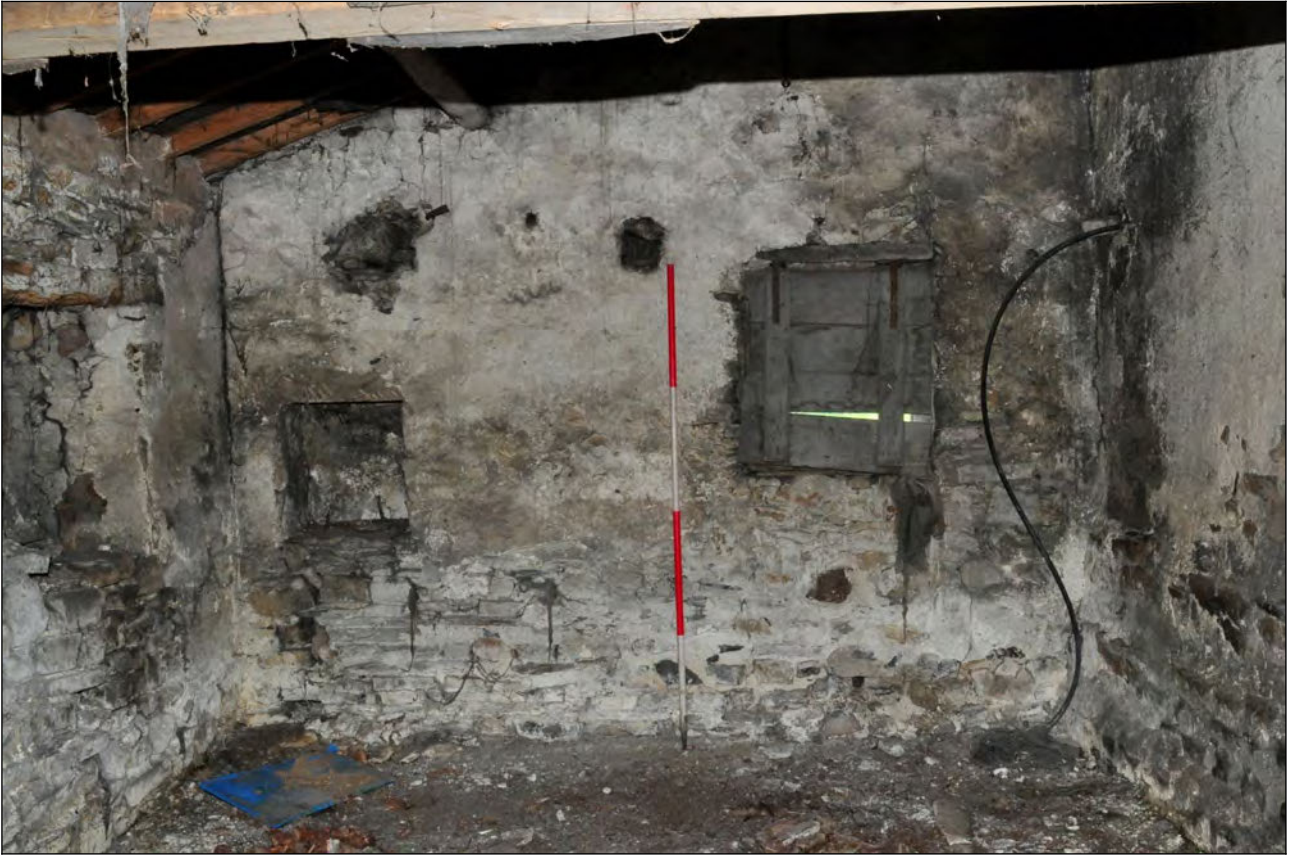
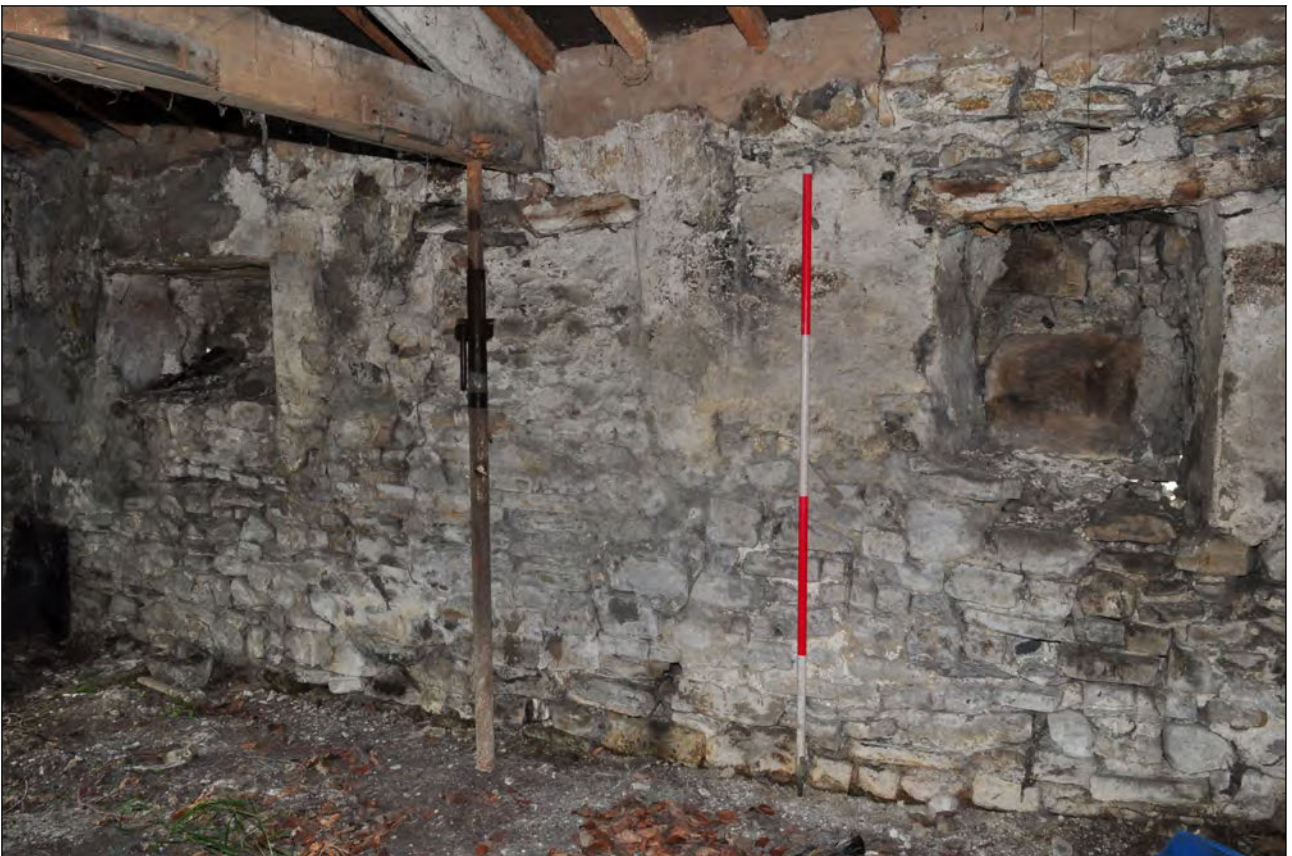
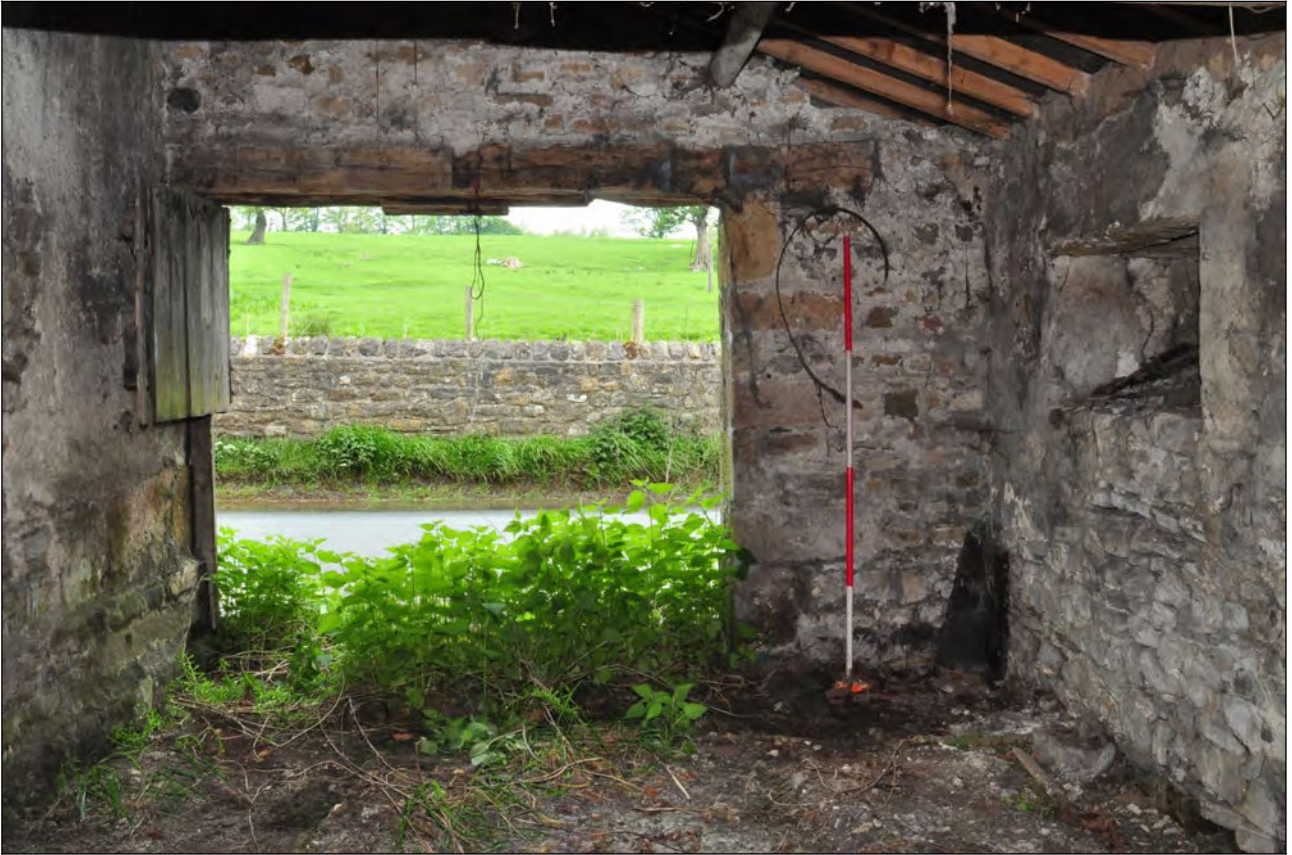
- 7.14 The much smaller lean-to added to the barn's east gable seems to have been a cart store originally, and the opening in its north side formerly occupied its full width (55). Its east wall has been much disturbed, apparently by the insertion of three openings, which have later been blocked (56), while the south side also has a blocked opening as well as an intact one (57). Many of these changes appear to have been associated with the adaptation to house livestock (58-60). The lean-to has a single raking truss of softwood, with tusk-tenon purlins, and

Photo 58: East lean-to: interior, looking south

Photo 59: East lean-to: interior, looking north-east

Photo 60: East lean-to: interior, looking north
