PRELIMINARY ECOLOGICAL APPRAISAL

SKIRDEN LODGE

Skirden Lodge, Tosside, North Yorkshire, BD23 4SX

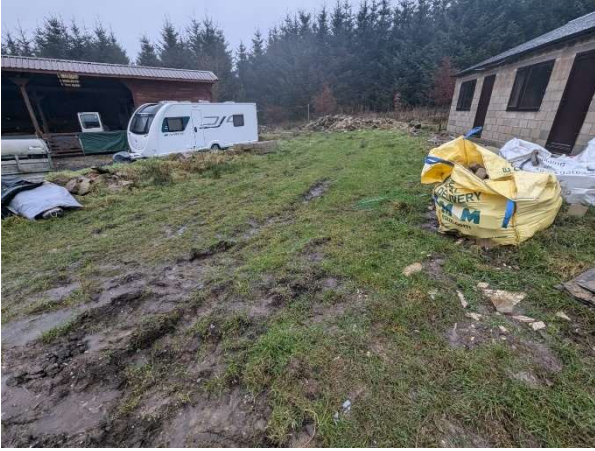
Photograph 1: Modified grassland in the center of the site.

In the northeast of the site is modified grassland mown short for use as a lawn. The grassland is dominated by perennial ryegrass (*Lolium perenne*) (D) with frequent occurrences of Yorkshire fog (*Holcus lanatus*) (F), red fescue (*Festuca rubra*) (F), and creeping buttercup (*Ranunculus repens*) (F). Soft rush (*Juncus effusus*) (O) is observed occasionally in wetter areas.

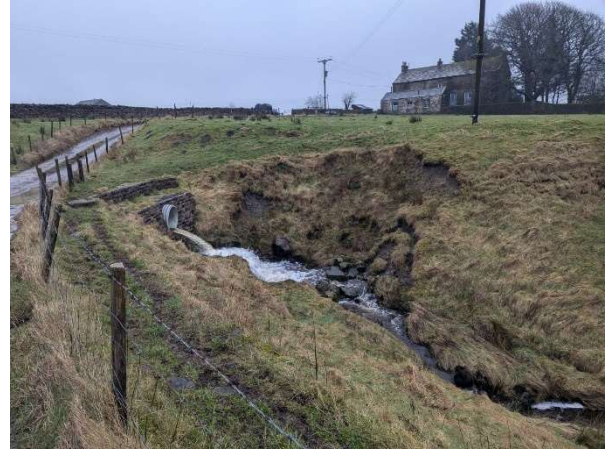
A brook flows southwest through the site and is culverted under the access road. The watercourse has an average width of 50cm and average water depth of 30cm. The substrate varies between boulder and grit/sand. The banks of the water course are natural and comprise grassland and bare earth and are steep in places. There is limited aquatic vegetation within the water and grasses and

rushes dominate the banks. The section of the watercourse that flows through the site is fully culverted with no open sections within the site boundary.

Photograph 4: Brook running through culvert under access track.

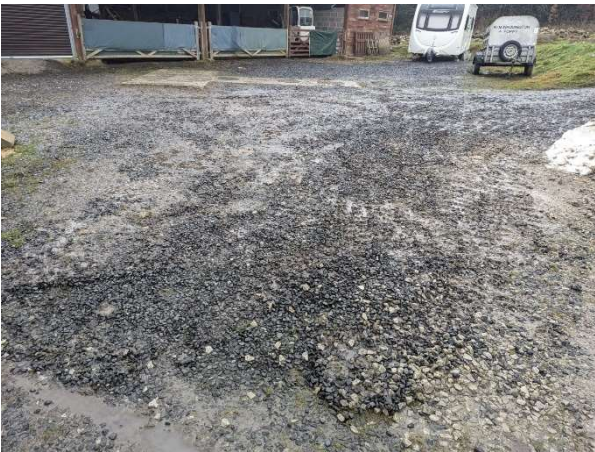
Photograph 2: Artificial unvegetated, unsealed surface currently used for parking.

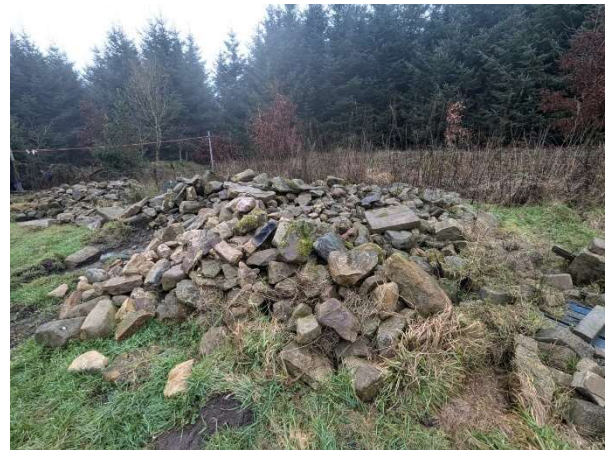
Photograph 5: Potential amphibian refugia in the north of the site (Target Note 1).

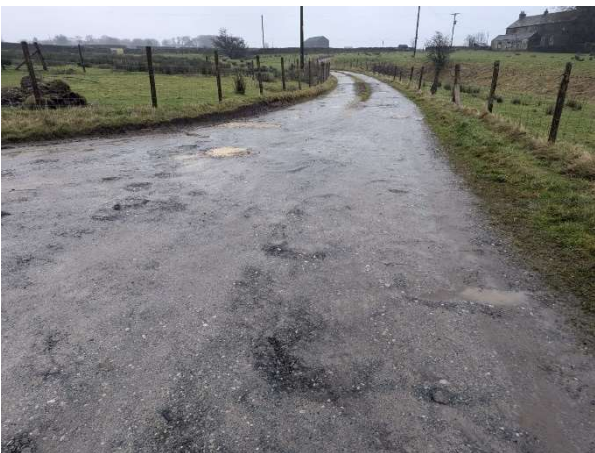
Photograph 3: Existing artificial substrate access road.

Access to the main development area is via a concrete track. The habitat is sparsely vegetated with grassland species inhabiting the verges in some areas. Species include perennial ryegrass (D) with frequent occurrences of Yorkshire fog (F), cock's-foot (*Dactylis glomerata*) (F), and creeping buttercup (F). Soft rush (O) is observed occasionally in wetter areas.

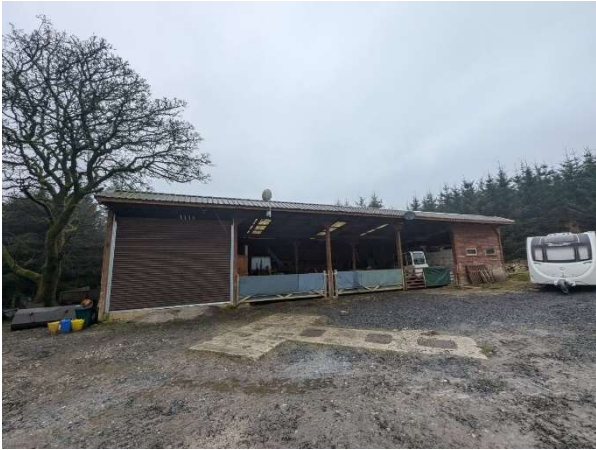
B1 is a wooden agricultural barn with timber cladding and a corrugated metal roof. The barn is open on its eastern aspect. No signs of bats (e.g. bat droppings) were identified during the survey. Overall, the barn is in good condition with only minor signs of damage/decay which could be used by roosting bats. Three potential roost features (PRFs) were recorded on the building which are described in Table 3.1 and Figure 3.1 below.

B1 is considered to have '**Moderate**' bat roost potential.

Photograph 6: B1 – eastern aspect of agricultural barn.

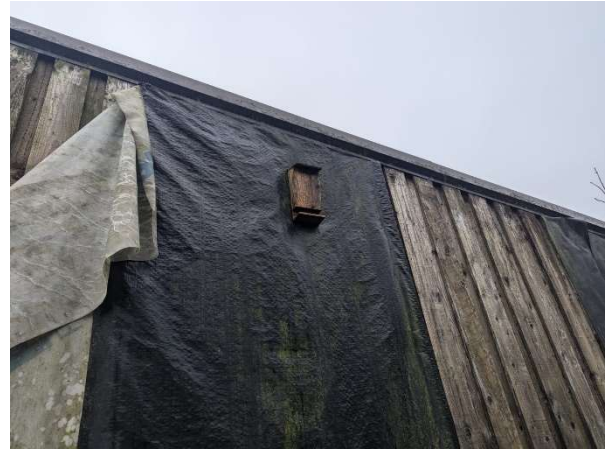
Photograph 9: B1 – PRF3: Wooden bat box on northern aspect of the barn.

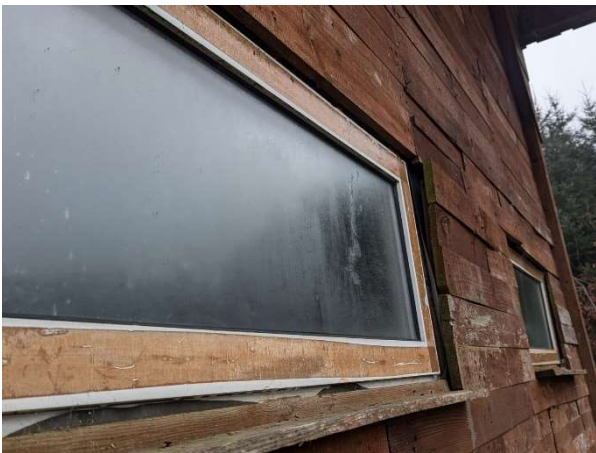
PRF ref	PRF description	PRF suitability
1	Gap under timber cladding right of window on eastern aspect. Gap has depth of approximately 20cm which could accommodate low numbers of crevice dwelling bats only.	Low

Photograph 7: B1 - PRF1: Gap behind cladding right of window on eastern aspect.

As B1 is to be retained and potential roost features on the building will not be impacted by the development, no further surveys will be required.

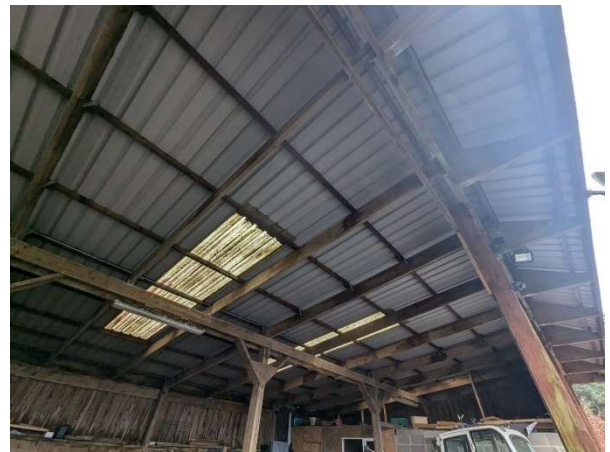
No nests were identified within B1, however, the open structure has "**High**" potential for nesting birds.

Photograph 10: Internal structure of B1.

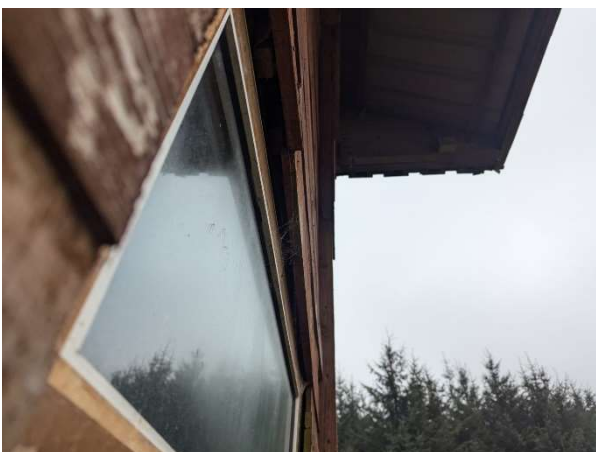
2	Gap under timber cladding above window on eastern aspect of the building. Gap has depth of approximately 40cm, but it is unlikely to lead into a larger cavity. This feature has potential to accommodate small-moderate numbers of crevice dwelling bats.	Mod
3	Wooden rectangular bat box on northern aspect of the building. The bat box is clear of obstructions and faces the adjacent woodland. This bat box design has potential to accommodate moderate numbers of crevice dwelling bats but is unlikely to be support larger roosts such as maternity.	Mod

Photograph 8: B1 – PRF2: Gap under cladding over window on eastern aspect.

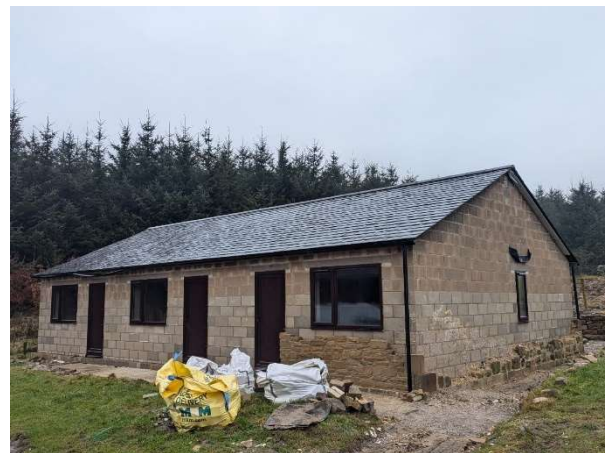
B2 is a single-storey residential building which currently comprises three dwellings separated by internal walls. The building is to be converted into two dwellings as part of the development proposals. The building is in a state of partial construction with completed exterior block walls and pitched timber and slate roof. The roof is vaulted and is lined with a breathable membrane. The building is in good condition typical of a newly built structure. There are no signs of damage or decay and no gaps on the exterior or interior of the building which could be used by roosting bats.

B2 is considered to have '**Negligible**' bat roost potential.

Photograph 11: Western and southern aspects of B2.

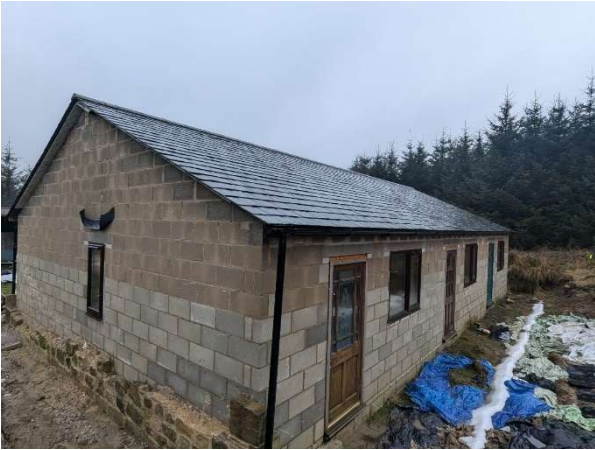
Photograph 12: Southern and eastern aspects of B2.

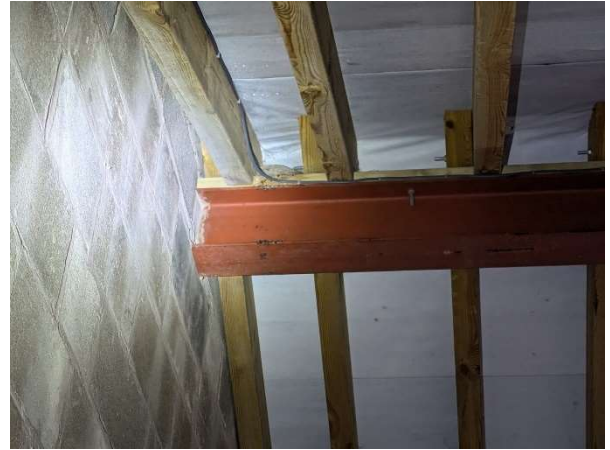
A historic swallow nest was recorded within B2. This is likely to have been built during a phase of construction when the building was not sealed.

Photograph 15: Historic swallow nest on steel ridge beam in southern-most section of B2.

Additional bird nesting provisions should be included upon the new buildings. These enhancement measures would contribute to achieving an overall biodiversity net gain for this proposal.

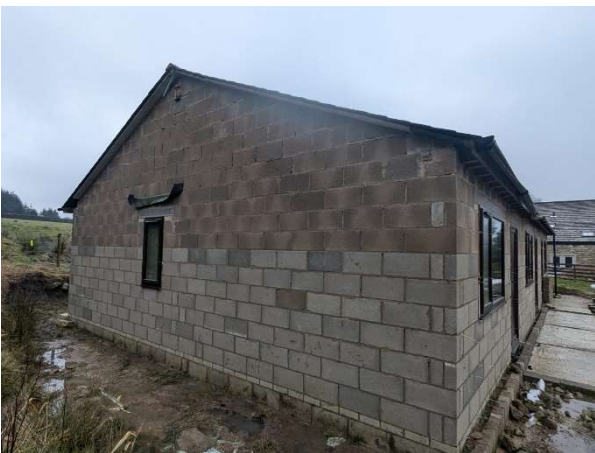
Photograph 13: Northern gable of B2.

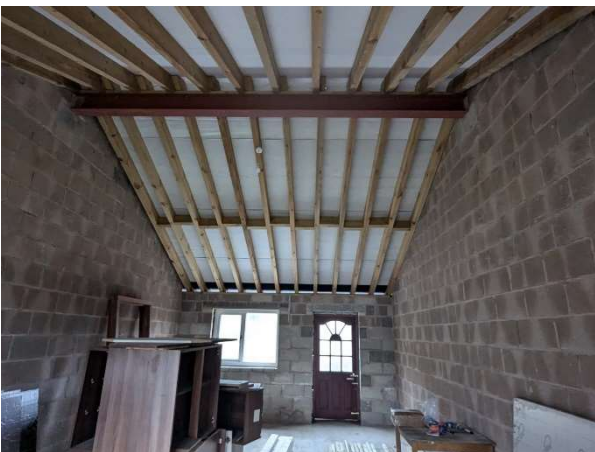
Photograph 14: Internal structure of B2 showing vaulted ceiling with breathable membrane.

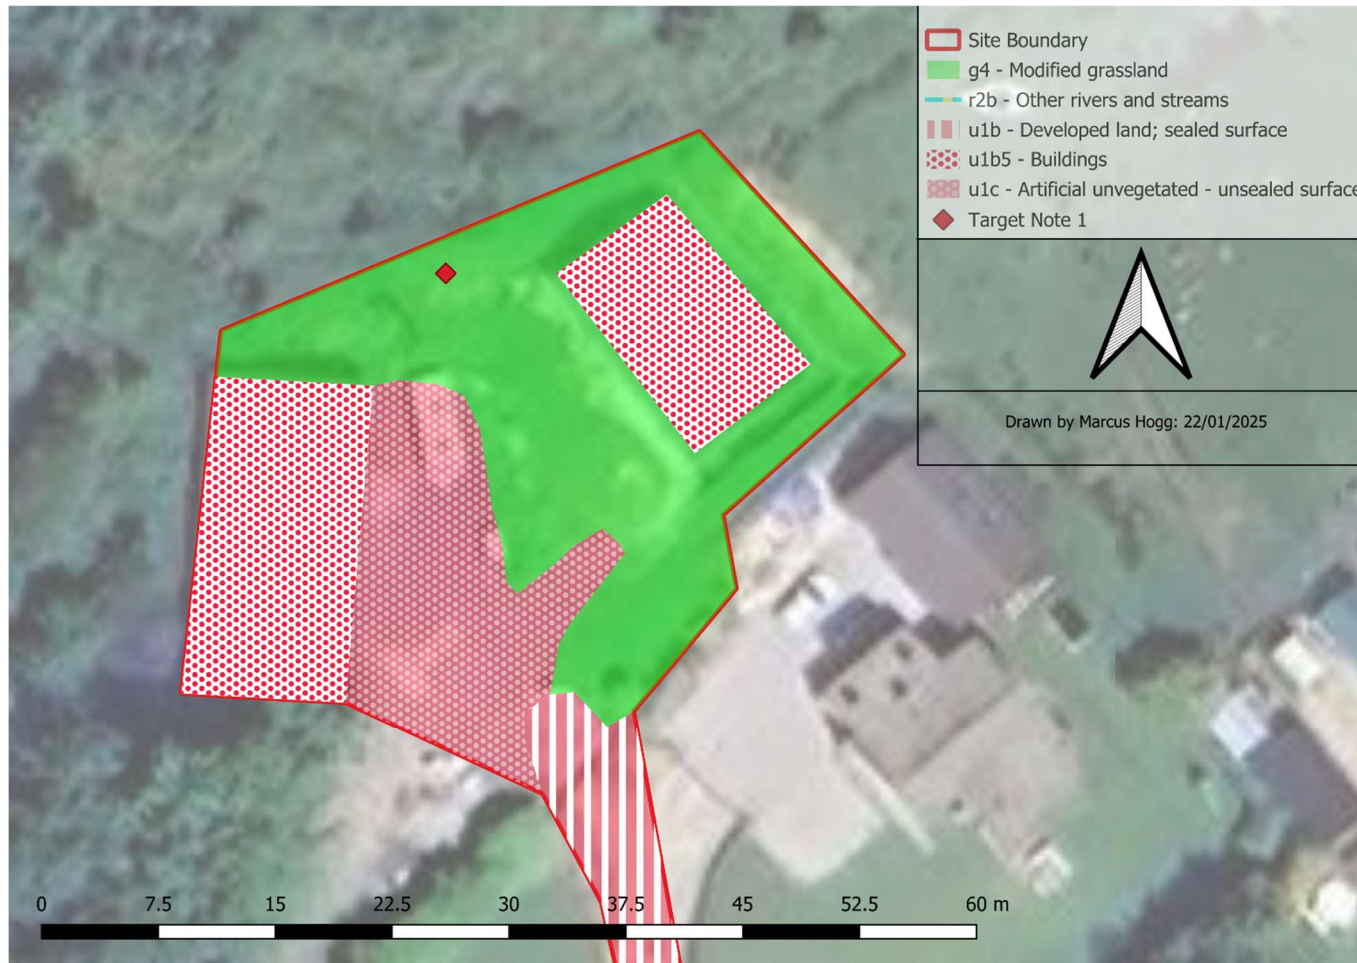
Figure 1 – UKHabs Baseline Map

A UK Habitat Classification (UKHabs) survey (UKHab Ltd, 2020) of the habitats within the red line boundary was undertaken on 21/01/2025. The site's habitats were mapped, and vascular plant species were recorded and given a DAFOR ((Dominant (D), Abundant (A), Frequent (F), Occasional (O), Rare (R)) score. Each habitat was given a distinctiveness and habitat condition score (Natural England, 2023). Secondary codes have been applied where required to describe the primary habitats. Habitats have been mapped using the fine-scale minimum mapping unit.
