TECHNICAL NOTE: PRELIMINARY BAT ROOST ASSESSMENT

SITE NAME & ADDRESS	19 Scott Avenue, Simonstone, BB12 7HY
DATE	11 th November 2024
AUTHOR	Ryan Knight BSc (Hons) MCIEEM - Principal Ecologist
AGENT	Sunderland Peacock and Associates Ltd

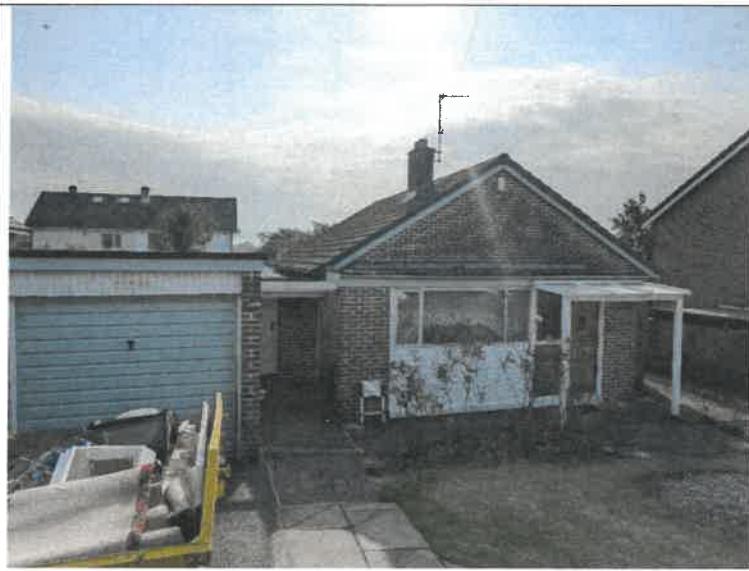
Photo 1.

Front (north) elevation.

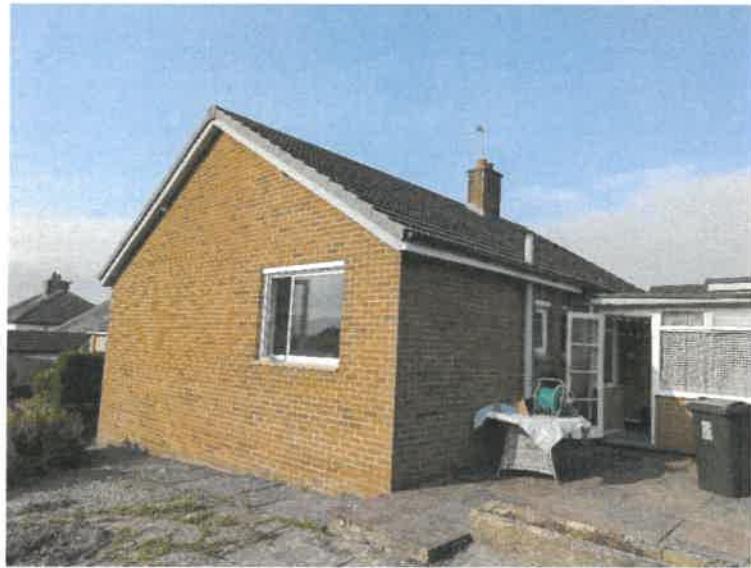
Photo 2.

Rear (south) elevation.

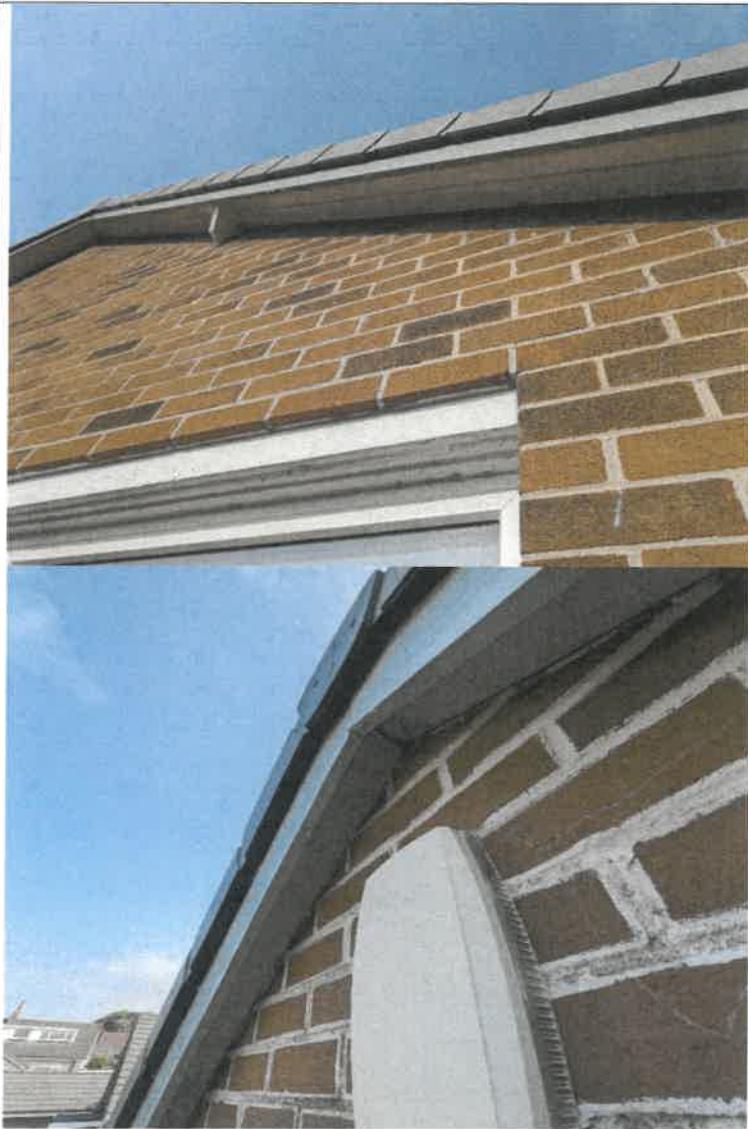
Photos 3 a & 3b.
Example of soffits
well sealed to the
walls.

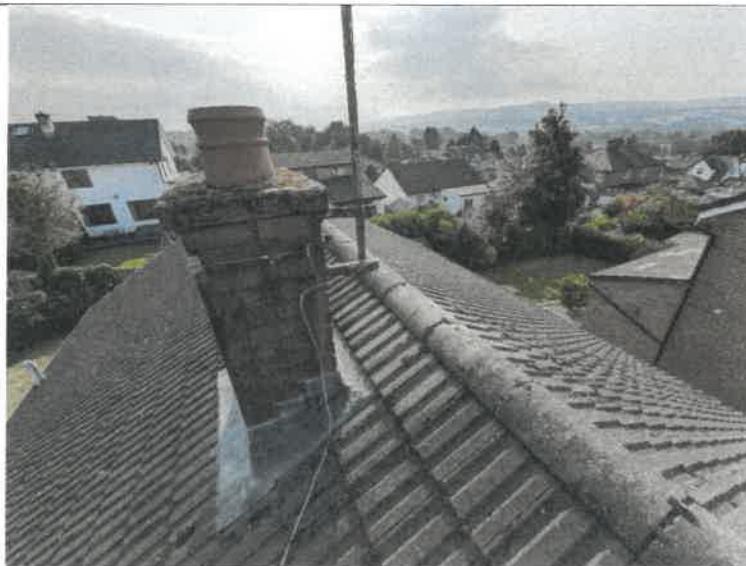
window. Upon further inspection, this gap was cluttered with detritus and cobwebs and did not appear suitable for use by bats. The loft of the property was disused and the loft floor was fully insulated throughout. The roof had a modern breathable underlining and no daylight gaps within the roof or suitable roost features within the roof trusses were observed.

Photo 4.
View of roof.

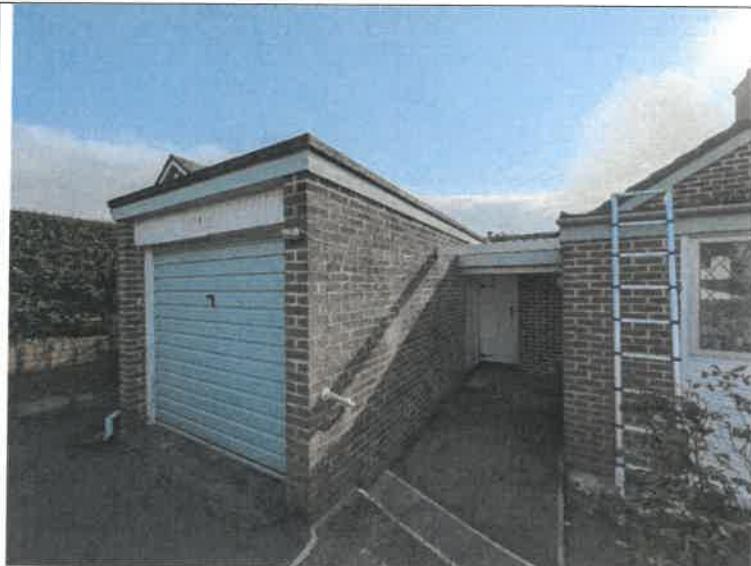
The garage and side extension were of a similar construction to the house and no potential roost features were recorded.

Photo 5.
Garage (north elevation).

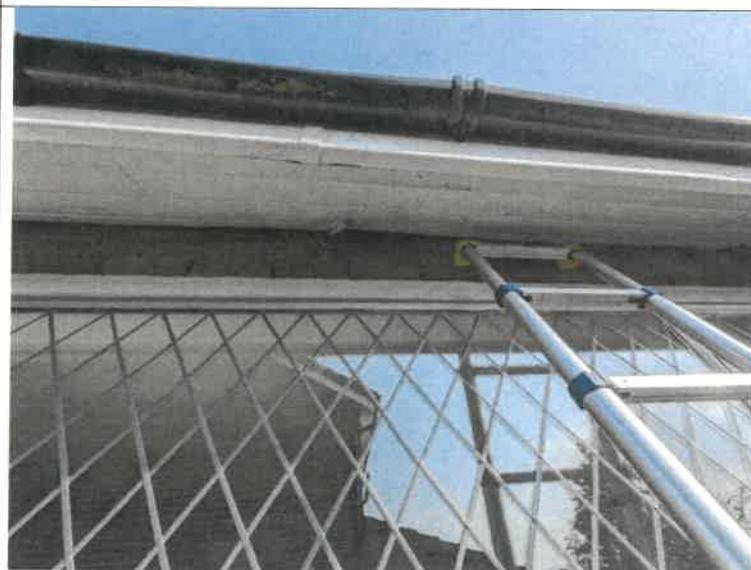
Photos of the property are provided at the foot of this document. The property comprised a brick-built bungalow with a flat roofed side extension which is also connected to a flat roofed garage. The bungalow had a pitched gable roof with interconnecting concrete tiles and modern plastic dry verge caps. The roof also had a dry ridge system. No suitable roost features were identified in the roof. The property featured uPVC fascias and soffits aside from the front elevation (timber) and overall, the house appeared to be well maintained. The soffits were tightly sealed to the wall on all elevations aside from the south elevation where there was a small 15mm-20mm gap adjacent to a water pipe above a

Photo 6.
Gap in soffit from
spout above
window. Sub-
optimal suitability
for bats.
