**BAT SURVEY AT -
WOODCOTE
YORK LANE
LANGHO**

DATE AND TIME OF VISIT
12TH FEB 2025 5,00PM

REFERENCE. Mr R SINGH

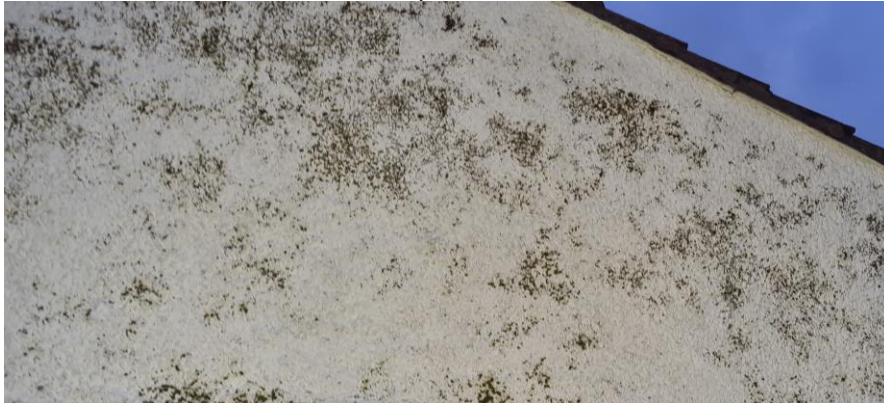
The house walls have a textured white painted render finish

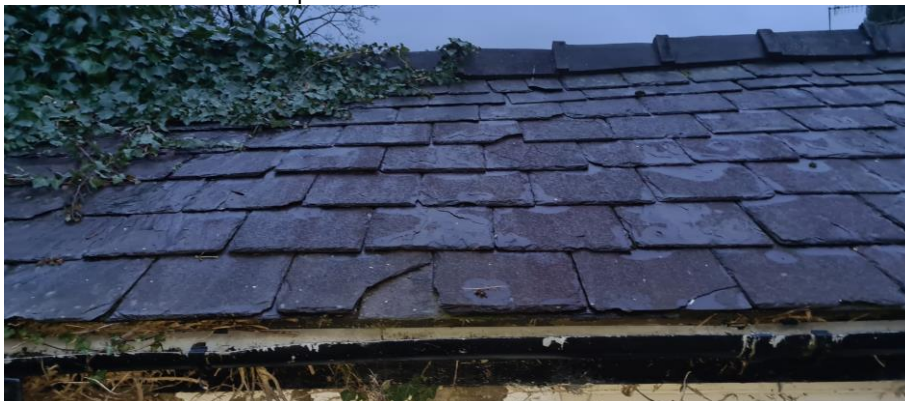
Garage roof

The garage roof is pitched with blue slate finish and ridge tiles. The verges are pointed.

There are no fascia boards present. .

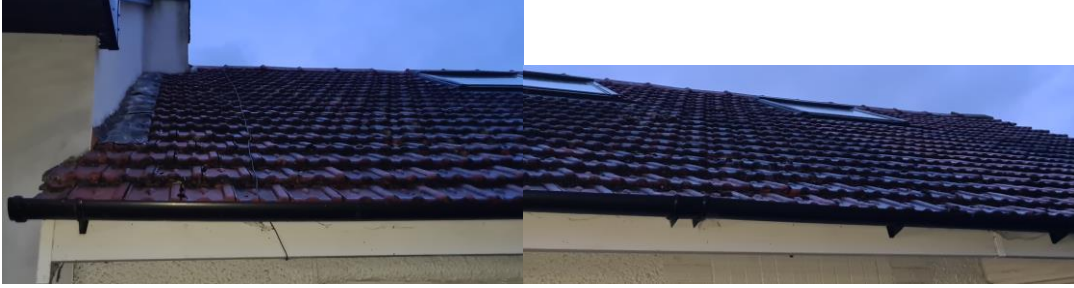
House Front roof pitch

The house main roof has ridged concrete roof tiles with mortar fixed ridge tiles. Two roof windows are present in the front pitch. There is an overhang to the front elevation with a boarded soffit .The abutment with the adjacent property is lead flashed to the wall. The verges are pointed.

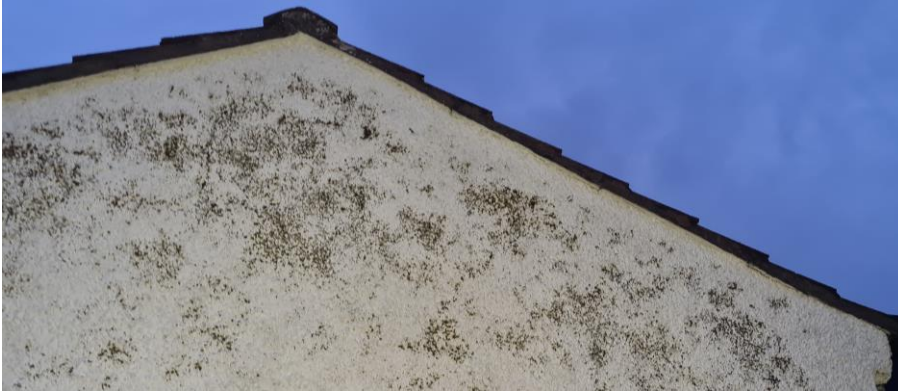
Rear extension with pitched roof.

Ridged concrete roof tiles with mortar fixed ridge tiles vented soffits to the eaves fascias.

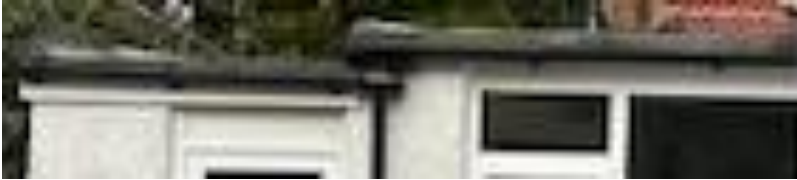
Rear Flat roof extensions

The rear extensions have a felt finish with flush fitting fascias .

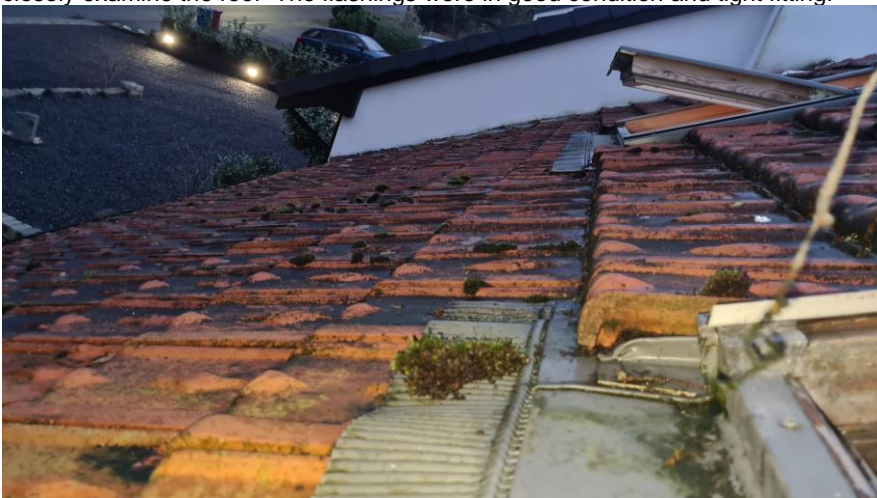
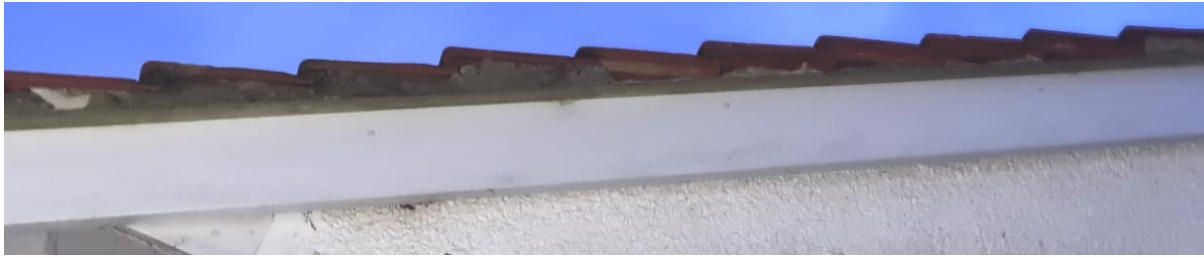
The main roof and pitched rear extension tiles are all in reasonable condition and tight fitting it was possible to closely examine the roof The flashings were in good condition and tight fitting.

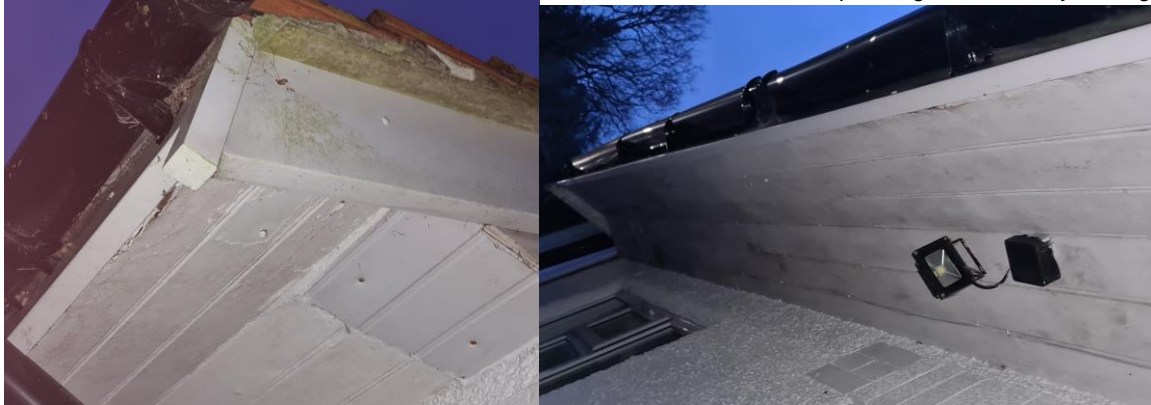
The verge pointing was slightly degraded, however there were no crevices deep enough to allow any bat ingress.

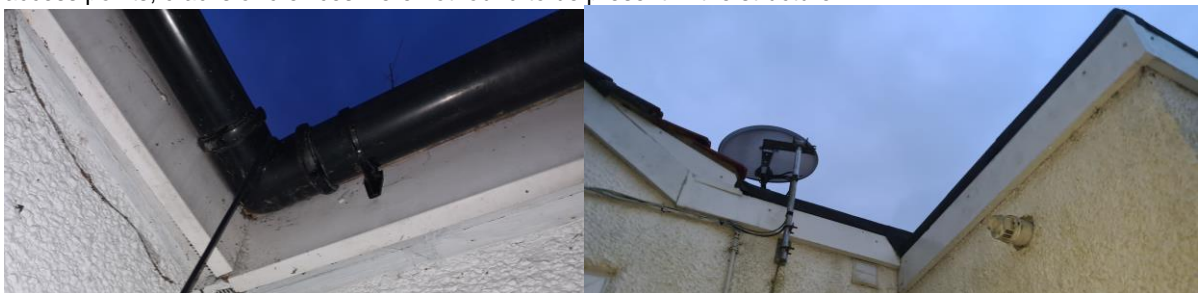
The overhang soffits are in very good condition and did not provide any access points

The flat roofs are in good condition with no degradation or lifted joints. The fascias are flush fitting, access points, cracks or crevices were not found to be present in the structure..

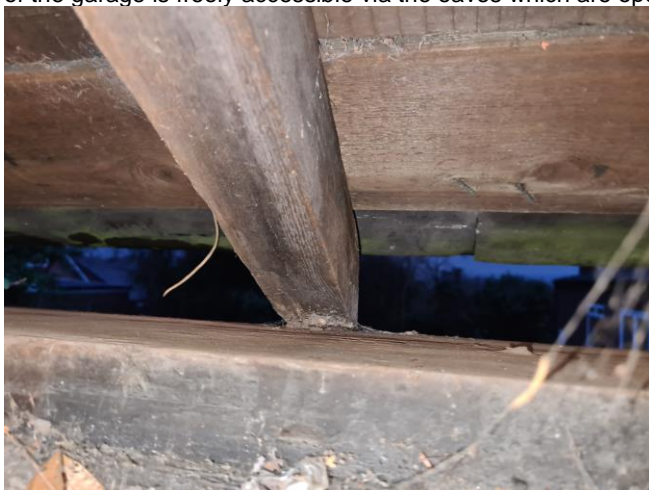
The Garage roof has some broken slates, however they are tight fitting with no gaps or lifted slates. The interior of the garage is freely accessible via the eaves which are open. .

If the re roofing of the garage is to be carried out during the activity period (April-September) although no signs of current or historic Bat presence were found, its accessibility necessitates a further inspection to check the status regarding bat presence prior to the re roofing commencing.

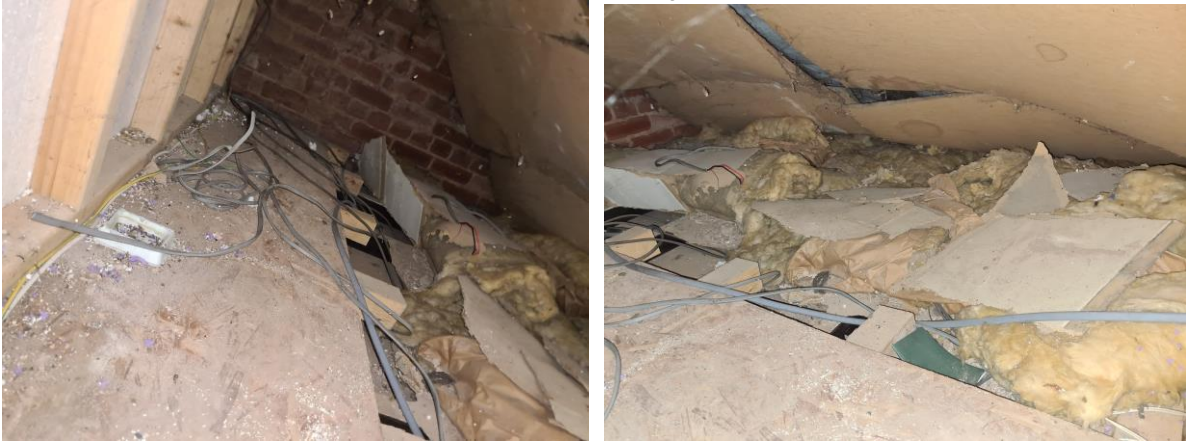
The main roof void has been converted to form a room which is accessed via a spiral stair the floor is boarded and the rafters are lined with plasterboard. The room is well lit by velux roof windows, stud walls are present with access hatches to the eaves voids which could be closely examined. The spaces were clean with no signs of current or historic signs of Bat presence they did not provide high value roost habitat.

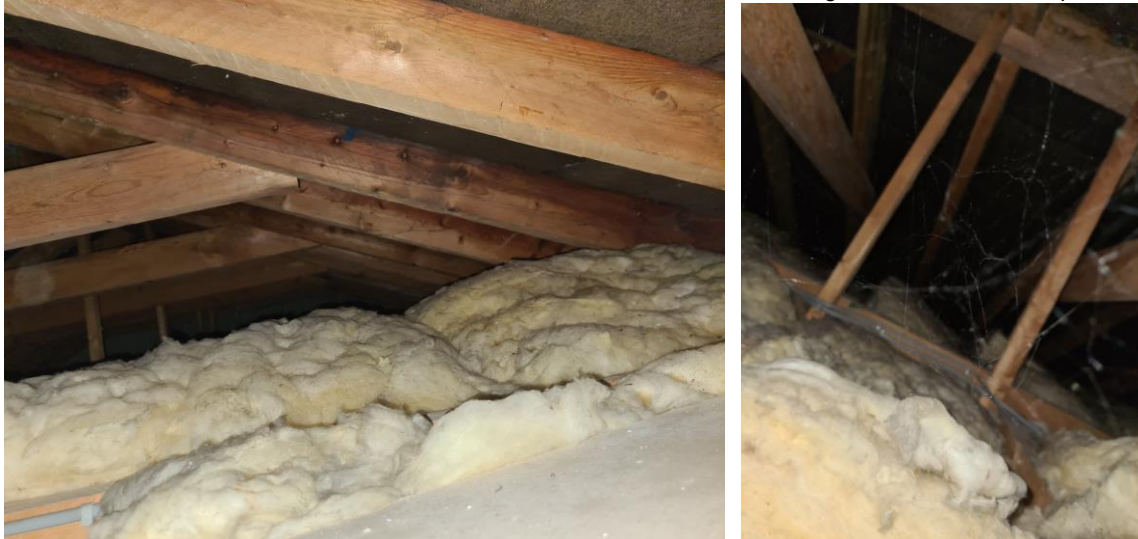
The pitched roof void over the rear extension was accessible via a ceiling hatch. The timber rafters were in excellent condition as was the felt. Insulation quilt was present between the ceiling joists. The space was clean with no signs of current or historic signs of Bat presence there was no high value roost habitat present.

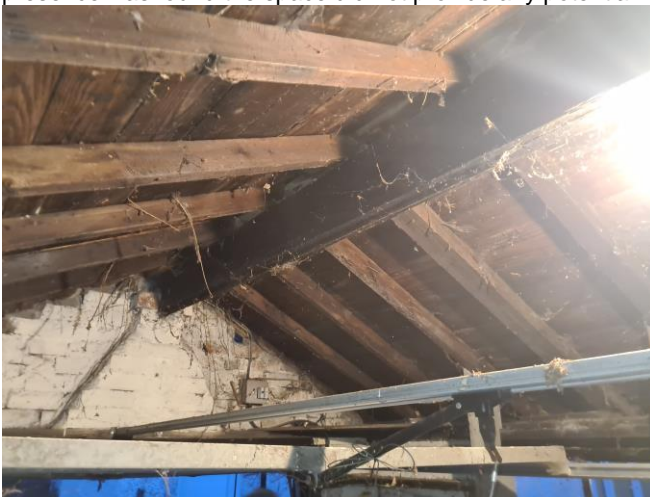
Garage roof structure was timber rafters with sarking board over. There was no enclosed roof void in the building the structure was fully visible and easily inspected. All the timbers were in reasonable condition with no rot, cracks or crevices. The space was very draughty due to the open eaves. No signs of current or historic Bat presence was found the space did not provide any potential roost habitat for bats.
