Re: Proposed development at 55 Fairfield Drive, Clitheroe, BB7 2PS

We understand that the proposal is for the construction of a roof dormer on the east (rear) and west (front) elevations.

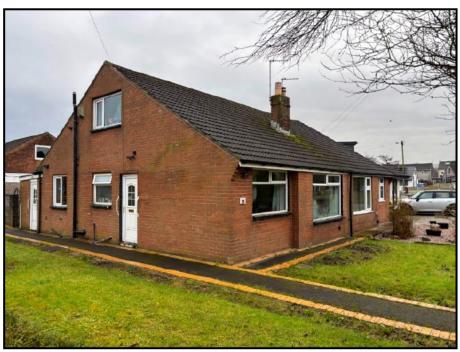
Image showing north west gable and south west (front) elevation of 55 Fairfield Drive.

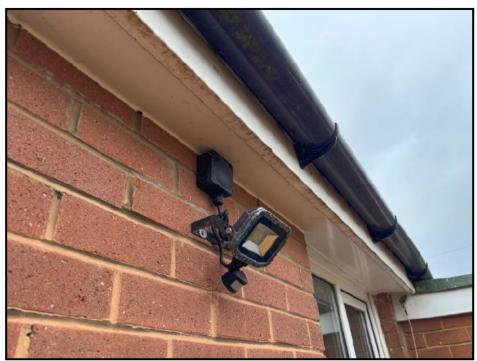
55 Fairfield Drive is an occupied, semi-detached bungalow. The walls are constructed of brick, in good condition with no gaps. The roof is covered with cement interlocking tiles, well-sealed apart from a small number of gaps around the base of the chimney associated with lead flashing. All windows, doors and soffits are upvc, sealed tight with no gaps. The north west gable, although well mortared, has two discrete gaps; both of which were inspected with an endoscope. No signs of use or evidence of bats or birds were found to be present.

Image showing sealed soffits, no gaps present along roof edges.

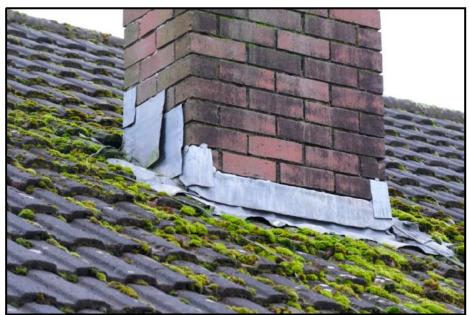
Low potential – small, discrete gaps associated with the lead flashing at the chimney base and a single potential access point into roof void from the northwest gable verge.

Low potential – small, discrete gaps associated with the lead flashing at the chimney base.

Image showing lead flashing on chimney base with some small gaps and cavities present providing some potential for use by bats.

Protected	Impacts, Issues & Rationale	Action Required
Species		-
Bats	There are no known impacts to	Advice (mitigation):
	bat roosts as a result of the	All personnel involved in the
	proposed development.	proposed development should be
		carefully advised about bats, so that
	It is advised that there are	all works are undertaken with a clear
	potential roost features suitable	understanding about legal aspects,
	for bats associated with a small	precautions to be adopted and what to
	number of gaps lead flashing and	do if a bat is found. Prior to
	gable edge. In this location and	development.
	landscape setting, these features	
	have low potential for bats to	Advice (mitigation): As a precaution,
	use throughout the year.	it is advised that when removal or
	All bat apaging and bat recets are	disturbance of potential roost features
	All bat species and bat roosts are afforded full protection under	such as lead flashing are to take place, this should be done carefully by hand.

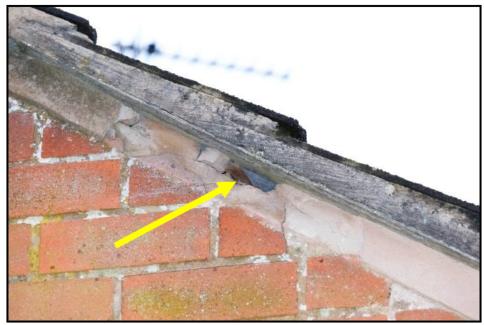
Image showing single cavity on north west gable with some potential for bats to gain access into roof void.

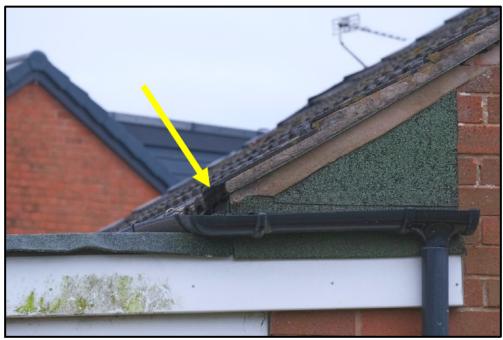
There is potential for birds, including house sparrows, to utilise the lower roof edge gap on the north west gable as well as garden vegetation (cherry trees and low hedge) during the nesting season (February to September).

Image showing gap on lower roof edge of north west gable with potential for use by nesting birds.

Protected species	Impacts, Issues & Rationale	Action Required
Nesting	There are potential impacts	Advice (mitigation): It is advised that the
birds	(disturbance, damage and	most appropriate way to address the risk to
	destruction) to nesting birds,	nesting birds is:
	nests and eggs as a result of the	
	proposed development.	Avoid disturbance to the building during the nesting season.
	It is advised that there is potential	Or
	for birds to utilise the building	If works cannot be delayed, the proposed
	and garden vegetation during the	work area should be carefully checked,
	bird nesting season (February to	immediately prior to works commencing.
	September).	Checks should be carried out by a suitably experienced ecologist. If the risk of nesting
	Under the Wildlife and	birds remains, then monitoring for nesting
	Countryside Act 1981 (as	bird activity should continue for the
	amended), wild birds are	duration of works. Prior to any work

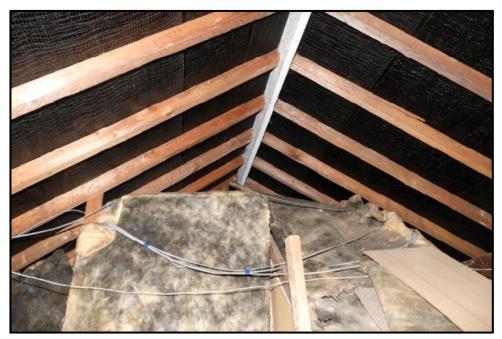
There is a single, large roof void accessed via a door from a small bedroom. The roof void is traditional cut and pitch design with an exposed ridge. The roof is underlined with bitumastic hessian which is intact with no rips or sagging visible. Part of the floor is boarded with rock wool insulation beneath, and used for storage. The remaining floor comprises deep rock wool which has also been use to seal the roof edges at the eaves and the walls of the bedroom. The interior block walls are also well sealed with only one small potential access point for bats on the north west gable.

Image of roof void showing deep rock wool and intact bitumastic hessian roof liner.

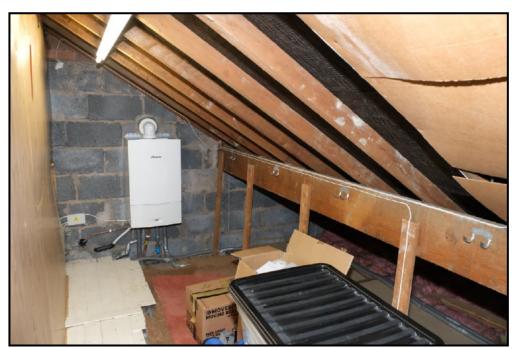
Image of roof void showing boarded floor and internal block walls. This area is currently used for storage.
